| REPORT DOCUMENTATION PAGE | | READ INSTRUCTIONS<br>BEFORE COMPLETING FORM |
|---|---|---|
| 4. TITLE (and Subtitle)<br>Phase I Inspection Report<br>Mead Reservoir Dam<br>Lake Champlain Basin, Clinton County, N.Y.<br>Inventory No. 237 | | 5. TYPE OF REPORT & PERIOD COVERED<br>Phase I Inspection Report<br>National Dam Safety Program |

**LAKE CHAMPLAIN BASIN  
MEAD RESERVOIR DAM  
CLINTON COUNTY, NEW YORK  
INVENTORY NO. N.Y. 237  
PHASE I INSPECTION REPORT  
NATIONAL DAM SAFETY PROGRAM**

**NEW YORK DISTRICT CORPS OF ENGINEERS  
AUGUST, 1981**

OVERVIEW  
MEAD RESERVOIR DAM  
I.D. NO. NY 237

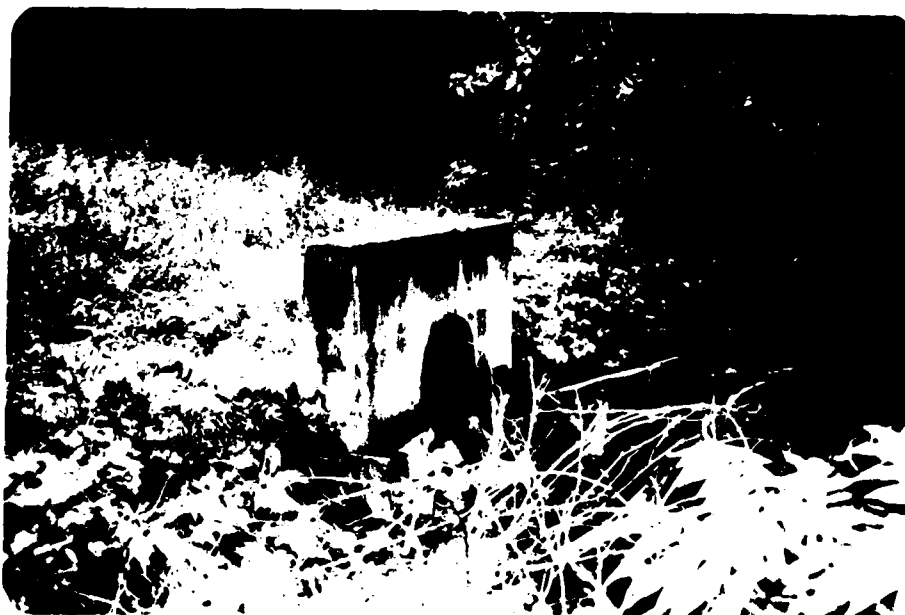
DIVERSION CONDUIT INTO RESERVOIR  
AT RIGHT END OF DAM

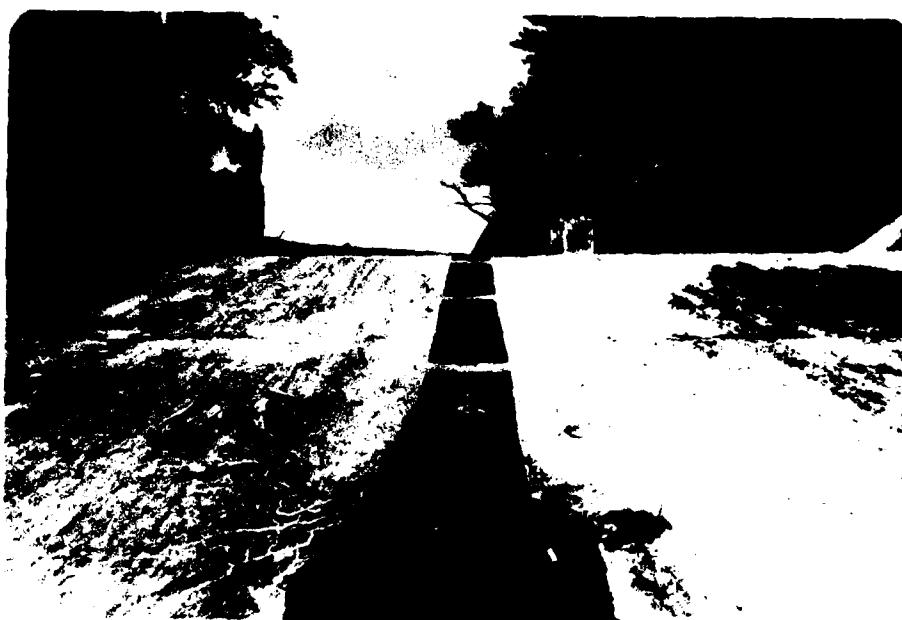
A small amount of water was flowing out of the concrete channel which drains the upper plunge pool. This water flowed over the concrete slabs which line the exit channel and then disappeared beneath the slabs. The water then reappeared approximately 50 feet downstream and flowed over the remainder of the slabs. There was grass and weeds growing through the joints between several of the slabs at the lower end of the channel. Some minor cracking was noted on the channel walls. The lower plunge pool was partially filled with sediment and debris. Brush and weeds were growing in this plunge pool as well. There was some debris around the inlet to the lower plunge pool drain conduit. A spring was observed bubbling up through the bottom of the lower plunge pool. This spring was probably related to the underdrain pipes beneath the spillway channel.

DRAINAGE CHANNEL FROM UPPER  
PLUNGE POOL TO EXIT CHANNEL
