WESTCOTT RESERVOIR  
ONONDAGA COUNTY  
NEW YORK

INVENTORY No. NY 1471

PHASE I INSPECTION REPORT  
NATIONAL DAM SAFETY PROGRAM

MAY 1981

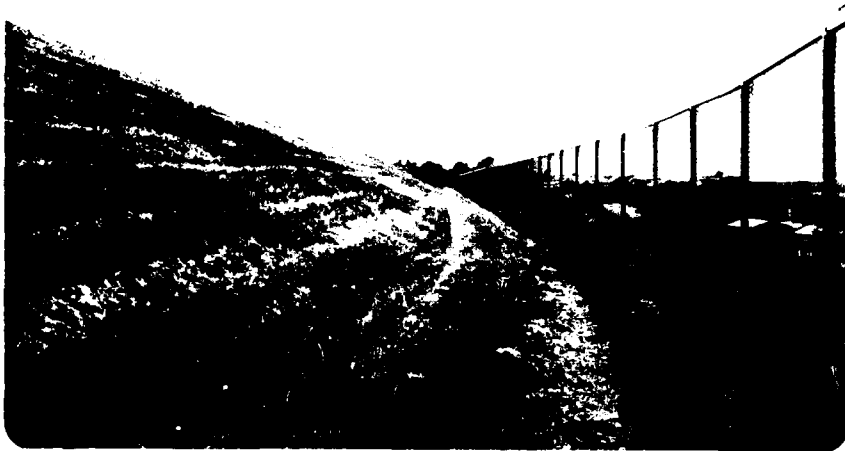
3. Top of westerly embankment.

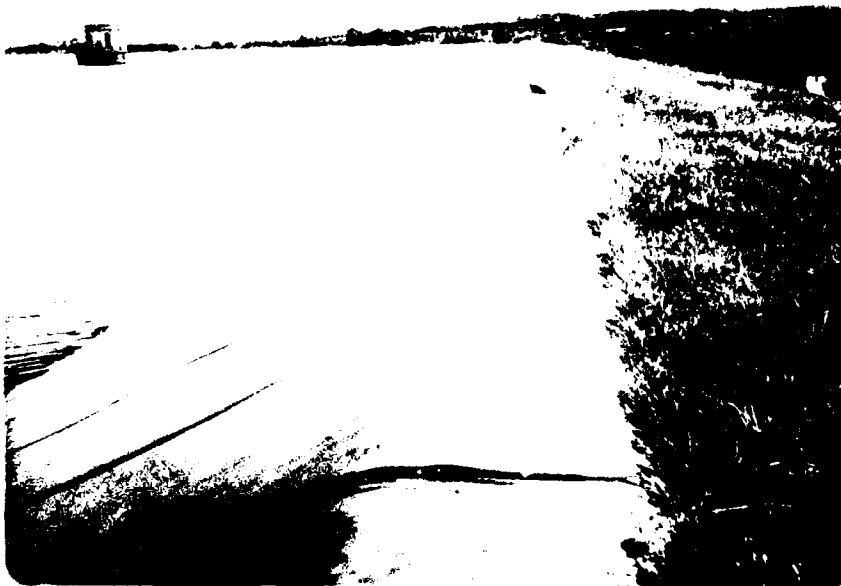
4. Easterly slope of embankment.
