NATIONAL DAM INSPECTION PROGRAM. POTIC RESERVOIR DAM (NY 00307)--ETC(U)

AUG 81 K J MALE

| REPORT DOCUMENTATION PAGE | | READ INSTRUCTIONS<br>BEFORE COMPLETING FORM |
|---|---|---|
| 4. TITLE (and Subtitle)<br>Phase I Inspection Report<br>Potic Reservoir Dam<br>Lower Hudson River Basin, Greene County, N.Y.<br>Inventory No. 307 | | 5. TYPE OF REPORT & PERIOD COVERED<br>Phase I Inspection Report<br>National Dam Safety Program |

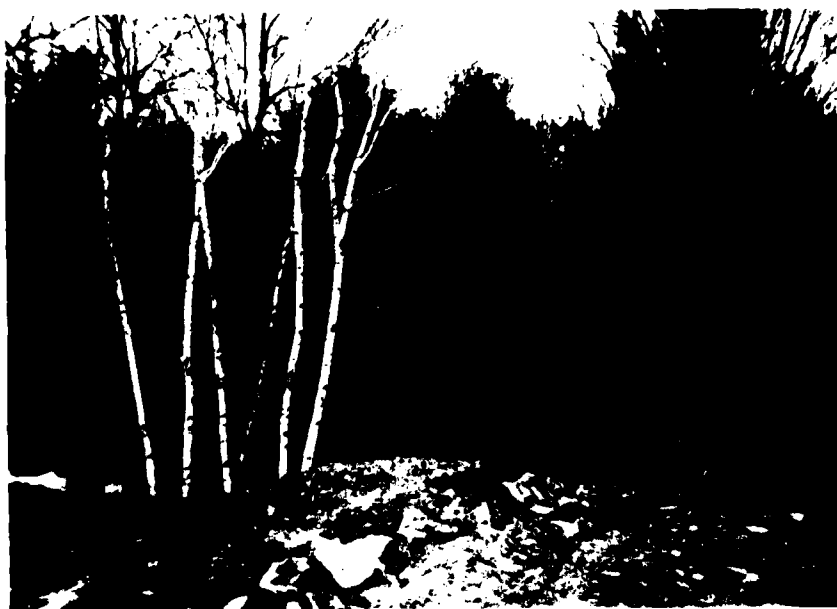
A-2B Downstream slope of dam looking from area recently filled  
with rock and construction debris - 4/9/81

- 1) Inspect the downstream side of the dam after the miscellaneous fill has been removed.
- 2) Measure the piezometric pressure in the embankment downstream of the core as recommended in Section 2.1c.
- 3) Investigate and monitor seeps along the concrete box diversion conduit, other selected seeps in the vicinity, and seeps that may be uncovered by removal of the miscellaneous fill.

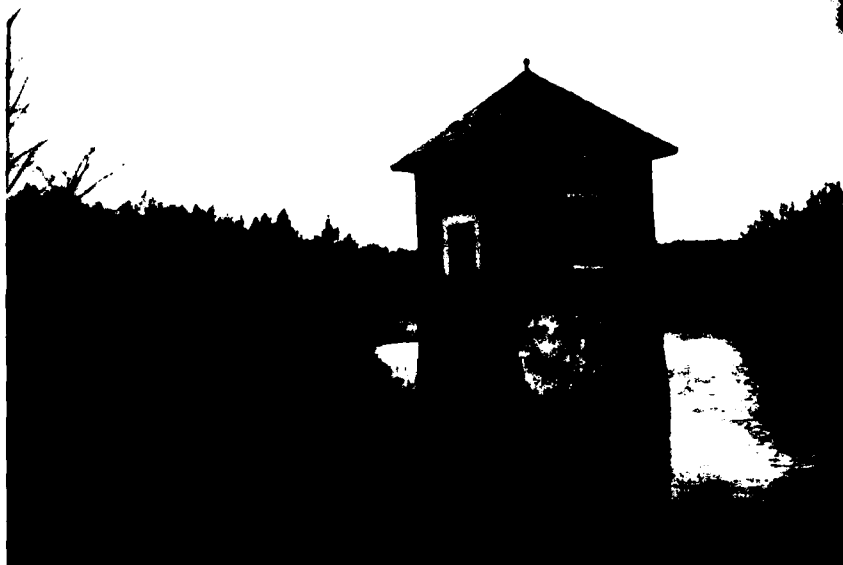
The gate house for the dam is a brick structure with a wood-framed, slate-shingled roof. The gate house was in good condition. The wooden parts of the gate house, however, could use a coat of paint. Inside the gate house there are 2 hand crank, bevel gear floor stand controls for the 2 slide gates at the bottom of the control tower (see Photo A-6A). Both of these control mechanisms were well lubricated, operable, and in good condition. The upstream gate was closed and the downstream gate was open at the time of inspection. The uppermost gate stem guide for the downstream gate is broken and detached from the stem.

The service bridge is a concrete walkway with steel pipe railings spanning from the gate house to the top of dam. The bridge deck and its supports are in good condition. The railings, however, are loose and are rusting in spots.

A-5B Gate house and service bridge - 4/9/81

- 9) Repair the uppermost gate stem guide on the downstream gate in the intake structure.
  - 10) Develop and implement effective routine operation and maintenance procedures for the dam and its appurtenances. The sluice gates and blowoff valve should be exercised regularly.

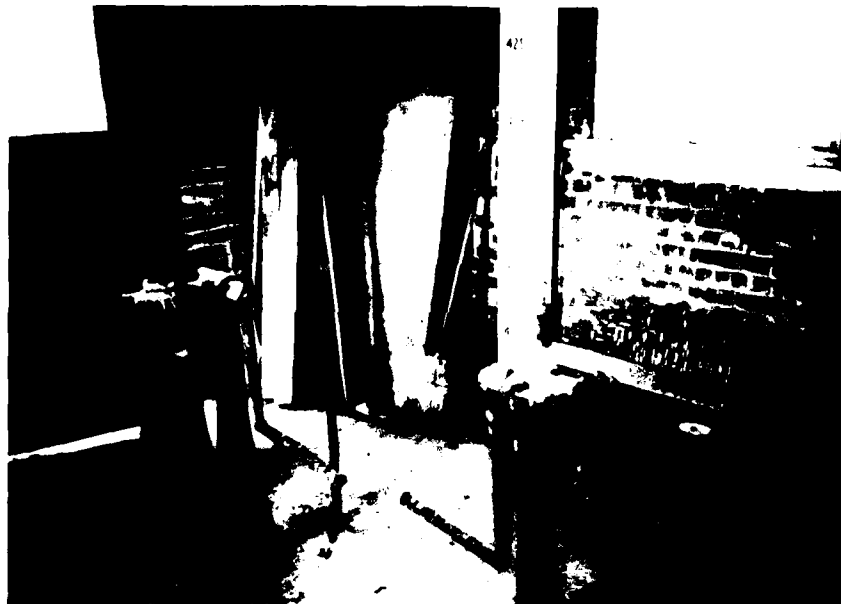
A-6A Hand crank, bevel gear floor stand controls for slide gates  
4/9/81

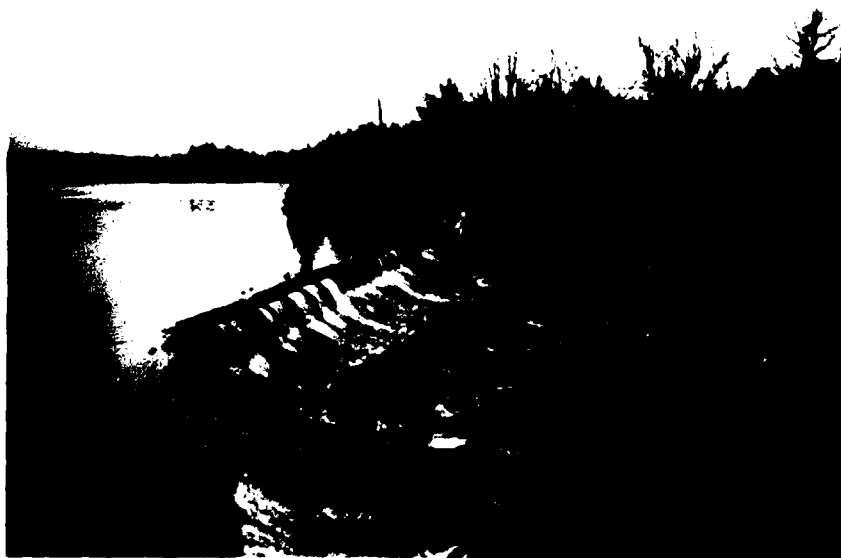
The ogee weir cap is in fairly good condition (see Photos A-7B, A-8A, and A-8B). The toe of the ogee section is broken off in spots and there is some deterioration of the concrete at the construction joints. There is some leakage through the flashboards and some of their support pipes are bent.

A-8B Ogee spillway weir cap looking toward left abutment 4/9/81
