MALE (C T) ASSOCIATES SCHENECTADY NY  
NATIONAL DAM INSPECTION PROGRAM. WRIGHT LAKE DAM (NY 00757), LO--ETC(U)  
AUG 81 K J MALE

Phase I Inspection Report  
Wright Lake DamLower Hudson River Basin, Rensselaer County, N.Y.  
Inventory No. 7575. TYPE OF REPORT & PERIOD COVERED  
Phase I Inspection Report  
National Dam Safety Program

KENNETH J. MALE

18 August 1981

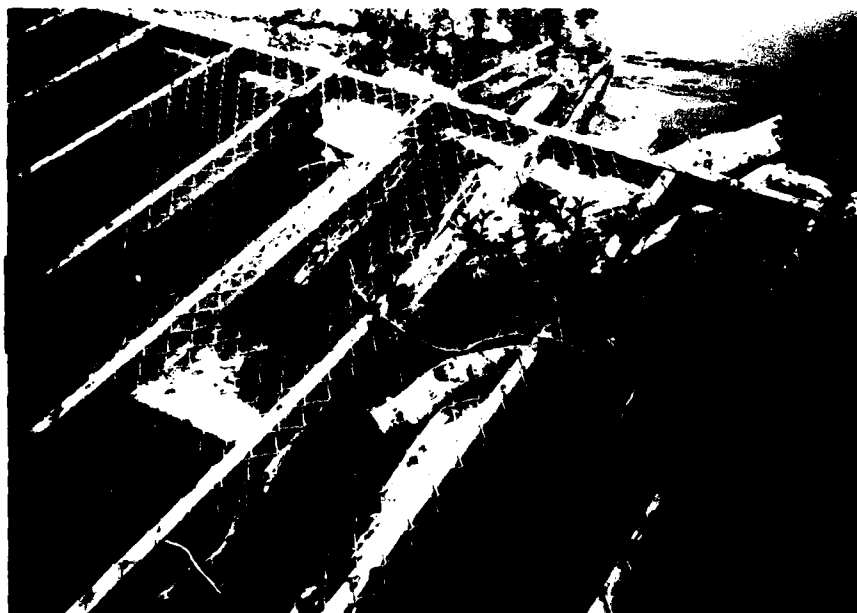
A-6B View of drop inlet weir at location of displaced capstone - 5/6/81
