PHASE I INSPECTION REPORT  
NATIONAL DAM SAFETY PROGRAM  
STUMP POND DAM  
I.D. No. NY 746  
CORTLAND COUNTY, NEW YORK

| Date of Inspection: | October 23, 1980 |

PHASE I INSPECTION REPORT  
NATIONAL DAM SAFETY PROGRAM  
STUMP POND DAM I.D. NO. NY 746  
DEC #95A-4270 SUSQUEHANNA RIVER BASIN  
CORTLAND COUNTY, NEW YORK

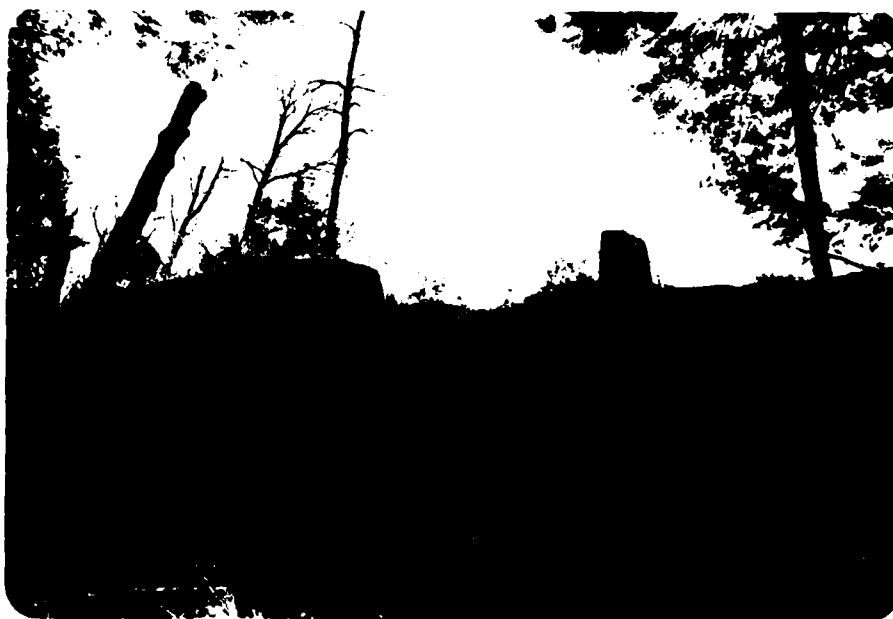
5. A bulge was noted in the laid up stone segment below the spillway section (see photo 7).
6. The stones at the right end of the dam were displaced upward above the horizontal with respect to the remainder of the dam (see photo 8).

Photo 8 - Downstream Face of Dam -- Note Tilting Stones to Left and Concrete Footing at Base of Dam
