NATIONAL DAM SAFETY PROGRAM. LITTLE CHOCONUT WATERSHED SITE 2E --ETC(U)

| REPORT DOCUMENTATION PAGE | | READ INSTRUCTIONS<br>BEFORE COMPLETING FORM |
|---|---|---|
| 4. TITLE (and Subtitle)<br>Phase I Inspection Report<br>Little Choconut Watershed Site 2E Dam<br>Susquehanna River Basin, Broome County, N.Y.<br>Inventory No. 723 | | 5. TYPE OF REPORT & PERIOD COVERED<br>Phase I Inspection Report<br>National Dam Safety Program |
| 9. PERFORMING ORGANIZATION NAME AND ADDRESS<br>Flaherty-Giavara Associates<br>One Columbus Plaza<br>New Haven, CT 06510 | | 8. CONTRACT OR GRANT NUMBER(s)<br>151 DACW51-81-C-9996 |
| 13. MONITORING AGENCY NAME & ADDRESS (if different from Controlling Office)<br>Department of the Army<br>26 Federal Plaza New York District, CoFE<br>New York, NY 10287 | | 12. REPORT DATE<br>11 30 June 1981 |

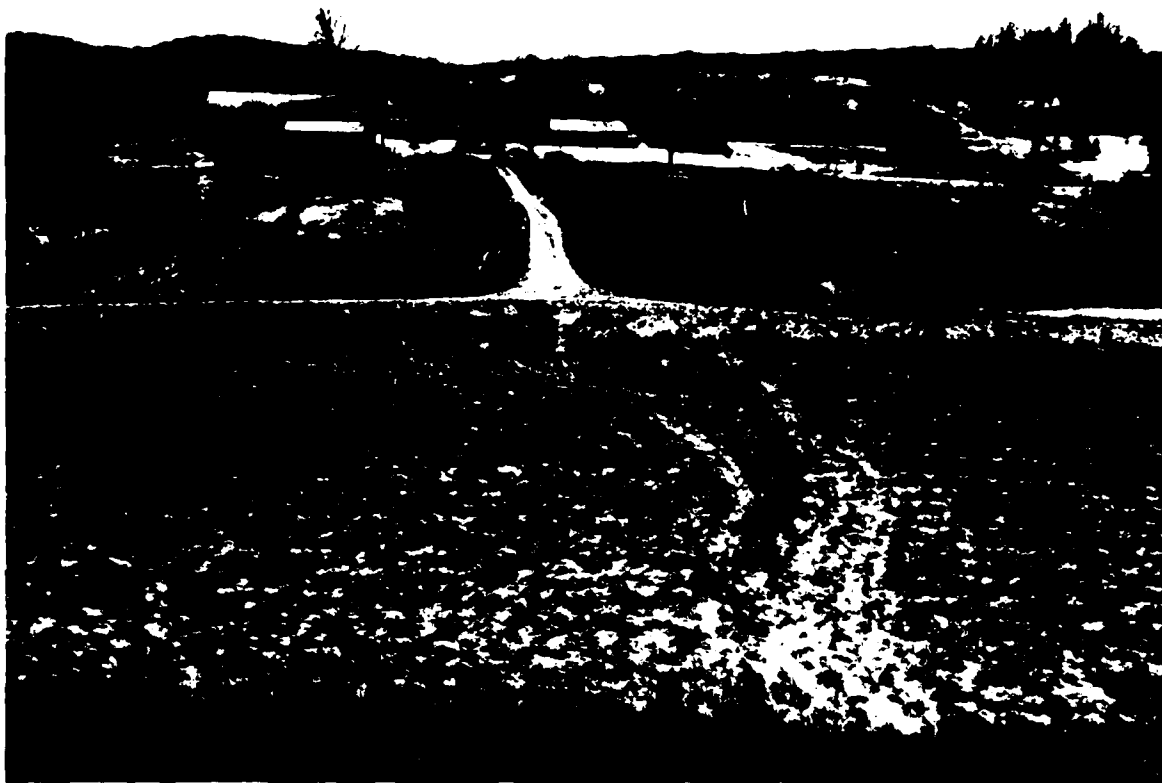
PHOTO #1: Overview of  
Little Choconut Watershed Site 2E Dam  
Inventory No. NY 725

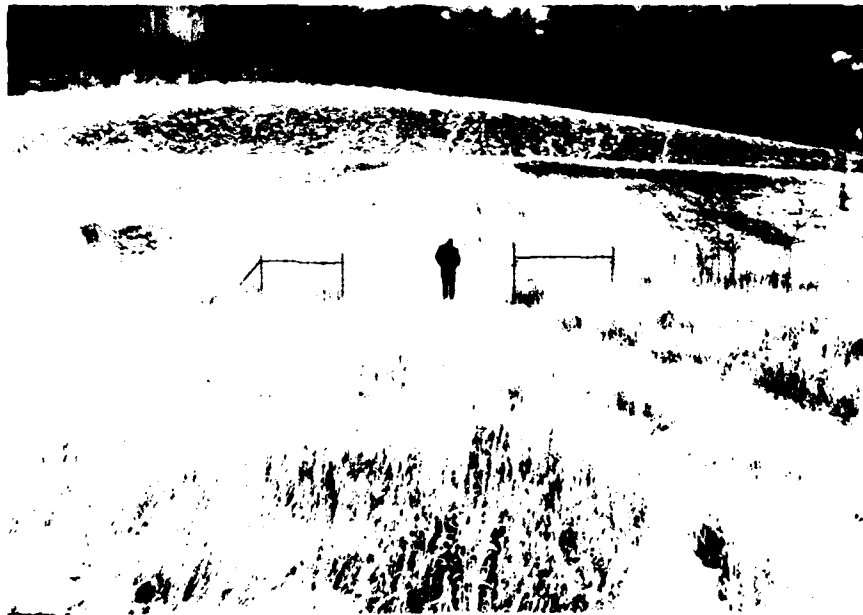
4. The gate was open and apparently traffic has worn slight ruts along the crest (See Photo No. 3).
5. A small quantity of broken rock was evident at the contact between the upstream embankment slope and the left abutment. This may indicate past erosion.

- c. Toe drain pipes discharging on either side of the principal spillway outlet pipe project unsupported for about 5 feet.
- d. The gate was open and apparently traffic has worn slight ruts along the crest.

PHOTO #3: Crest of dam looking toward left abutment

1. Repair the small eroded area on the downstream slope at the right abutment using granular fill and broken stone to permit drainage.
2. Mow the grassed slopes of the embankment and emergency spillway channel at least annually.
3. Restore the riprap support or shorten the toe drain outlet pipes.
4. Control access and vehicular traffic and take necessary measures to prevent further rutting of the crest.

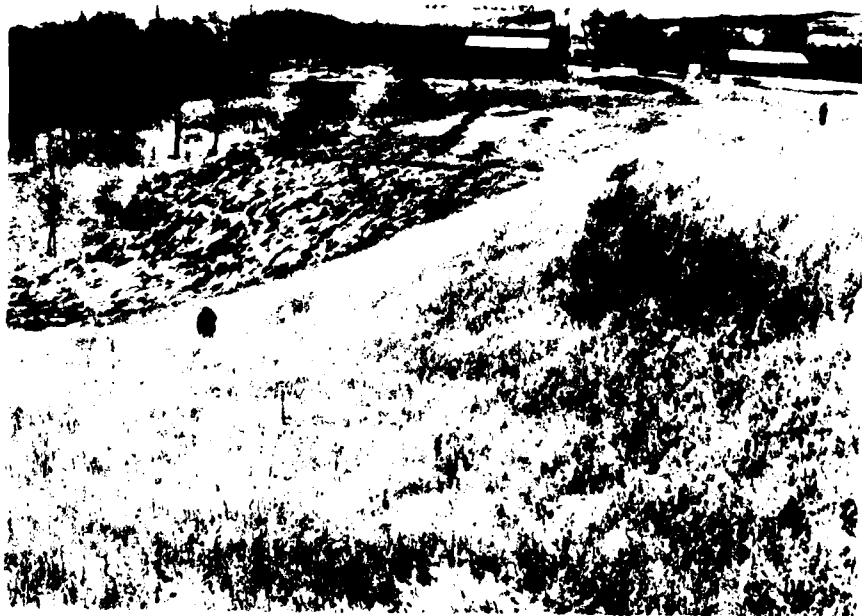
PHOTO #5: Downstream face of dam

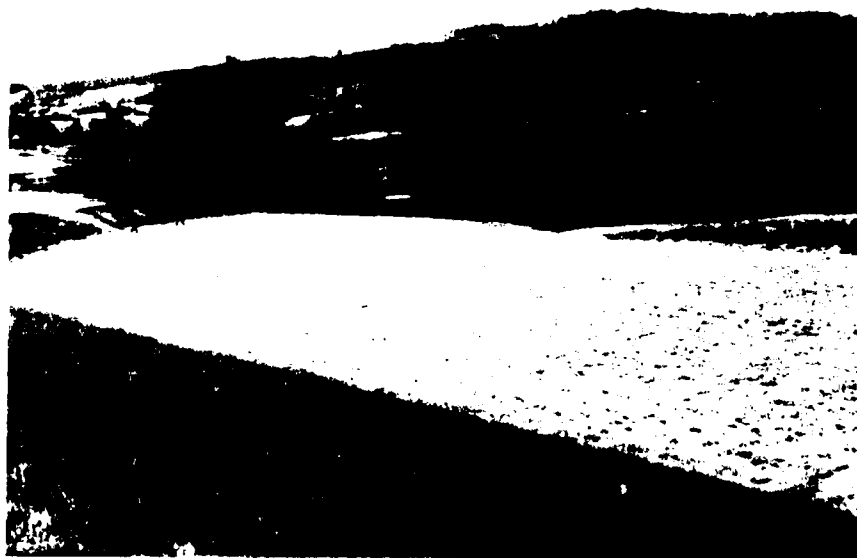
PHOTO #7: Emergency spillway looking downstream

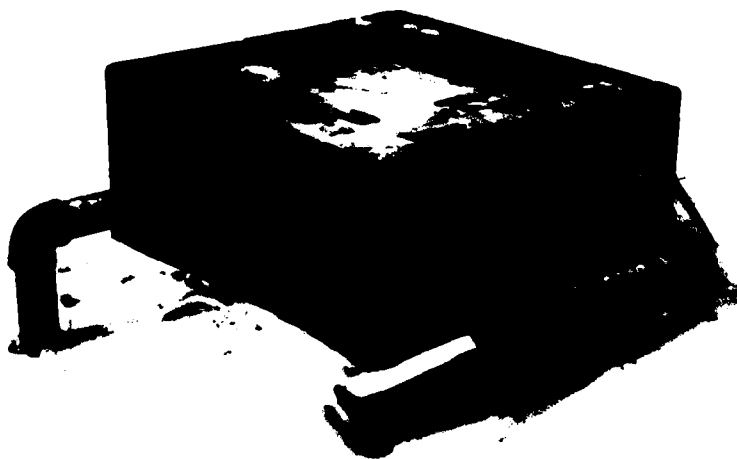
The reinforced concrete drop inlet structure is in excellent condition. However, there was a moderate amount of debris on and in front of the metal trash rack (See Photo No. 9). The gate stem for the low level drain was observed but not operated during the inspection.

- f. A small quantity of broken rock was evident at the contact between the upstream embankment slope and the left abutment.
- g. Debris was observed on the trash rack at the orifice of the principal spillway concrete riser.

PHOTO #9: Drop inlet structure
