ERDMAN ANTHONY ASSOCIATES ROCHESTER NY  
NATIONAL DAM SAFETY PROGRAM. DAVIS BROOK DAM (SITE 1) (INVENTOR--ETC(U)  
AUG 81 R J FARRELL

| REPORT DOCUMENTATION PAGE | | READ INSTRUCTIONS<br>BEFORE COMPLETING FORM |
|---|---|---|
| 4. TITLE (and Subtitle)<br>Phase I Inspection Report<br>Davis Brook Dam<br>Allegheny River Basin, Cattaraugus County, NY<br>Inventory No. 564 | | 5. TYPE OF REPORT & PERIOD COVERED<br>Phase I Inspection Report<br>National Dam Safety Program |

**Davis Brook Dam  
(Site 1)**

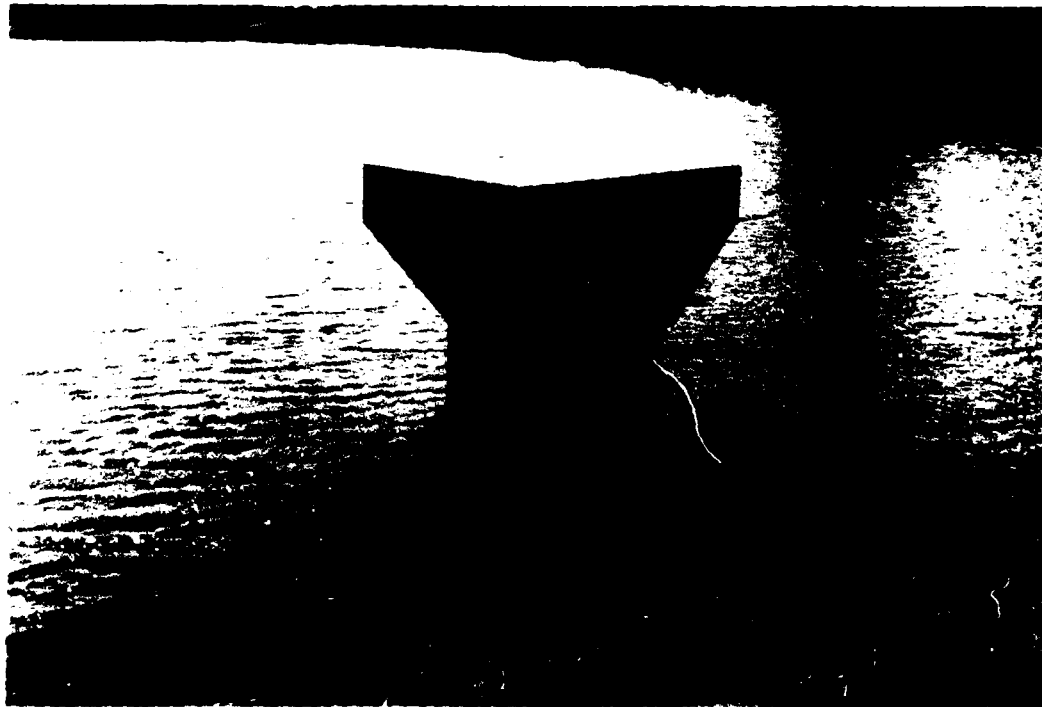
The structure is in good condition with no evidence of spalling, cracking, or efflorescence. The trash racks are in good condition, and free from debris accumulation.

2. Principal spillway inlet structure showing low stage inlet and trash rack
