**TUXEDO LAKE DAM**

ORANGE COUNTY, NEW YORK  
INVENTORY NO. N.Y. 14

**PHASE I INSPECTION REPORT  
NATIONAL DAM SAFETY PROGRAM**

AUGUST 1981

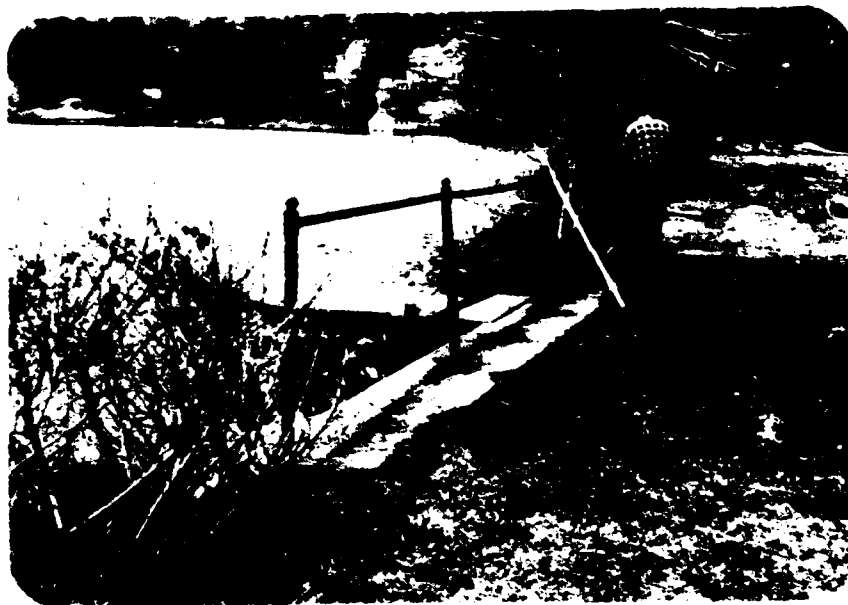
The bottom of the spillway is made of rock slabs. Minor erosion was observed at the left training wall. Minor wetness on both sides of spillway training walls was observed, indicating areas of minor seepage. No significant flows or signs of turbidity were noted.

Photo 4. View of Spillway Entrance  
9 March 1981

The wet areas near the masonry spillway training walls should be monitored regularly and during periods of high reservoir levels for any signs of increased flow and turbidity. If increased flow or turbidity is noted, a qualified geotechnical engineering firm is to be retained to perform a stability check of the dam and develop remedial measures to reduce the flow.

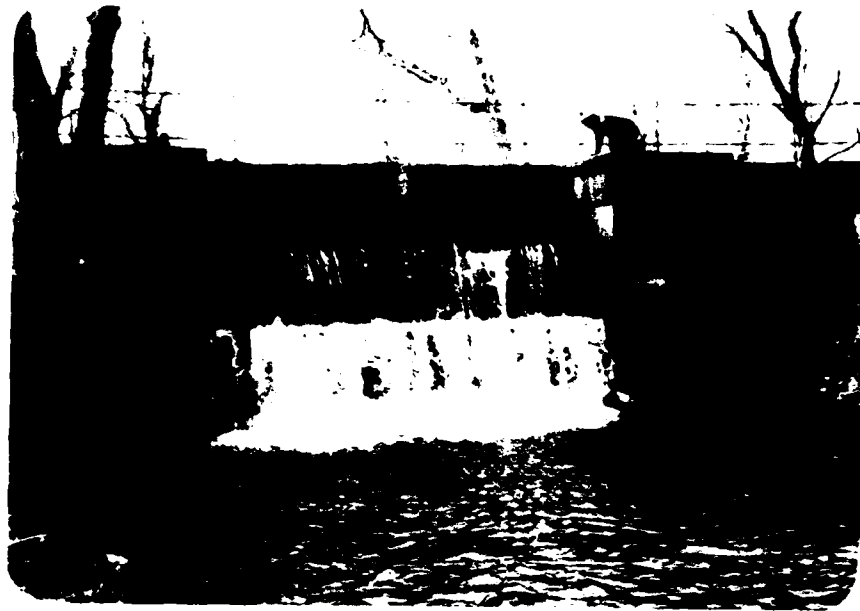
Photo 5. View of Spillway Discharge  
9 March 1981

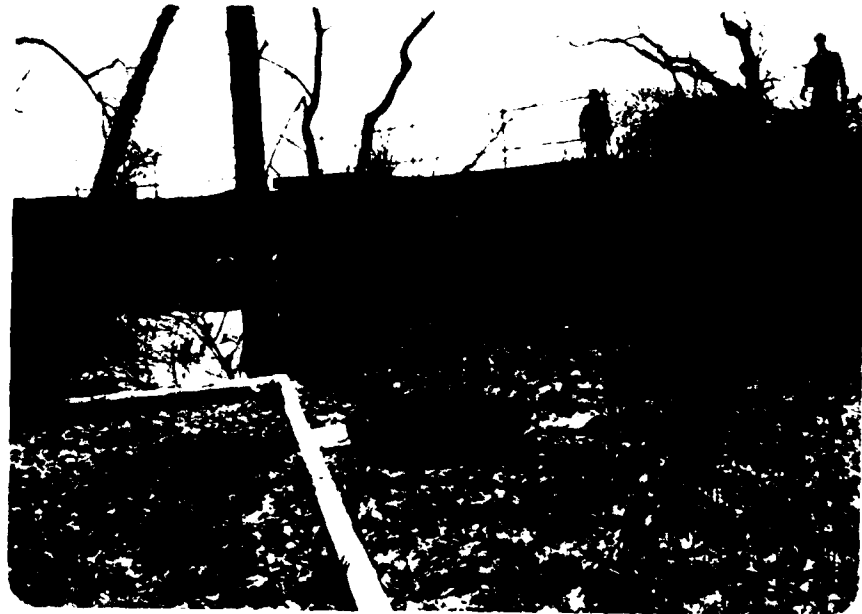
Brush and trees were located at the bottom and along the downstream slope near the spillway. Tennis courts were located immediately beyond the downstream toe. Forty-five feet downstream of the toe is an excavated pit, 3.5 feet wide by 5 feet long by 2 feet deep.

Photo 6. View of Excavated Pit to the Left and Downstream  
of the Spillway Structure  
9 March 1981
