1. REPORT NUMBER	2. GOVT ACCESSION NO.	3. RECIPIENT'S CATALOG NUMBER
	AD-A106-852	
4. TITLE (and Subtitle) Phase I Inspection Report Congers Lake Dam Passaic River Basin, Rockland County, NY Inventory No. 972		5. TYPE OF REPORT & PERIOD COVERED Phase I Inspection Report National Dam Safety Program

National Dam Safety Program, Congers Lake Dam (Inventory Number NY 972), Passaic River Basin, Lower Hudson River Area, Rockland County, New York. Phase I Inspection Report.

PHASE I INSPECTION REPORT
NATIONAL DAM SAFETY PROGRAM
CONGERS LAKE DAM
I.D. No. NY 972
DEC DAM No. 214A-290
PASSAIC RIVER BASIN
ROCKLAND COUNTY, NEW YORK

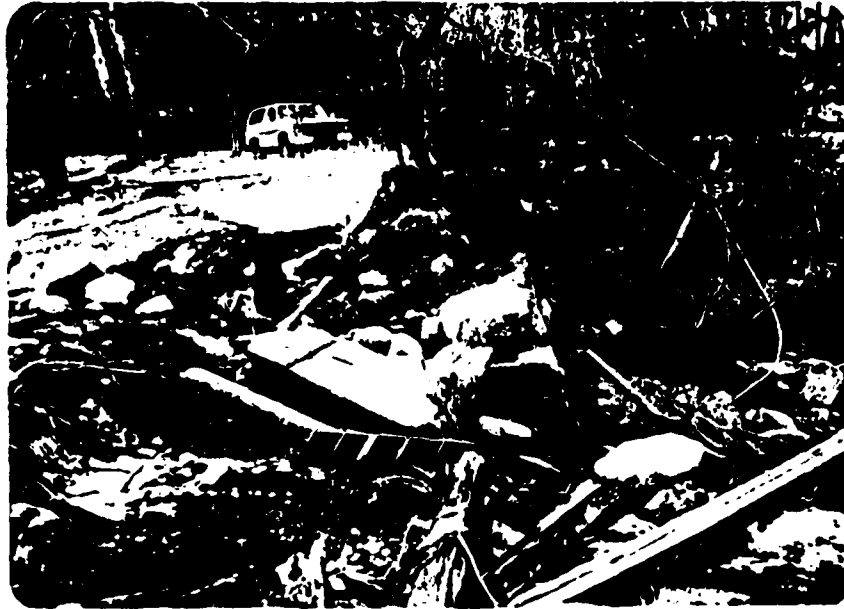
- b. Spillway - At the time of the inspection, the spillway was found to be badly deteriorated. Only part of the old lift gate or stoplog structure is still present. The left stone wall that originally protected the embankment has collapsed. The bottom of the spillway was very irregular and partly protected from erosion by a combination of stone, concrete and asphalt. There is an abundance of riprap in the spillway discharge channel. Some logs, railroad ties and other debris are present, but are not clogging the channel.

Photo 1. Spillway and Left Abutment
7 March 1981

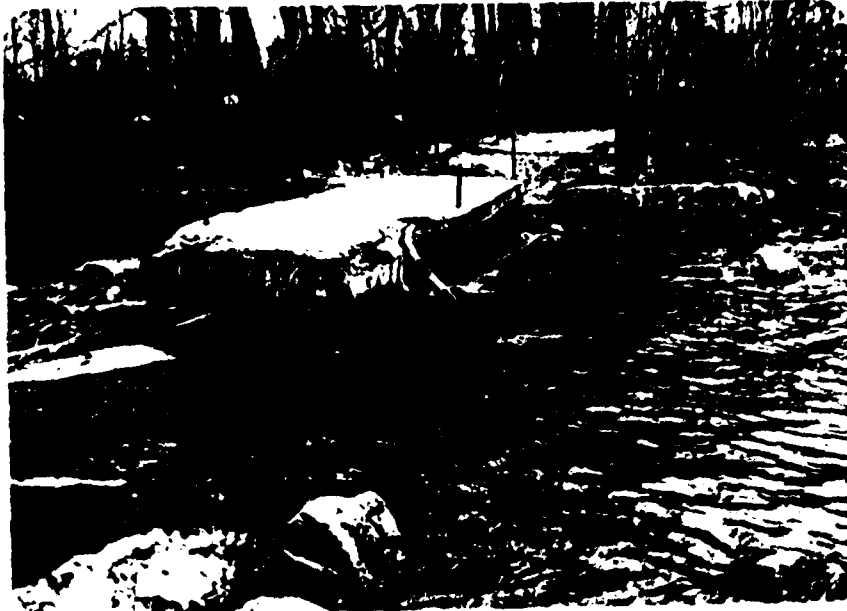
At some later date the spillway was reconstructed because its paved bottom was being undercut and washing was occurring behind the masonry side walls. From field observations for this investigation, it appears that concrete piers were last installed across the spillway for stoplogs or liftgates. These structures have deteriorated badly and have been partly knocked out (Photo 3). The 12-inch outlet pipes were not found during the field inspection.

Photo 3. Remains of Structure for Lift Gate or Stoplogs
7 March 1981

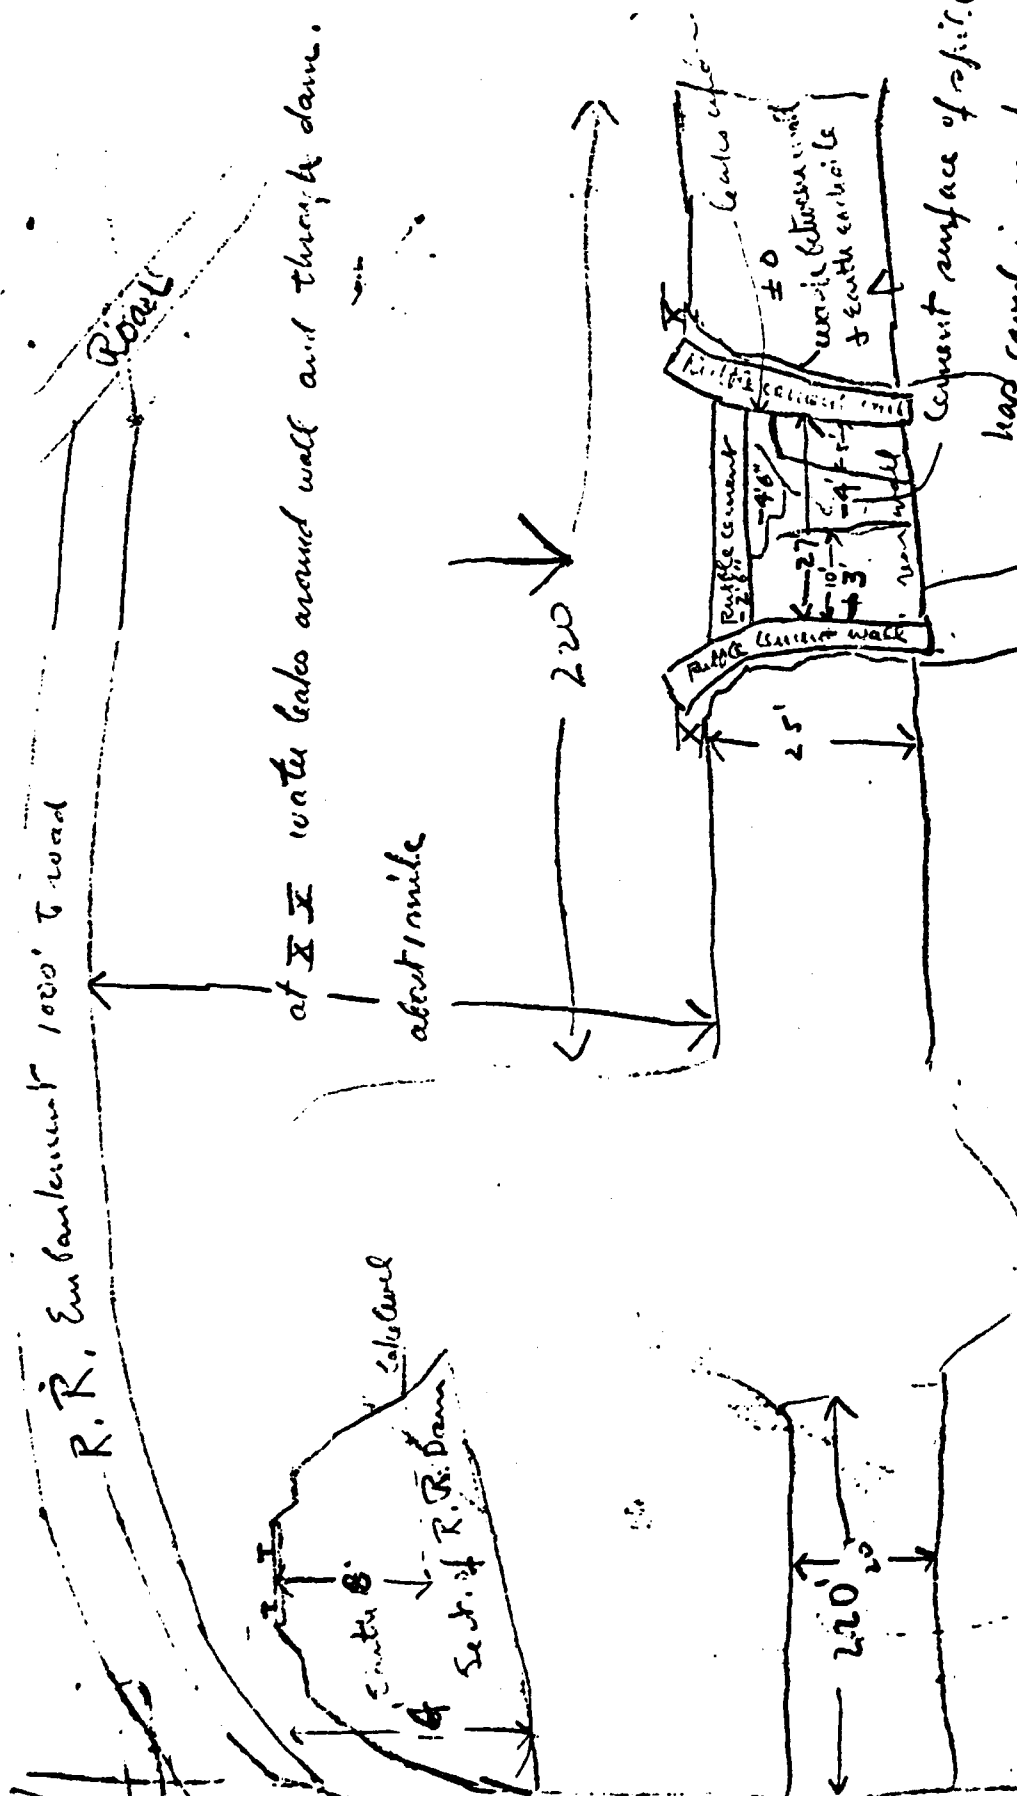
at XX water takes around wall and through dam.
 about 1 mile

Concrete surface of spillway
 has cured in as shown.
