| REPORT DOCUMENTATION PAGE | | READ INSTRUCTIONS<br>BEFORE COMPLETING FORM |
|---|---|---|
| 4. TITLE (and Subtitle)<br>Phase I Inspection Report<br>Tomahawk Lake Dam<br>Lower Hudson River Basin, Orange County, NY<br>Inventory No. 618 | | 5. TYPE OF REPORT & PERIOD COVERED<br>Phase I Inspection Report<br>National Dam Safety Program |

PHASE I INSPECTION REPORT  
NATIONAL DAM SAFETY PROGRAM  
TOMAHAWK LAKE DAM  
I.D. No. NY 618  
DEC DAM No. 195A-2507  
LOWER HUDSON RIVER BASIN  
ORANGE COUNTY, NEW YORK

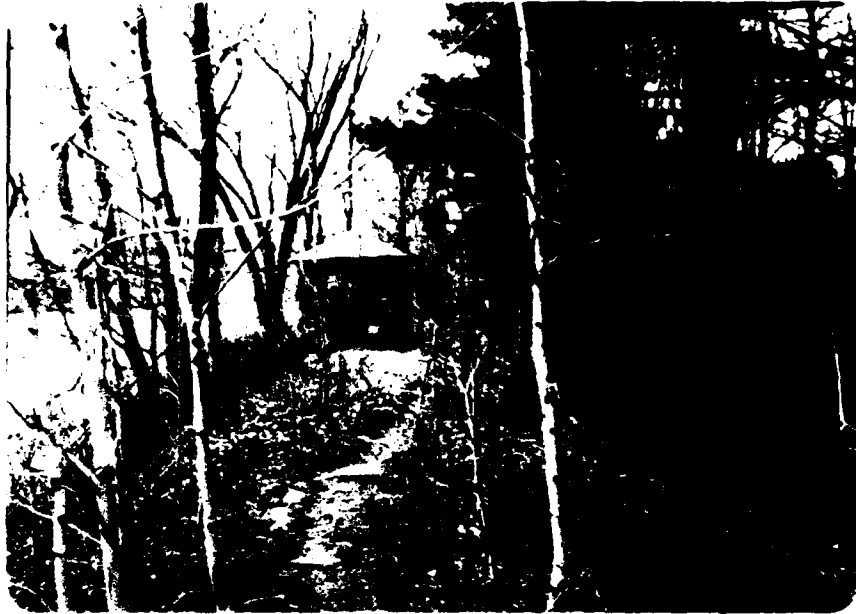
up the downstream slope, a large tree has overturned and created a 4 foot diameter hole about 18 inches deep where the root system has been pulled out of the ground. Animal burrows were observed near Station 1+10 and 9+50. There was embankment erosion behind both training walls on the upstream slope and some erosion on the downstream slope behind the right training wall. There is an overly steep area on the embankment above the outlet conduit. No evidence of an internal drainage system was found during the inspection.

Photo 1. View of Crest, Downstream Slope, and  
Valve House on Right Side of Spillway  
9 March 1981

5. The outlet conduit must be repaired and rebuilt near the discharge end.
6. The outlet conduit stilling basin must be completely lined with riprap.
7. All trees and brush must be cut at ground level over the entire embankment. All trees with a trunk diameter greater than 3 inches must have their root systems removed. All resultant areas of erosion and cavities must be filled, graded, compacted and seeded.
