**COLUMBIA MUNICIPAL GOLF COURSE DAMS**

**BOONE COUNTY, MISSOURI**

**PHASE 1 INSPECTION REPORT  
NATIONAL DAM SAFETY PROGRAM**

**PREPARED BY: HOSKINS-WESTERN-SONDEREGGER, INC.**

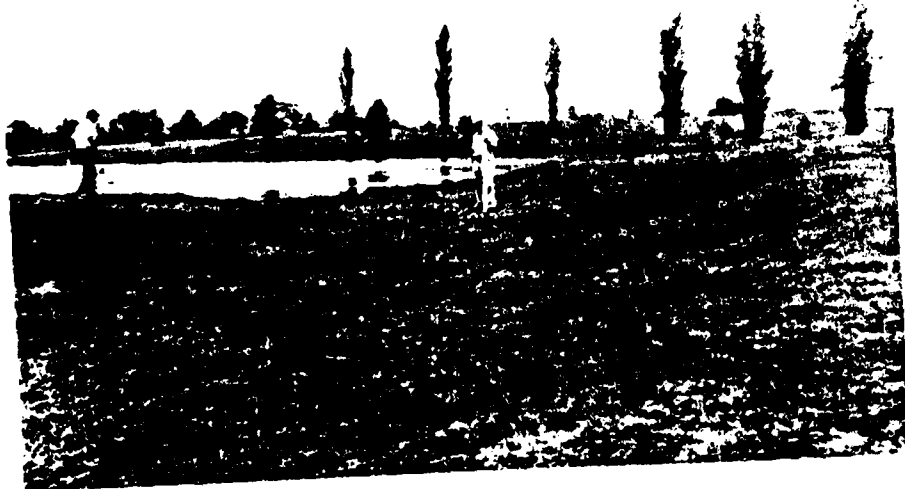
PHOTO. NO. 10  
LOOKING UPSTREAM  
AT UPPER DAM  
SPILLWAY.

- (2) The emergency spillway is in good condition but it also has a small hydraulic capacity relative to the 100 year and dam overtopping floods.
  - (3) The pool of the lower dam would extend up to the toe of the upper dam at all inflows greater than ½ PMF.
