Phase I Inspection Report  
 South Pond Dam  
 Long Island Basin, Nassau County, N.Y.  
 Inventory No. 109

PHASE I INSPECTION REPORT  
NATIONAL DAM SAFETY PROGRAM  
SOUTH POND DAM  
I.D. NO. N.Y. 109  
D.E.C. NO. 192  
LONG ISLAND BASIN  
NASSAU COUNTY, N.Y.

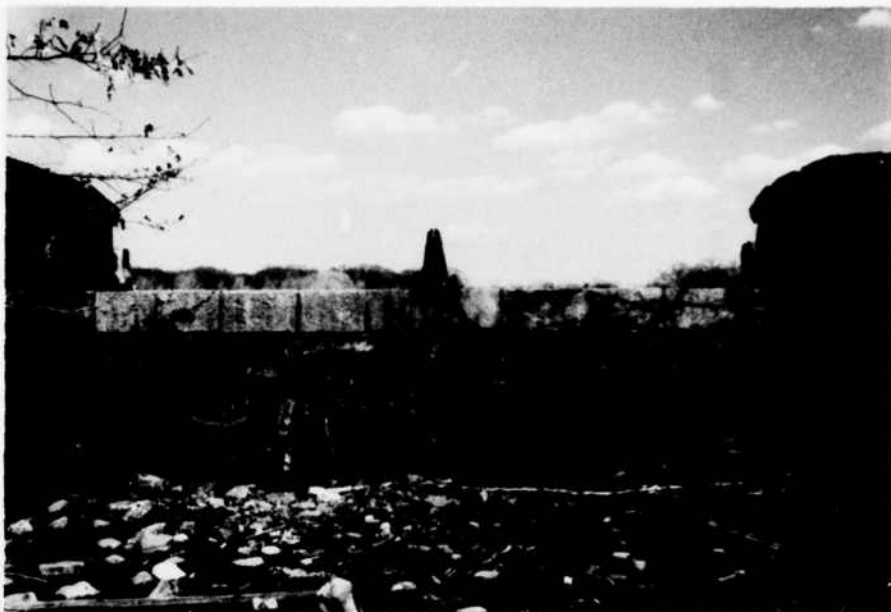
6. VIEW OF SPILLWAY FROM DOWNSTREAM SIDE
