MOHAWK RIVER BASIN  
COBLESKILL UPPER  
RESERVOIR DAM

SCHOHARIE COUNTY, NEW YORK  
INVENTORY NO. N.Y. 656

PHASE I INSPECTION REPORT  
NATIONAL DAM SAFETY PROGRAM

Name of Dam: Cobleskill Upper Reservoir Dam  
State Located: New York  
County: Schoharie  
Watershed: Mohawk River Basin  
Stream: Smith Brook  
(tributary of Cobleskill Creek  
and Mohawk River)  
Date of Inspection: October 30, 1980

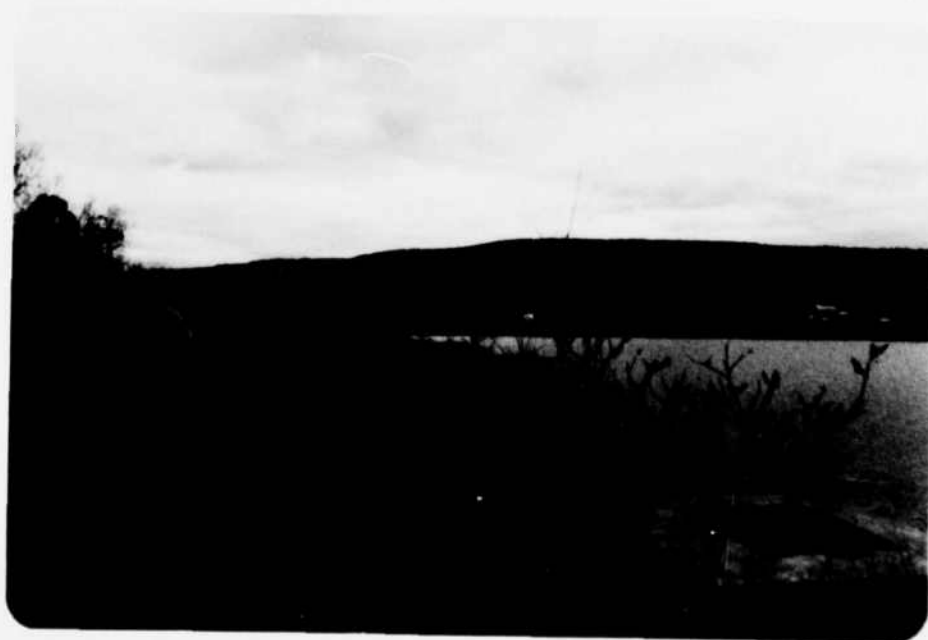
The embankment shows no signs of distress and appears to be in good condition. All slopes seem to be stable with no erosion or depressions. However, the embankment is in need of maintenance, there is tree and brush growth on both slopes. The upstream riprap is generally in good shape but the trees and brush will begin to displace it, if left unattended to. The crest is in good condition. No evidence of seepage was found on the embankment or beyond the downstream toe. Low reservoir elevation at the time of inspection may have reduced the possibility of finding seepage, however, there were no other factors pointing to seepage problems. The discharge channel of the reservoir drain is in need of small tree and brush removal.

Photo # 7.  
Reservoir drain control, Note: trees and brush.
