4. TITLE (and Subtitle) Phase I Dam Inspection Report National Dam Safety Program Fairview Lake Dam (MO 10976) Boone County, Missouri		5. TYPE OF REPORT & PERIOD COVERED Final Report

FAIRVIEW LAKE DAM  
BOONE COUNTY, MISSOURI  
MISSOURI INVENTORY NO. 10976

PHASE I REPORT  
NATIONAL DAM SAFETY PROGRAM

Name of Dam: Fairview Lake Dam  
State Located: Missouri  
County Located: Boone County  
Stream: Tributary to County House Branch  
Date of Inspection: 13 April 1978

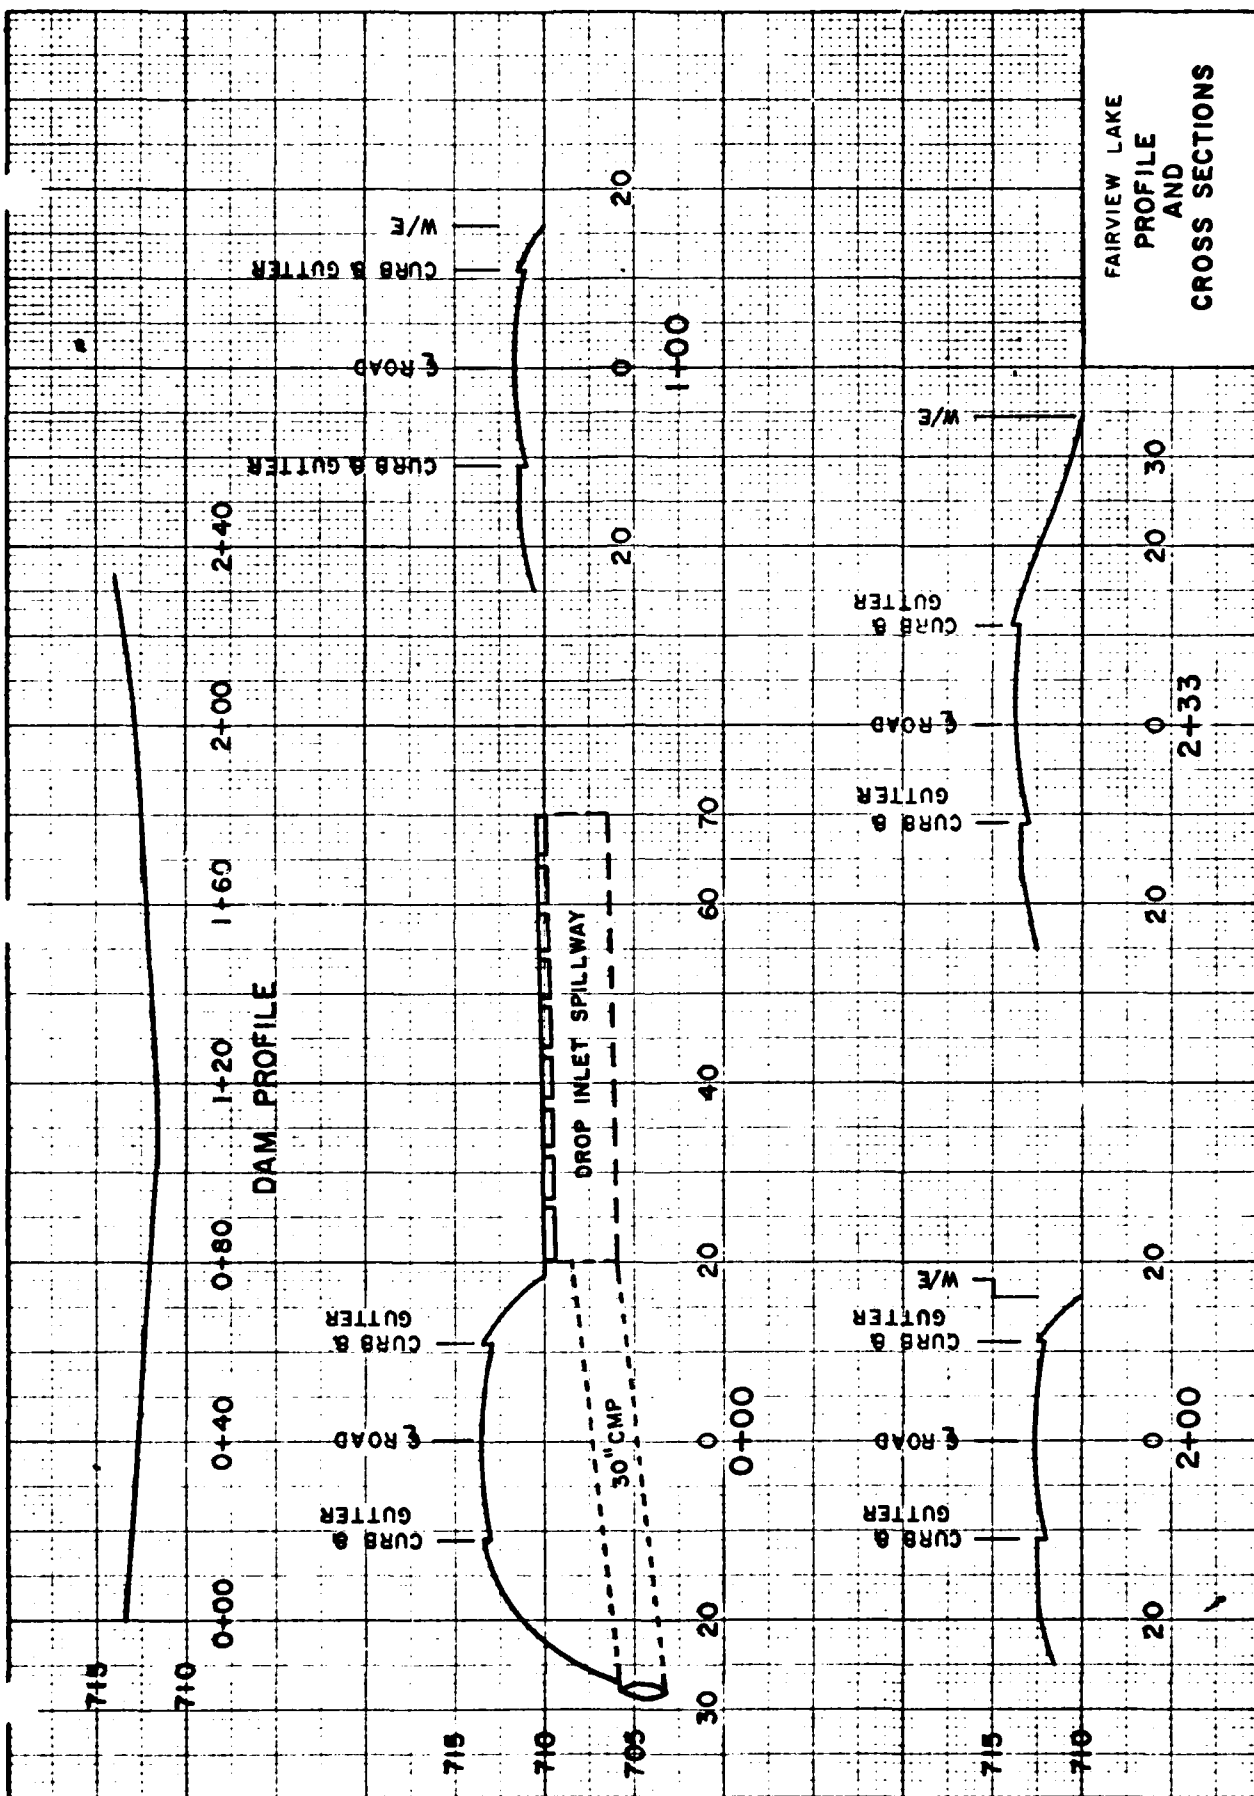
FAIRVIEW LAKE  
PROFILE  
AND  
CROSS SECTIONS

b. Dam. The location, profile, and section of the dam is shown on PLATES 1 through 5.

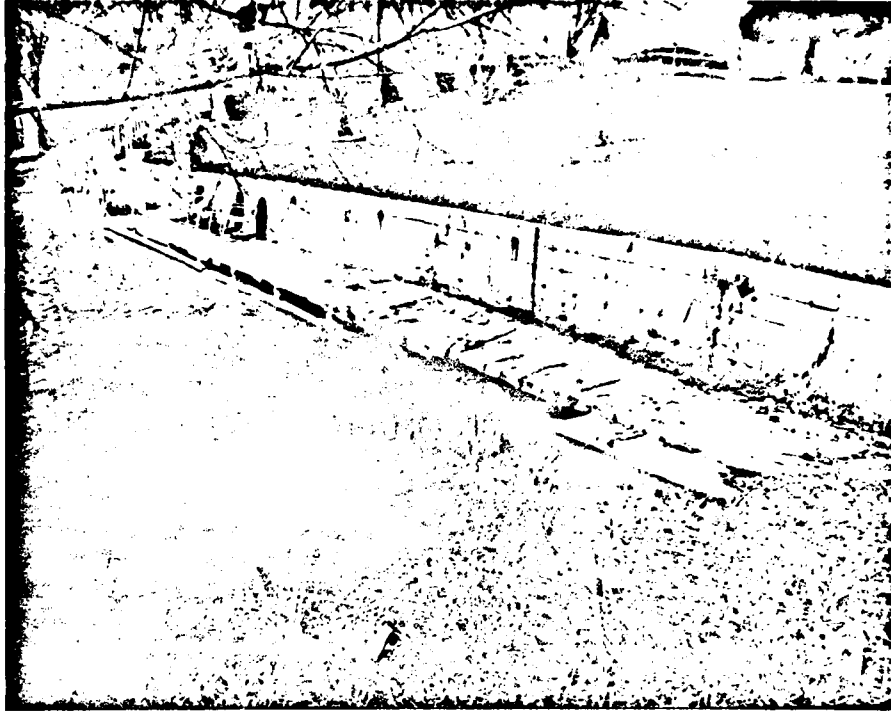
PHOTO 1

Some deterioration of concrete was noticed at the lower end of the horizontal lip of the curb opening drop inlet spillway (see Photo 1). Two pipes were visible on the downstream slope of the dam. One 30-inch CMP was near the left abutment to release the water from the upstream spillway. One 14 inch CMP was near the center of the dam several feet above the toe to drain the storm water from pavement on top of the embankment of the dam. A significant amount of erosion and undermining at the exit ends of both pipes were noticed (see photos 2 and 7). The collapse of the slab downstream of the 30-inch pipe, as shown in Photo 2, was probably attributed to flow overtopping the sides of slab in sufficient quantity and rate to cause erosion and undermining.

Curb opening drop inlet spillway, Fairview Lake Dam

(3) Keep the culverts and spillway clean.

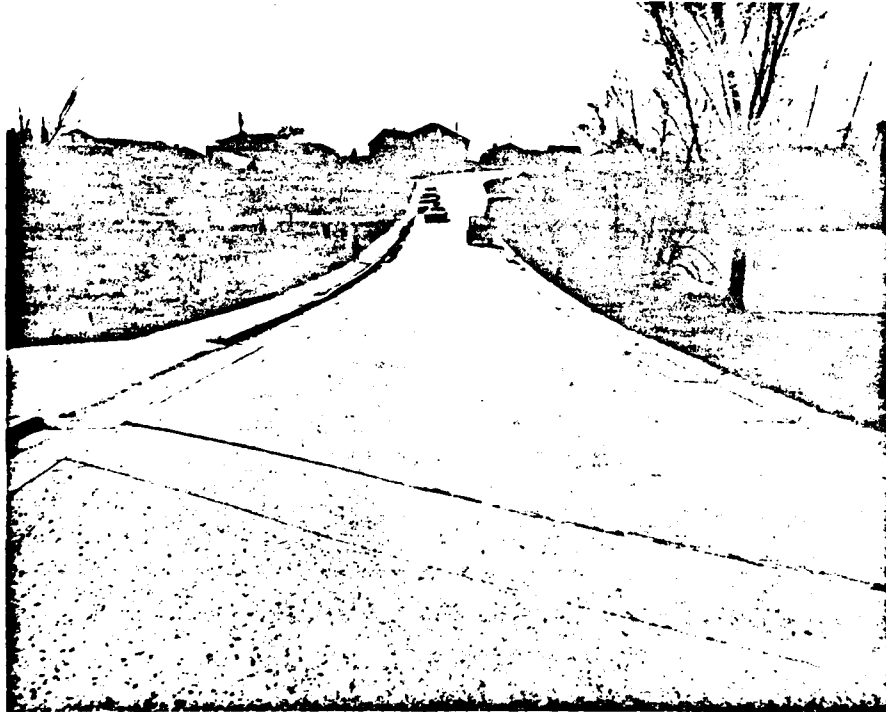
PHOTO 4  
Fairview Lake Dam

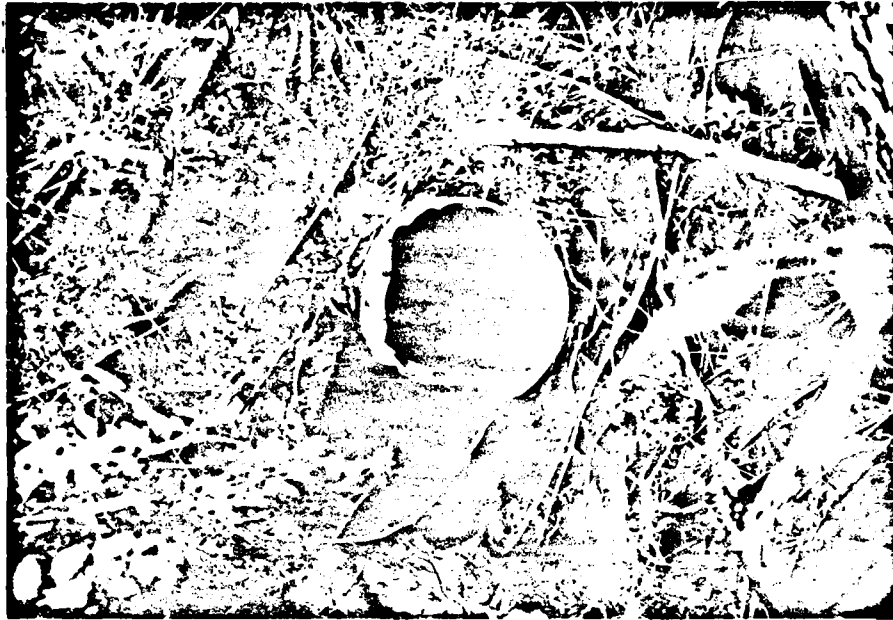
PHOTO 7

14" CMP (Downstream) Fairview Lake Dam

(2) Repair erosion and undermining and provide erosion protection and/or energy dissipators at the exit end of the two pipes on the downstream slope of Fairview Lake Dam.
