**HOUSATONIC RIVER BASIN
TOWN OF AMENIA
DUTCHESS COUNTY, NEW YORK**

**THORNES DAM
NY 00793**

PHASE I INSPECTION REPORT

Thornes Dam (Inventory Number NY 00793).
Housatonic River Basin. Town of Amenia.
Dutchess County, New York. Phase I Inspection
Report.

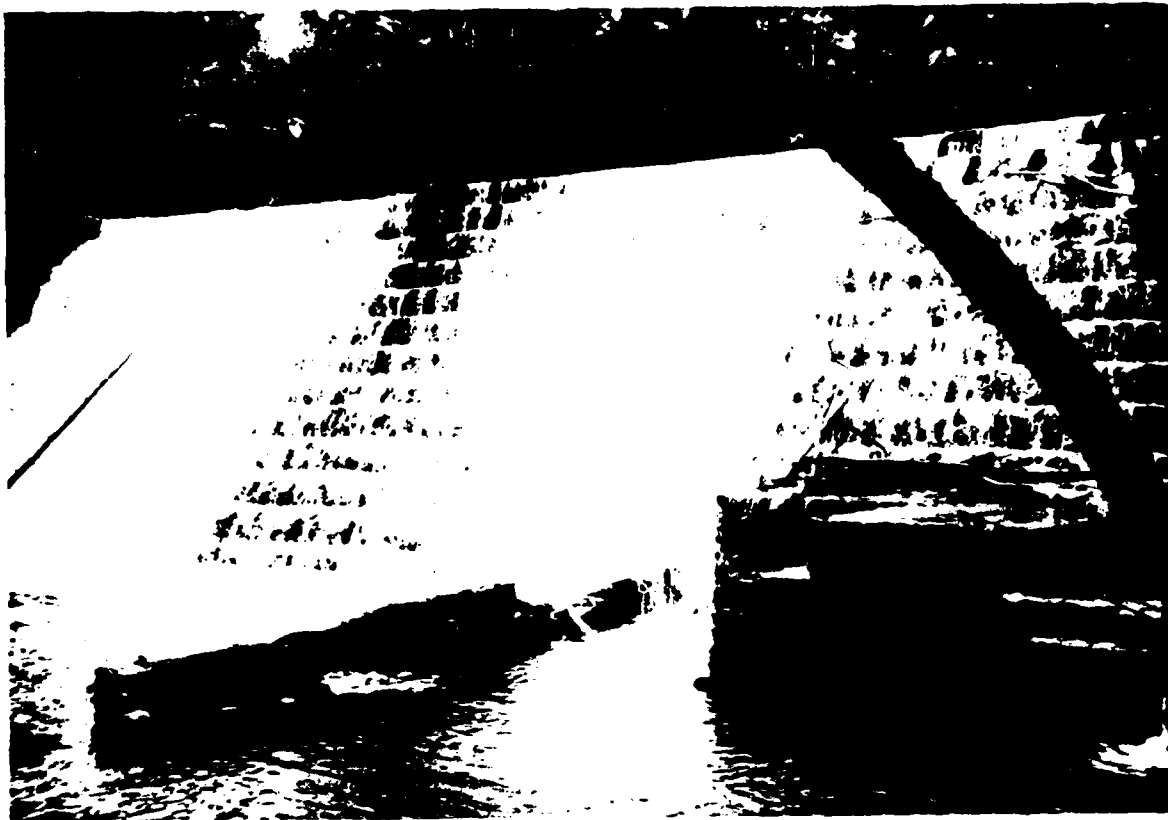
Overview Photo - Thornes Dam - 5/5/81

10 The entire stone masonry dam (see Overview Photo and Photo A-3A) is only in fair condition. The stone masonry of the stepped downstream face shows signs of deterioration due to water action and the weather. Stones are missing and broken; mortar joints are loose with mortar missing in spots; and there is seepage through the joints as mentioned previously (see Photos A-5A, A-5B, and A-6B). The stone masonry in the area of the dam under the spillway section, downstream of the crest, generally appeared to be in somewhat better shape than the downstream areas of the dam near the abutments.

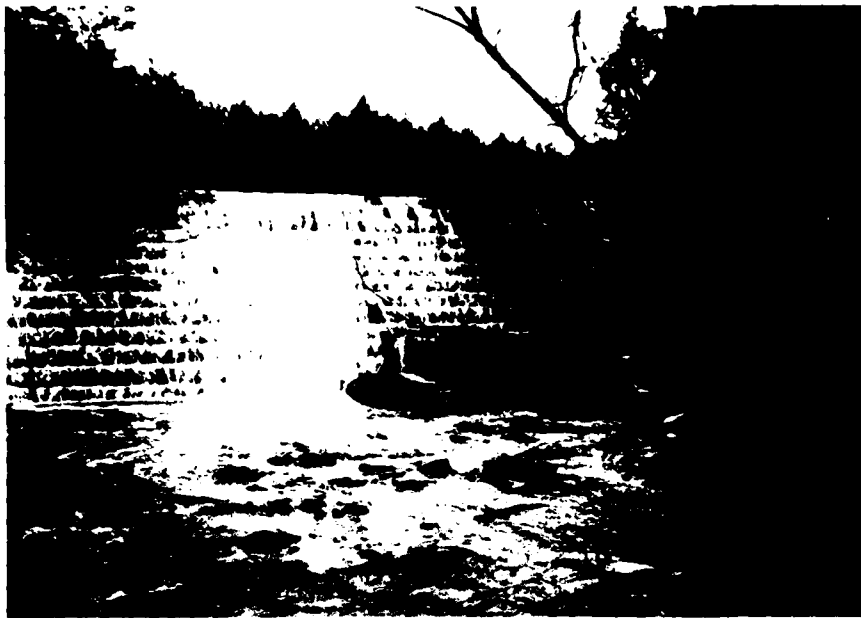
A-3A Downstream side of dam looking from downstream of right abutment - 5/5/81

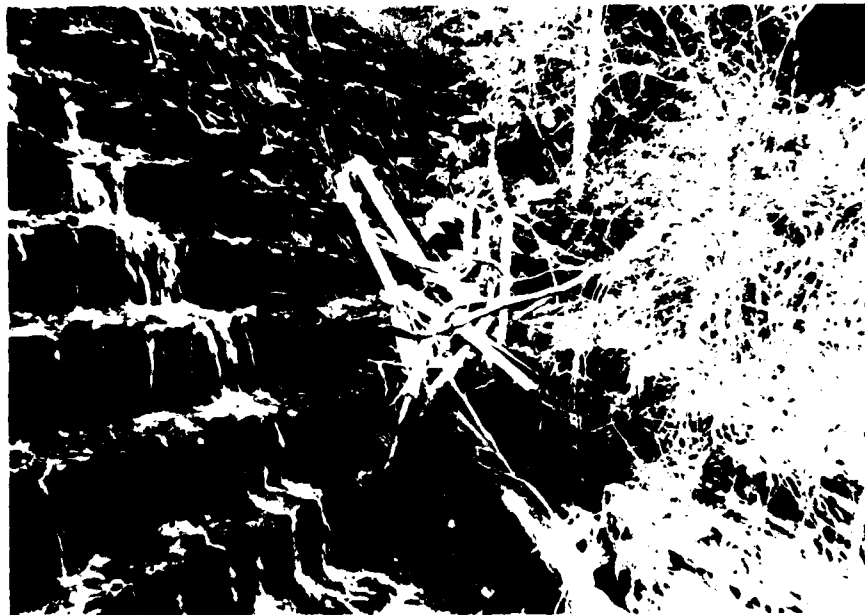
Abutments - Phyllite bedrock is exposed at the contacts between the downstream face of the dam and both abutments. No seepage was observed at the abutments. There is a thin soil cover on both abutments and some trees are growing on the abutments (see Photos A-4A and A-4B). There are logs and debris on the contact between the downstream face of the dam and the left abutment (see Photo A-3B).

A-3B Contact between downstream face of dam and left abutment. Abutment appears to be bedrock, but is somewhat obscured by sections of logs which have been dumped along the contact 5/5/81

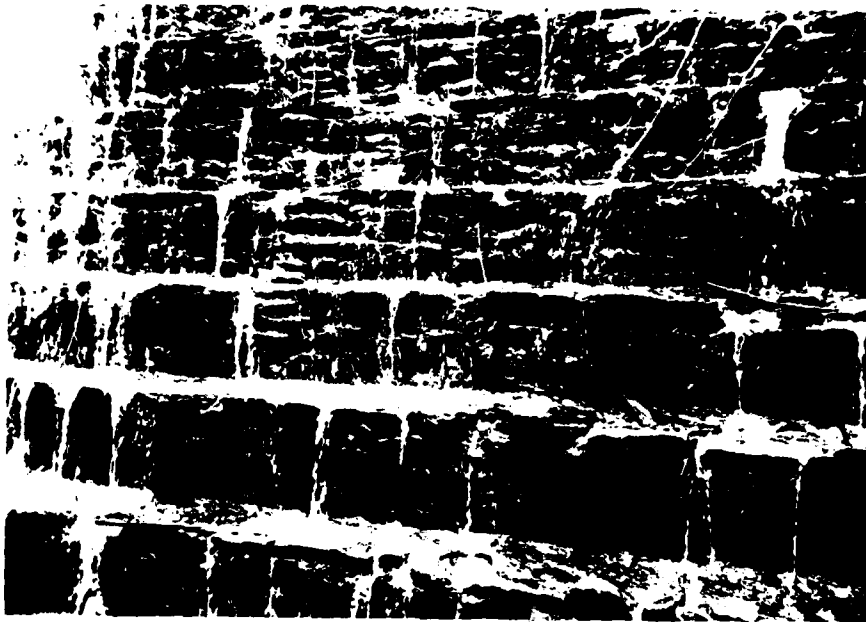
A-5A Typical view of stepped downstream face of dam. Note weathered condition of stones and missing mortar - 5/5/81

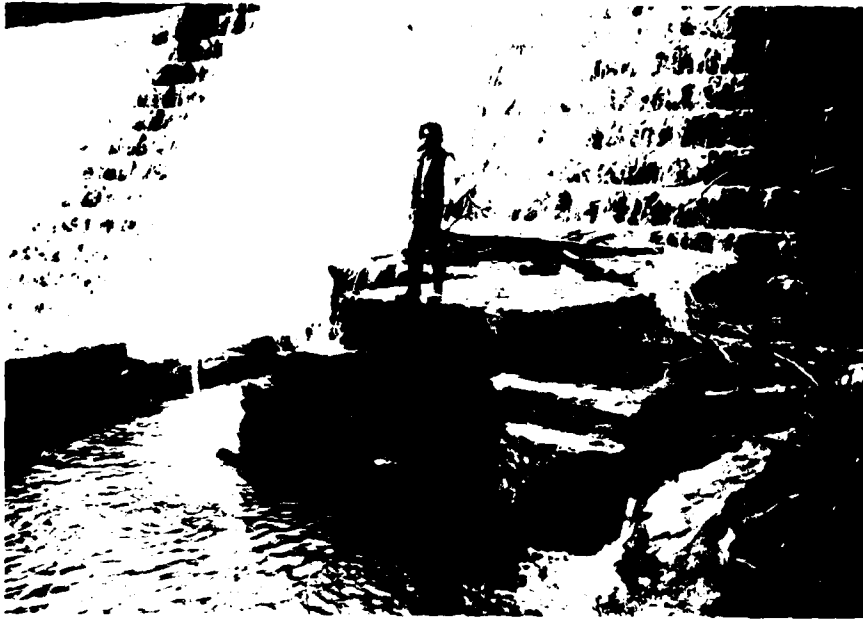
The outlet from the dam is a 48-inch cast iron pipe (see Photo A-8A). The inside of the pipe is rusty but no significant scaling of the iron has occurred. A portion of the pipe about 6 feet long by 2.5 feet wide is missing from the right side, near the gate end (see Photo A-8B).

A-8A Downstream end of outlet pipe - 5/5/81

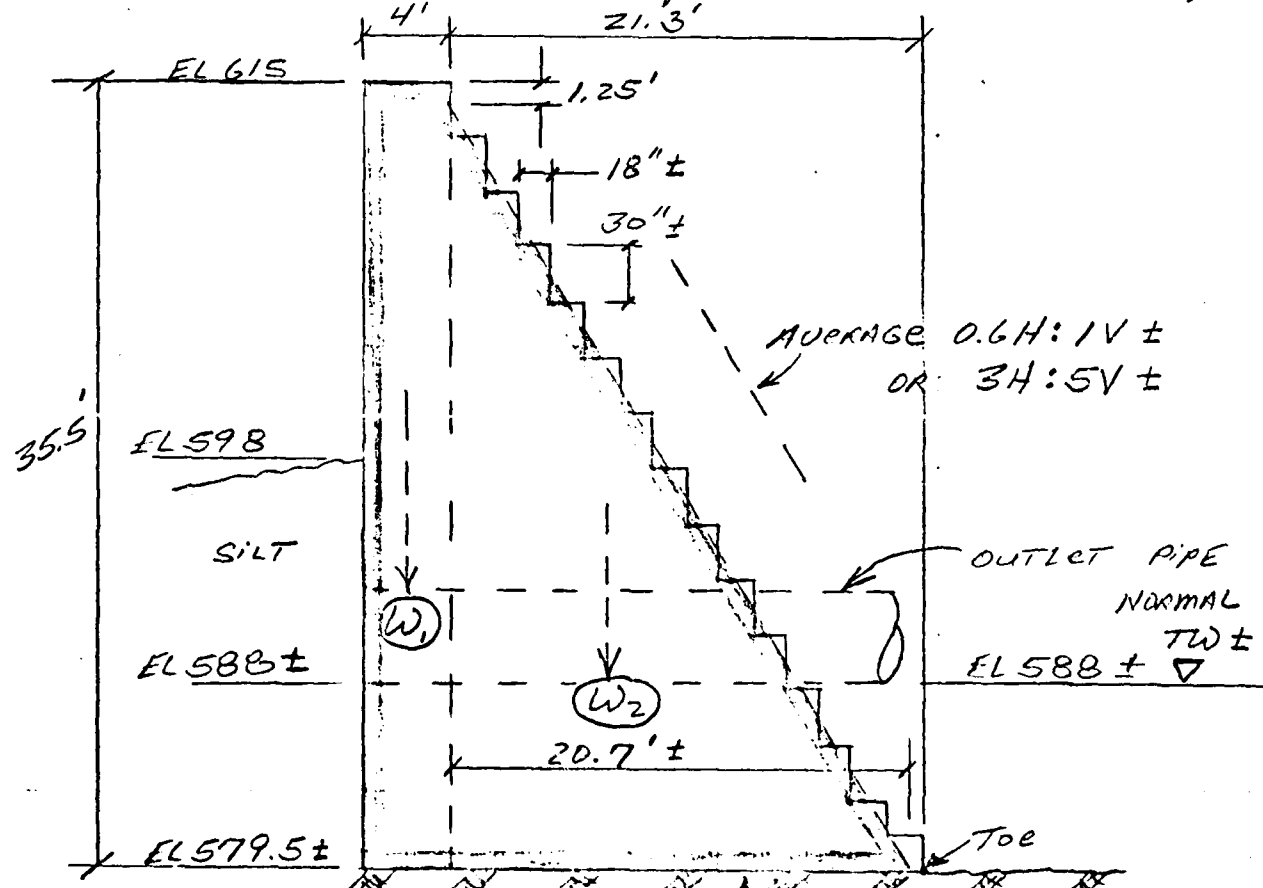
STABILITY ANALYSIS OF OVERFLOW SECTION

As noted from Table 6.1, the overflow section is unstable for all loading conditions. Included in the unstable rating are the normal spring-summer-fall condition (Case 1) and the winter ice load condition (Case 2).

ROCK FOLIATIONS 40°
ASSUMED CRITICAL FAILURE PLANE FOR O/T & FOUNDATION DETAIL & SLIDING ALONG DAM/ROCK CONTACT
ASSUMED BEDROCK

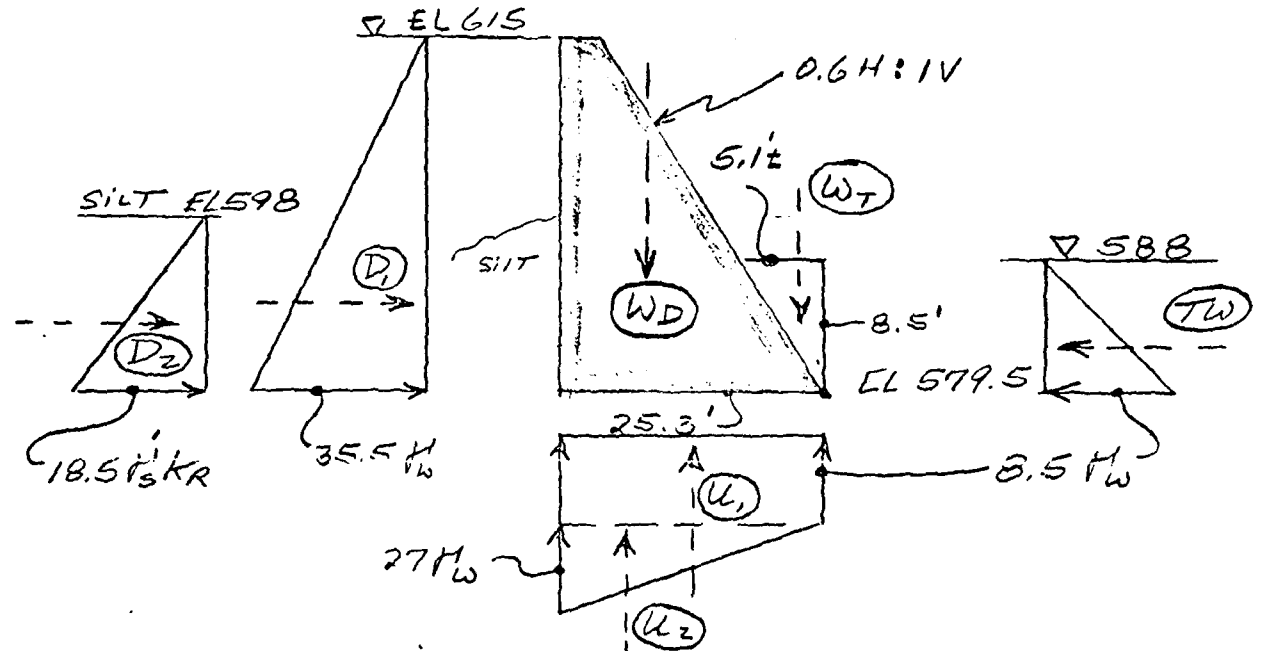
CASE 1 Normal pool at spillway crest, full HW & TW
uplift, silt 17' below crest by measurement,
TW about at outlet pipe by observation (8.5')

$FS = R_s / D_s = 32.25 / 37.07 = 0.87 < 1.0$ unstable
