SUNNEN LAKE DAM  
WASHINGTON COUNTY, MISSOURI  
MISSOURI INVENTORY NO. 30111

PHASE I INSPECTION REPORT  
NATIONAL DAM SAFETY PROGRAM

| Date of Inspection | 25 August 1978 |

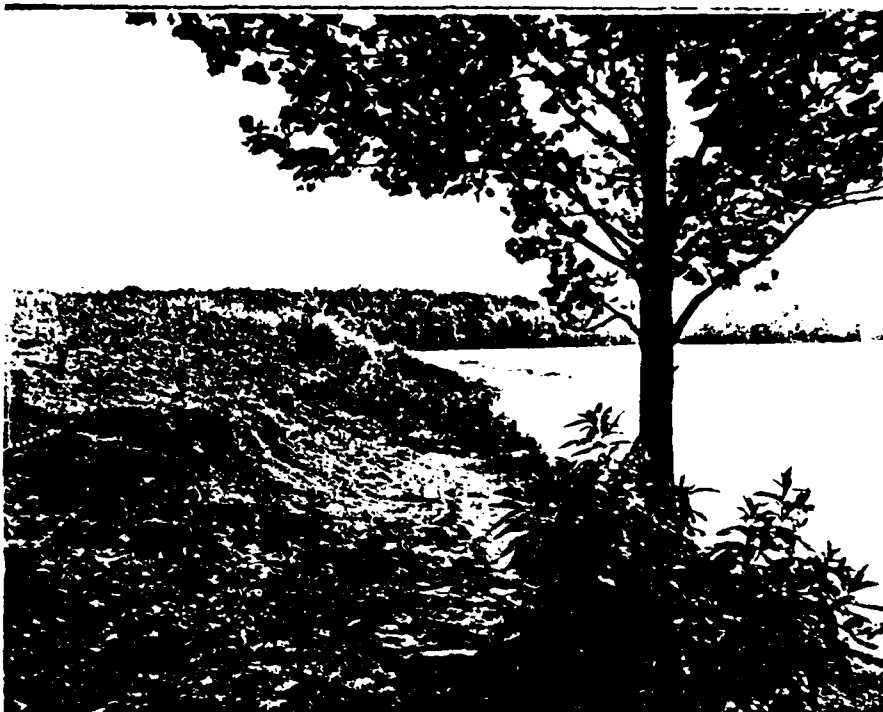
11 Benching in Upstream Slope

(1) Several items are deficient which should be corrected. No erosion protection is present on the upstream face of the embankment and wave action has caused benching along the length of the embankment. Brush and small trees are growing on the embankment. Horse traffic on the embankment has removed grass in localized areas. Voids under the spillway apron could lead to undermining. The outlet works is presently inoperable.

c. Provide adequate erosion protection such as riprap on the upstream face of the dam. Repair benching of the embankment.
