SNOW HOLLOW DAM  
IRON COUNTY, MISSOURI

MISSOURI INVENTORY NO. 30337

PHASE I INSPECTION REPORT  
NATIONAL DAM SAFETY PROGRAM

NAME: Snow Hollow (Mo. 30337)  
LOCATION: Iron County, Missouri  
STREAM:  
DATE OF INSPECTION: 14 September 1978

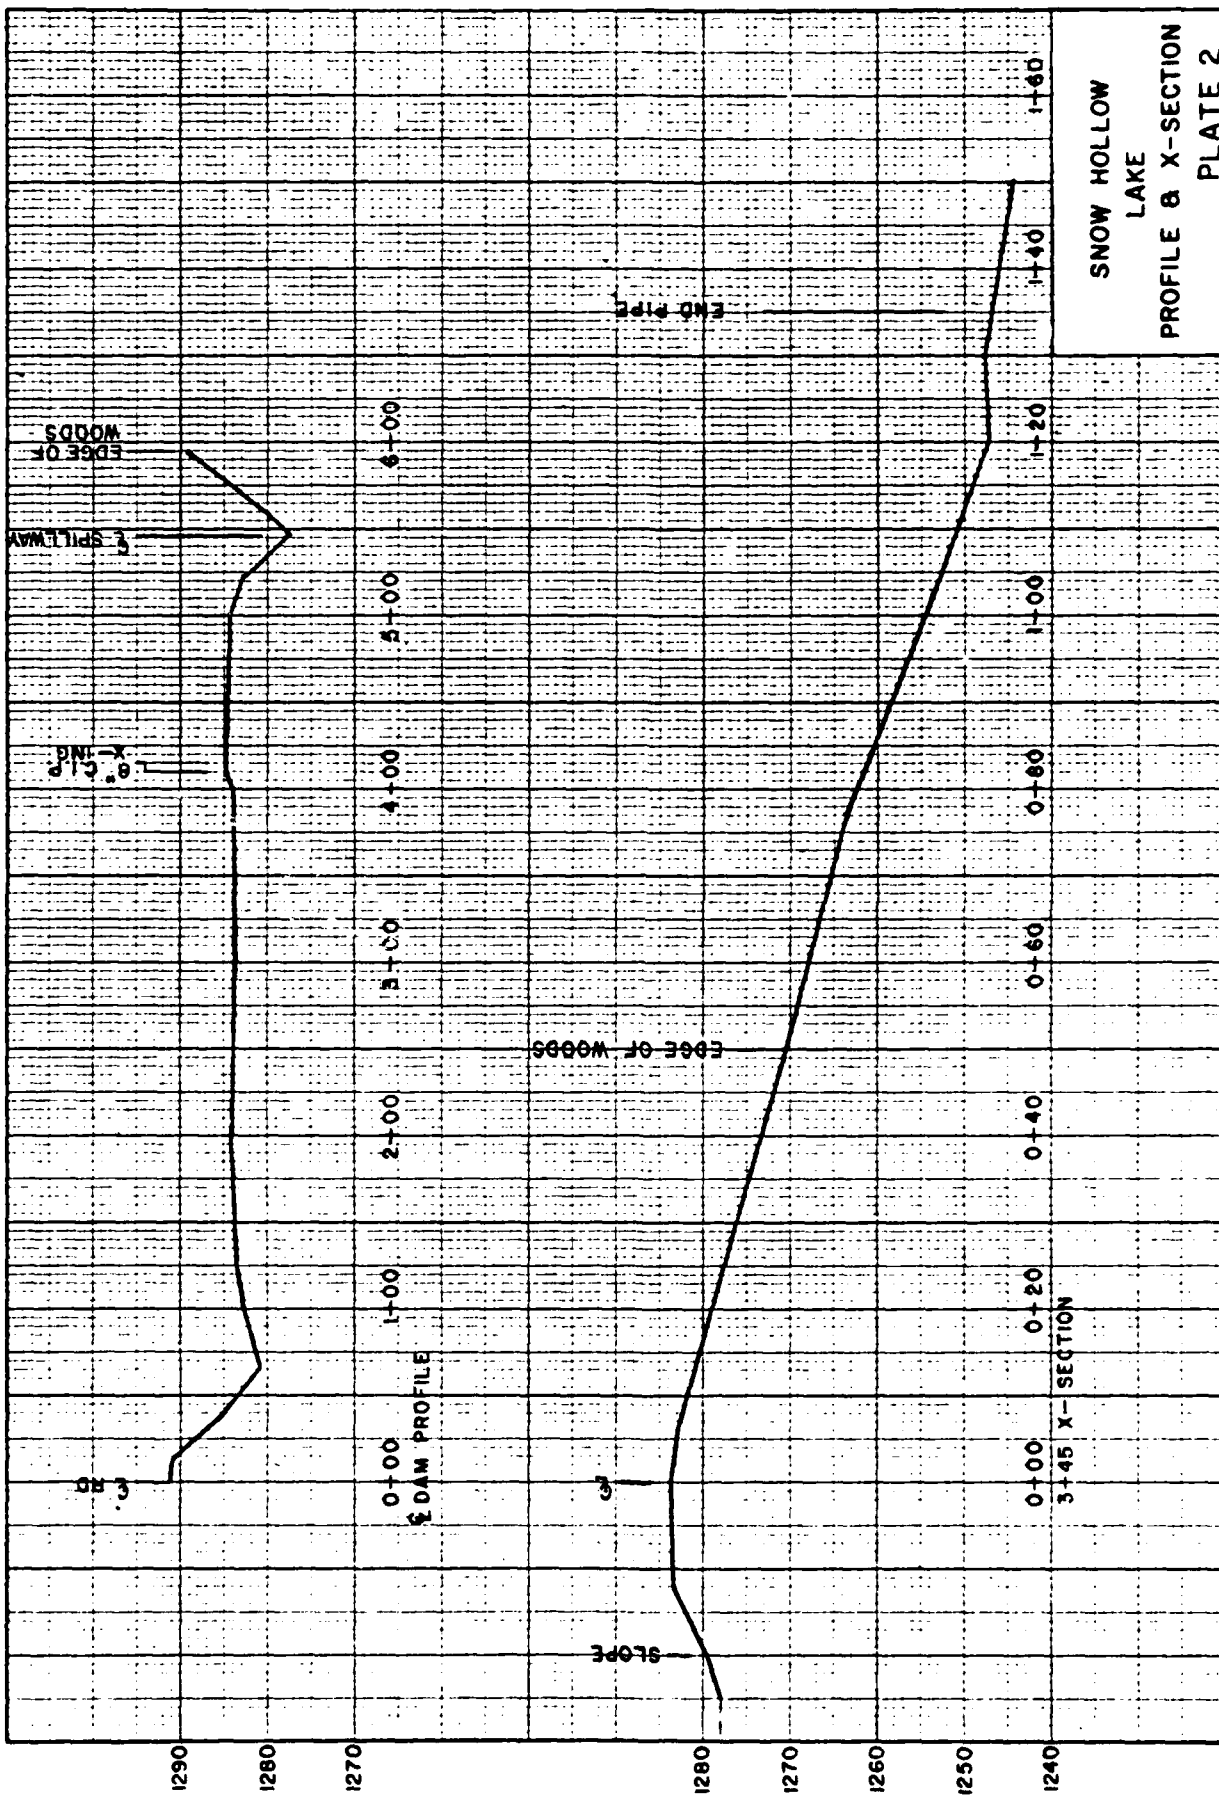
SNOW HOLLOW  
LAKE  
PROFILE & X-SECTION  
PLATE 2

- (4) Above the waterline, upstream slopes had no riprap protection and were quite steep (see PLATE 2 and PHOTO 4). Below the waterline, slopes appeared to be much flatter and were covered with rock and/or gravel.

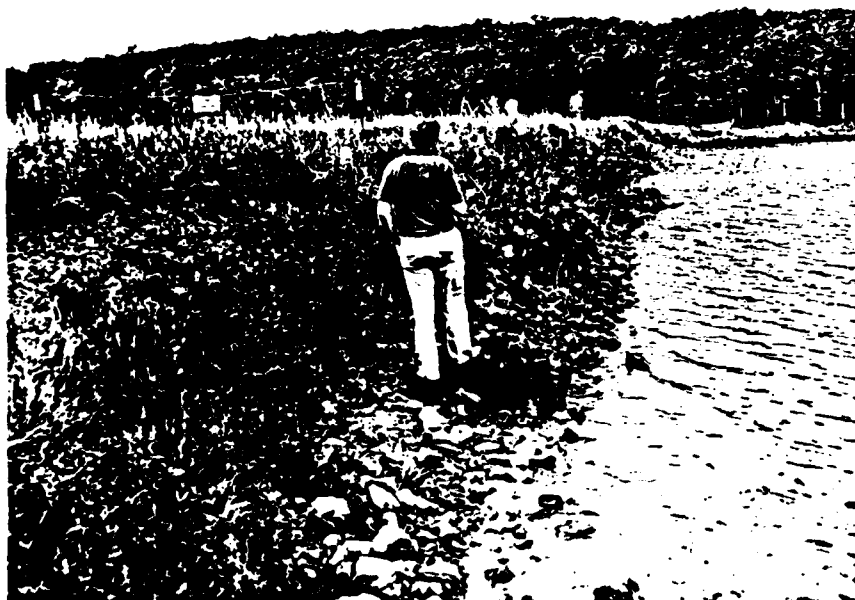
Provision of graded riprap on the upstream face of the dam is considered good engineering practice; however, the absence of existing wave erosion indicates the lack of riprap at this location is not of concern.

(1) Steep unprotected slopes above the waterline on the upstream face of the dam and on the inside (northeast) wall of the right spillway exit channel.

PHOTO 4: Upstream Slope of Dam

b. Provide erosion protection for the upstream slope above the waterline and on the inside (northeast) wall of the right spillway exit channel.
