**MELODY LAKE DAM  
FRANKLIN COUNTY, MISSOURI  
MO 30547**

**PHASE 1 INSPECTION REPORT  
NATIONAL DAM SAFETY PROGRAM**

MELODY LAKE DAM  
FRANKLIN COUNTY, MISSOURI  
MISSOURI INVENTORY NO. 30547

PHASE I INSPECTION REPORT  
NATIONAL DAM SAFETY PROGRAM

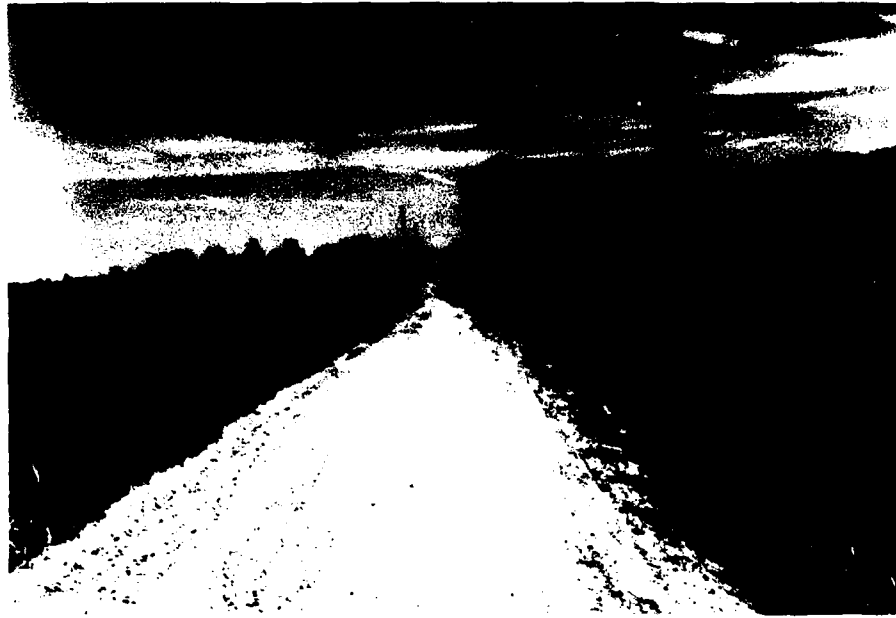
2. Several small trees also exist on the upstream face of the dam. Roots of these trees can also contribute to seepage that could develop into a piping condition.

b. Dam. The visible portions of the upstream and downstream faces of the dam (see Photos 1 and 2) appeared to be in sound condition, although numerous trees and brush exist on the downstream side. Seepage, as evidenced by wet ground, cattails (see Photo 6) and flowing water, was noticed adjacent to the downstream toe of slope near the right abutment. Seepage was also noticed at the downstream toe of slope in an area between the left abutment and the spillway outlet pipe. Limestone riprap, ranging in size from 2 inches to pieces estimated to weigh about 200 pounds, serves to protect the upstream face of the dam above and below the normal waterline. A road with a gravel surface traverses the top of the dam crossing the crest of the emergency spillway. No cracking of the exposed ground surface at the crest was noticed. A profile along the top of the dam extending through the crest of the emergency spillway is shown on Plate 3. Examination of the top of dam profile indicates a difference of approximately 0.6-foot between low and high elevations. It is probable that settlement, due to thawing and subsequent consolidation of frozen fill (see discussion in paragraph 2.2), could account for the irregular level of the top of the dam.

NO. 1: CREST AND UPSTREAM FACE OF DAM

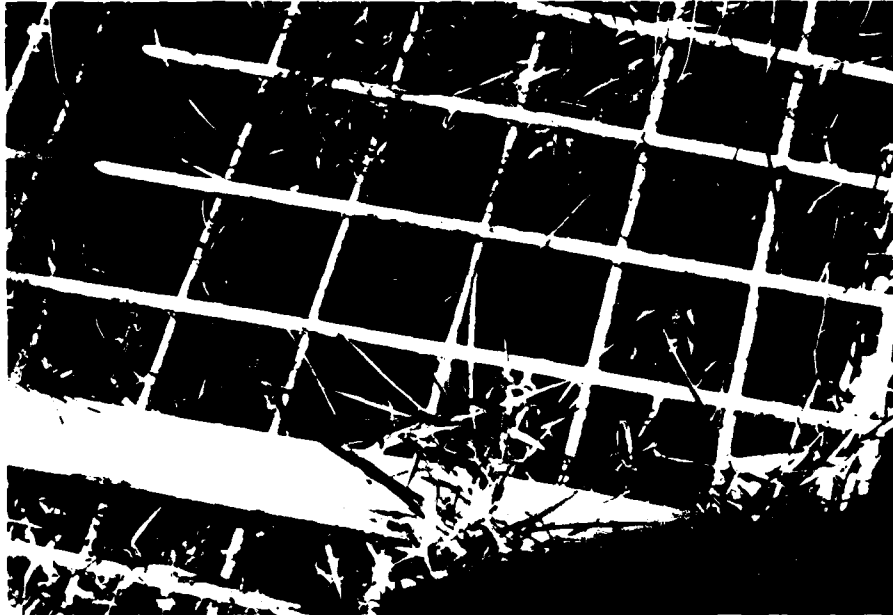
c. Drop Inlet Spillway. The 18-inch diameter steel pipe riser section for the drop inlet type spillway (see Photo 3), located near the center of the dam, appeared to be in good condition. A steel bar trash screen serves to protect the opening from clogging by debris. The screen also appeared to be in good condition. On the day of inspection, the lake level was approximately 2 - 3 inches below the top of the riser. The growth of grass around the riser indicates that the normal pool level has not been maintained for some period prior to the inspection. The visible part of the end of the 12-inch diameter steel pipe outlet for the drop inlet spillway appeared to be in satisfactory condition, although it did have a coating of rust. A profile of the drop inlet spillway is shown on Plate 4. The profile of the 12-inch line is assumed based upon the invert elevations measured at the upper and lower ends of the pipe. The channel subgrade at the 12-inch pipe outlet was eroded and filled with water (see Photo 5). Several medium-size willow trees were growing in the channel in the vicinity of the outlet pipe (see Photo 4). The downstream channel below the outlet pipe is unimproved and joins the Bourbeuse River approximately 2,000 feet below the dam. The channel lies adjacent to the lagoon dike for a distance of about 600 feet.

NO. 3: 18-INCH DROP INLET SPILLWAY
