LAKE AGGRAVATION DAM
FRANKLIN COUNTY, MISSOURI
MO. 30557

**PHASE 1 INSPECTION REPORT
NATIONAL DAM SAFETY INSPECTION**

LAKE AGGRAVATION DAM
Franklin County, Missouri
Missouri Inventory No. 30557

Phase I Inspection Report
National Dam Safety Program

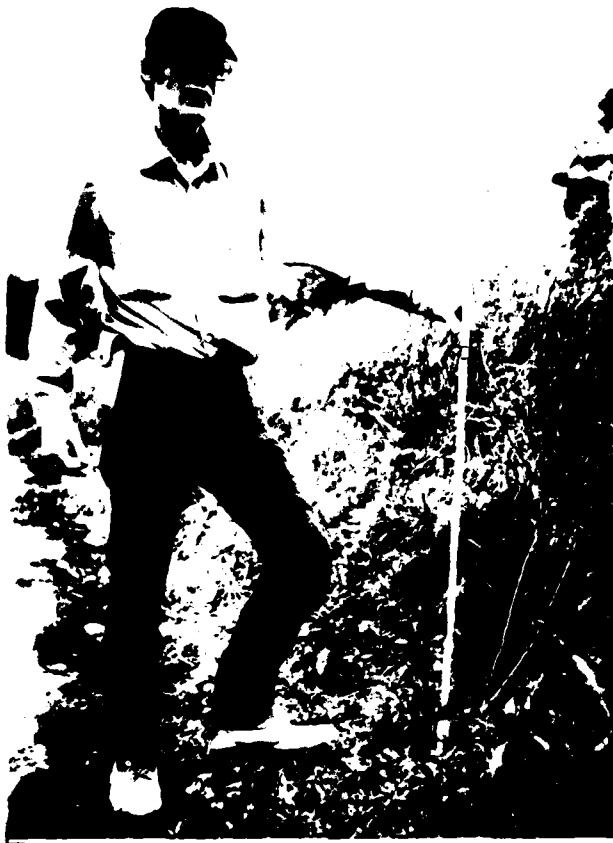
Evidence of minimal or no maintenance efforts on this facility include wave-cut erosion on the upstream bank of the dam, cracked and spalled concrete on the weir, trees growing in the discharge channel, and holes eroded through the discharge channel lining.

7. 2 ft wave-cut erosion on upstream edge of Lake Aggravation Dam; looking west.
