LONEDELL LAKE DAM  
WASHINGTON COUNTY, MISSOURI  
MO 31395

# PHASE 1 INSPECTION REPORT NATIONAL DAM SAFETY INSPECTION

SEPTEMBER 1980

**Phase I Inspection Report**  
**National Dam Safety Program**

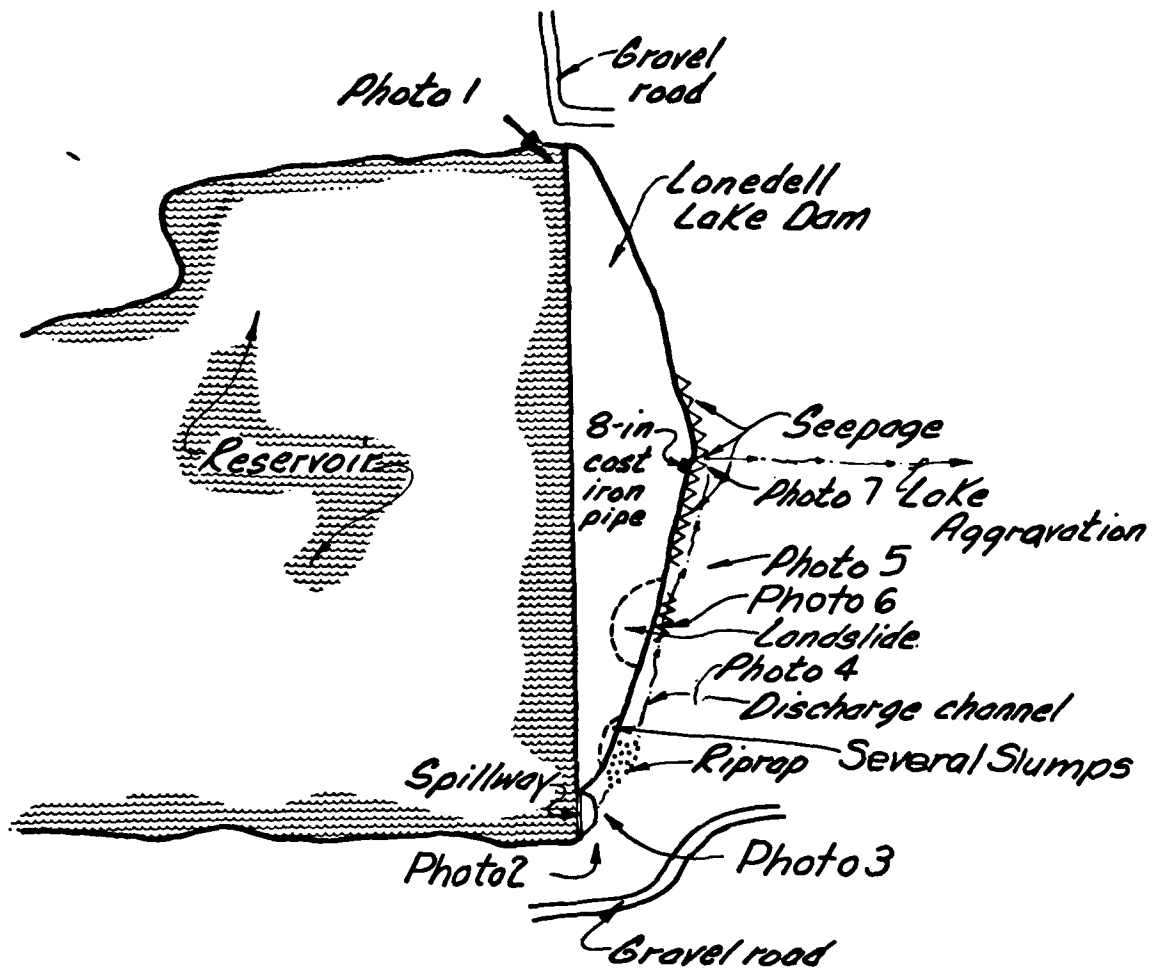
Fig. A-1

Several small to moderate size slumps and one landslide were noted along the toe of the south half of the dam (Fig. A-1, Appendix A). Seepage at the toe of these slides was estimated at approximately 5 gal/min.
