TEMPLES LAKE DAM
STODDARD COUNTY, MISSOURI

MISSOURI INVENTORY NO. 40065

PHASE I INSPECTION REPORT
NATIONAL DAM SAFETY PROGRAM

MARCH 1980

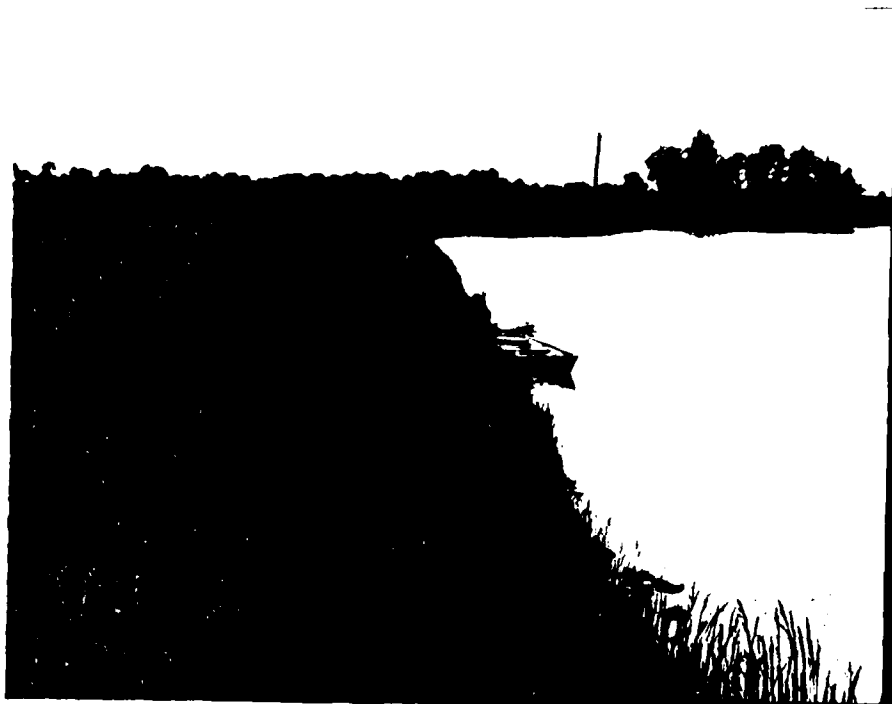
c. Dam. Based on the cross-section presented on Plate 5, the dam has an average upstream embankment slope of 1V on 3.54H and an average downstream slope of 1V on 3.12H. The crown width of the dam is 13 feet. The visual inspection indicates no evidence of any undue settlement, cracking or sliding of the dam. No animal burrows were observed in the dam. The crest and slopes are very well grassed and maintained. (See Photos 1, 2, and 3).

PHOTO 3: Upstream Slope from Left Abutment

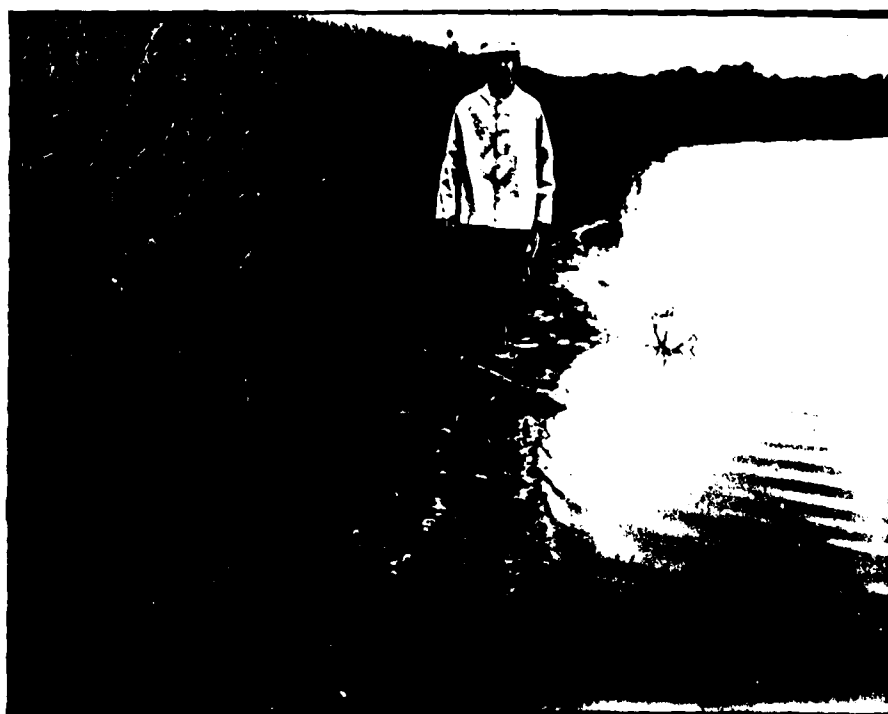
The upstream embankment has no erosion protection and some minor wavewash has occurred intermittently along the upstream face (See Photo 4). Minor erosion appears on the downstream face of dam; however, this appears to have been caused by the use of this portion of the dam by cattle. (See Photo 5). Also a marshy area was observed on the downstream toe of the embankment near the emergency spillway (See Photo 6). No evidence of piping material or seepage flow was observed. The area appeared to be a low marshy area.

None of the conditions observed are significant enough to indicate a need for immediate remedial action. However, the minor wavewash and minor erosion gullies on the downstream embankment slope of the dam should be corrected or controlled.

PHOTO 4: Wavewash on Upstream Slope

(1) The minor wave wash of the upstream embankment slope and the minor erosion gullion on the downstream embankment slope should be corrected or controlled.

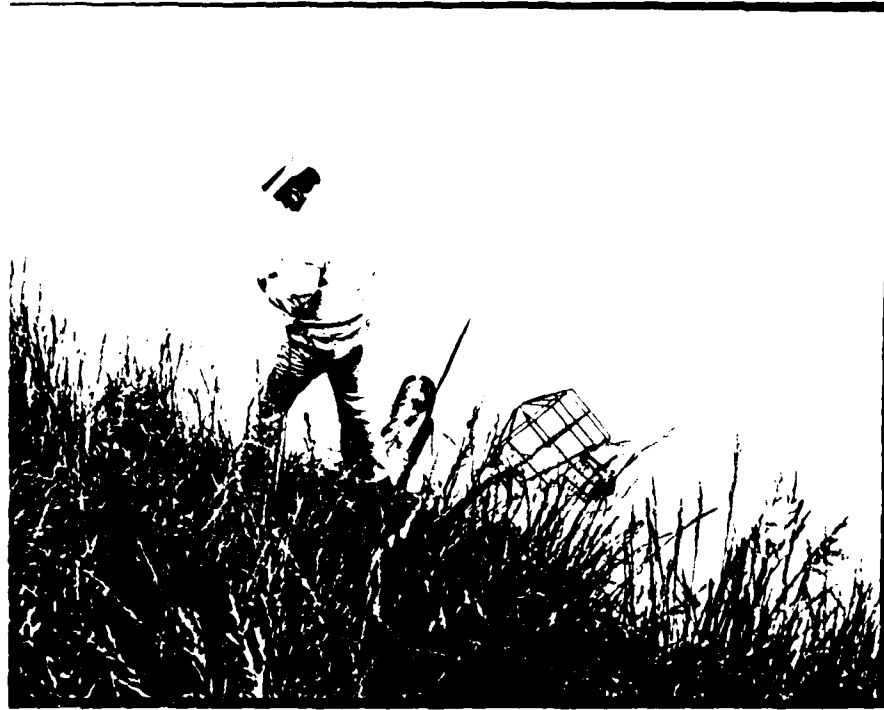
d. Appurtenant Structures. An 8-inch diameter smooth iron pipe with a canopy inlet and trash rack is the primary means of discharge. At the time of the inspection the trash rack had been removed. The lake was also being drained by a siphon constructed of PVC pipe inserted within the main discharge pipe. (See Photo 7). Minor seepage flow with a reddish iron oxide tint was observed in the area of the outlet. No piping of dam material was observed. Willow trees and cattails grew abundantly in the area. (See Photo 8). An earthen V-shaped emergency spillway was cut in the right abutment. The discharge of the emergency spillway empties into a side channel that extends for a distance of approximately 700 feet. The channel then connects to a small farm pond. The emergency spillway and side channel are very well maintained. (See Photos 9 and 10). Plate 6 shows the centerline profile of the top of the guide levee and the centerline of the bottom of the emergency spillway channel from the main dam to the farm pond.

PHOTO 7: Inlet Pipe

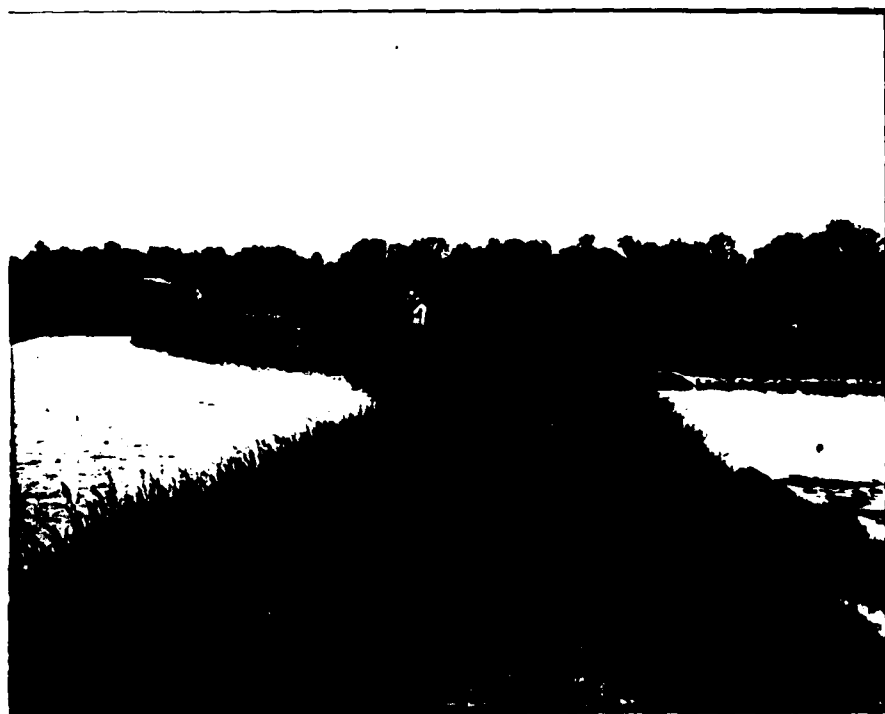
(4) The emergency spillway channel is connected to a farm pond approximately 700 ft. downstream from the centerline of the dam. On occasion, the flow from the emergency spillway could act as a source of water for the downstream pond (See Plate 3 and Photos 9, 10, 11, and 12).

PHOTO 10: Guide Levee between Farm Pond and Lagoon

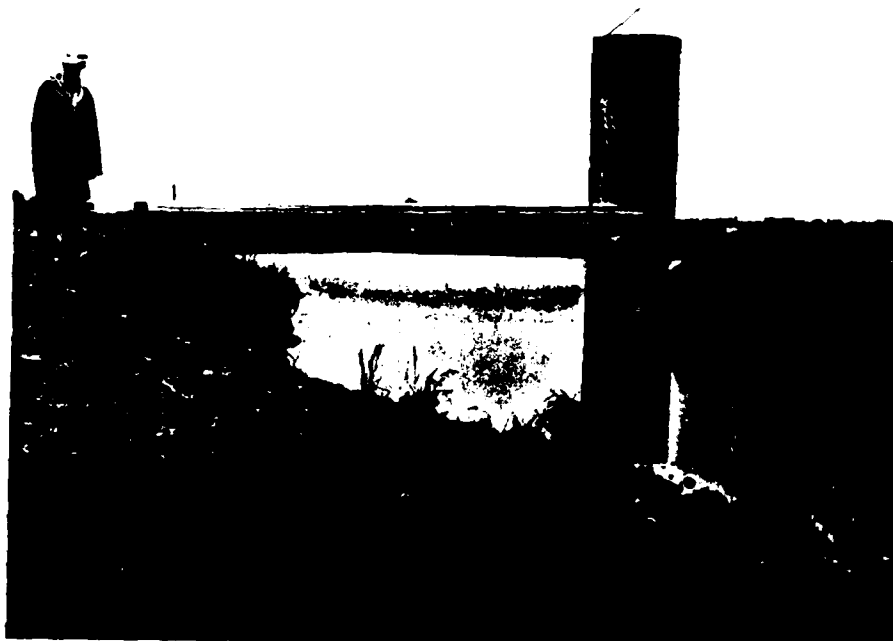
Plates 7 and 8 show cross-section along the emergency spillway channel as depicted on Plate 3. Photos 11 and 12 show the farm pond and lagoon respectively.

PHOTO 11: Farm Pond

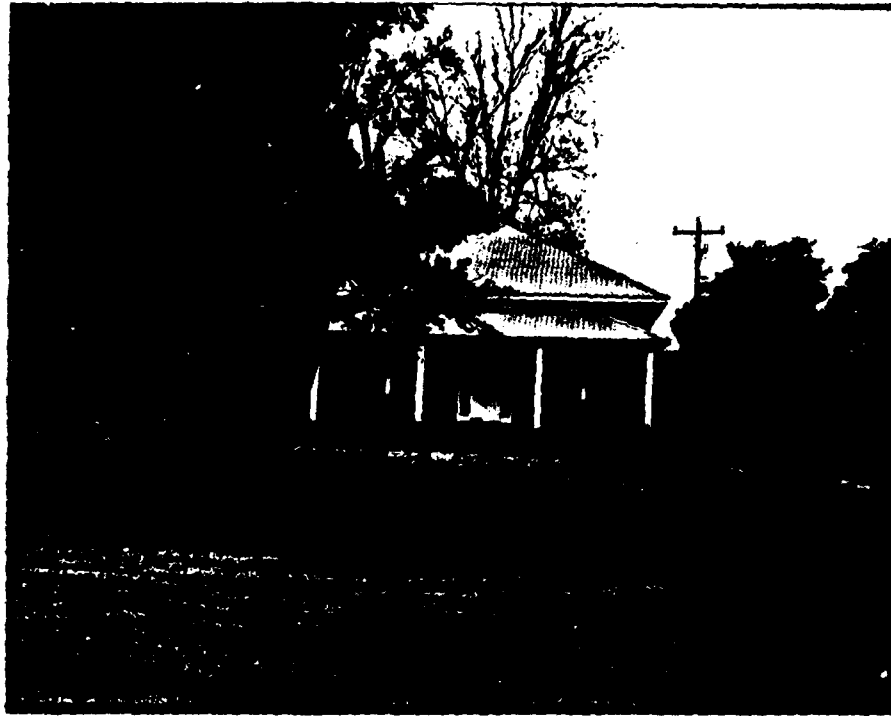
PHOTO 15: Uninhabited Dwelling Downstream of Dam .
