HARRISONVILLE CITY LAKE DAM

CASS COUNTY, MISSOURI

**PHASE 1 INSPECTION REPORT
NATIONAL DAM SAFETY INSPECTION**

BLACK & VEATCH
CONSULTING ENGINEERS
KANSAS CITY, MISSOURI

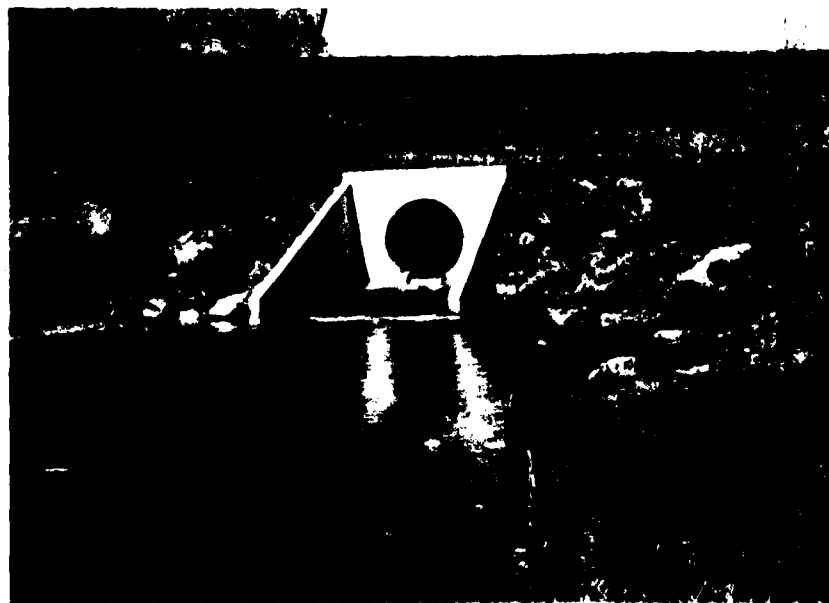
PHOTO 12: SHAFT SPILLWAY DISCHARGE STRUCTURE (LOOKING UPSTREAM)

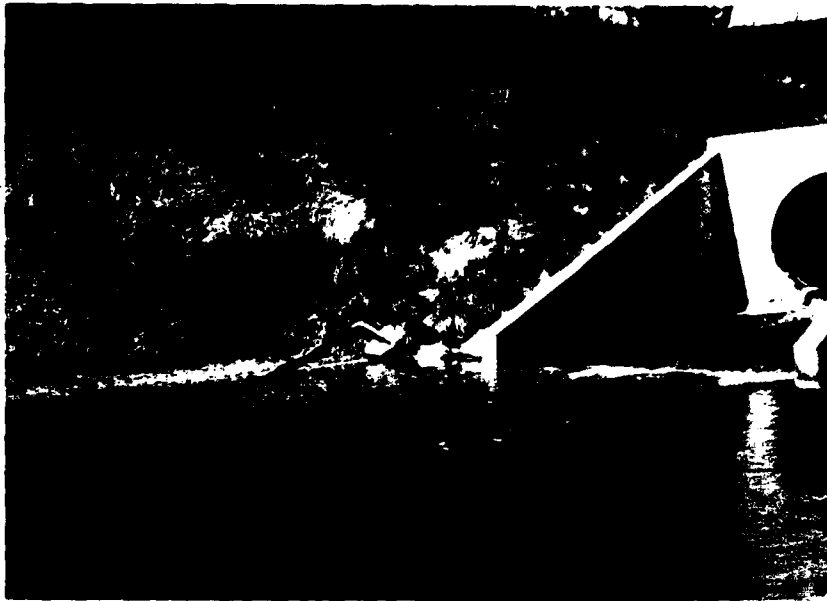
downstream of the axis of the dam. The condition of this discharge conduit is unknown, only the outlet end was accessible to inspection. The special concrete discharge headwall is generally in good condition, but there is an area of 3 feet by 4 feet on the right wall of the headwall in which the concrete has spalled to depths less than 1 inch. The channel immediately downstream of the discharge structure has eroded to a depth of 3 feet lower than the apron. Erosion probably due to surface runoff from the dam slope and downstream right abutment was also observed along the left wingwall. The earth and rock emergency overflow spillway near the left abutment of the dam is in good condition, with no significant erosion or obstructions to flow evident. The grass-lined channel downstream of the spillway also appears to be in good condition. A minor amount of rivulet erosion has occurred in the discharge channel, but it has no effect on the safety of the dam.

(6) Spalling of concrete on the right wingwall of the principal spillway discharge structure.

PHOTO 13: SEEPAGE FROM EMBANKMENT AND SPALLING OF CONCRETE ON WINGWALL

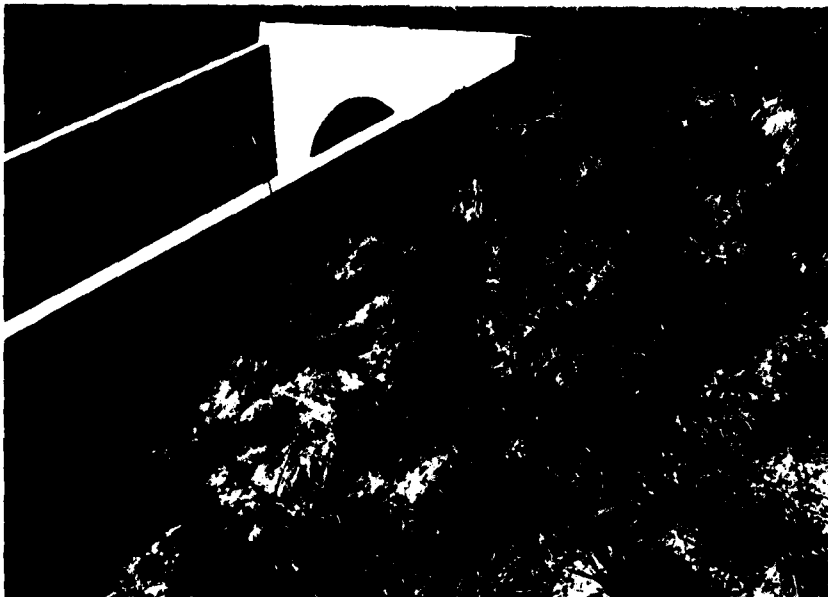
PHOTO 14: EROSION ALONG WINGWALL OF SPILLWAY DISCHARGE STRUCTURE

(4) Check the stream channel immediately downstream of the principal spillway discharge apron after periods of significant discharge to determine whether erosion is undercutting the floor of the headwall. If such a situation is noted, erosion protection should be provided.

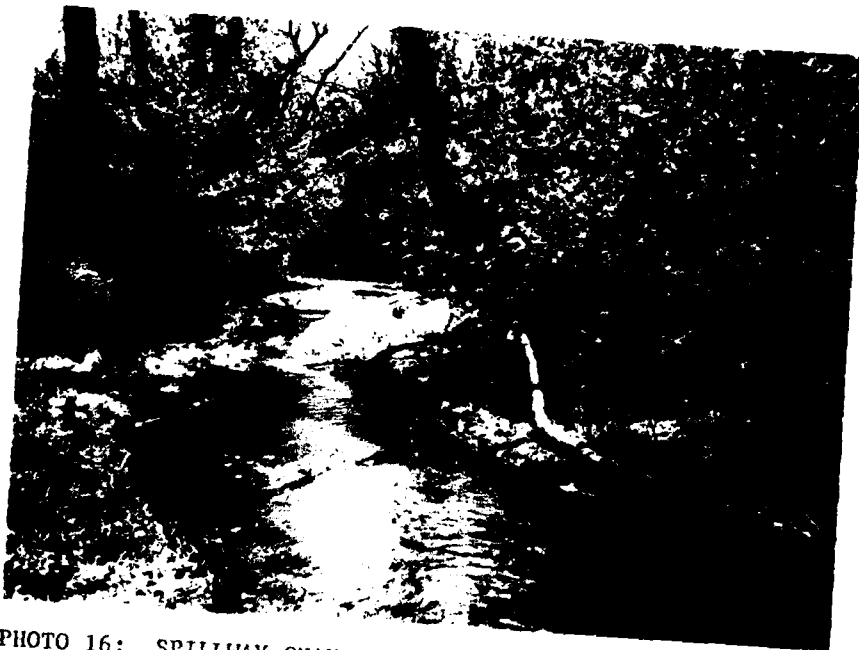
e. Downstream Channel. The natural stream channel downstream of the principal spillway discharge headwall is comprised primarily of the broken shale, with a moderate amount of vegetation in the form of medium to large trees along the channel. The channel downstream of the emergency spillway is 200 feet wide and is generally well covered by grass. The emergency spillway discharge channel leads to the natural stream channel 600 feet downstream of the principal spillway discharge headwall.

PHOTO 16: SPILLWAY CHANNEL (LOOKING DOWNSTREAM)
