**THERMAL DEGRADATION OF  
GRAPHITE/EPOXY COMPOSITES**

H. L. PRITT

**HERCULES INCORPORATED  
AEROSPACE DIVISION  
BACCHUS WORKS • MAGNA, UTAH**

Final Report

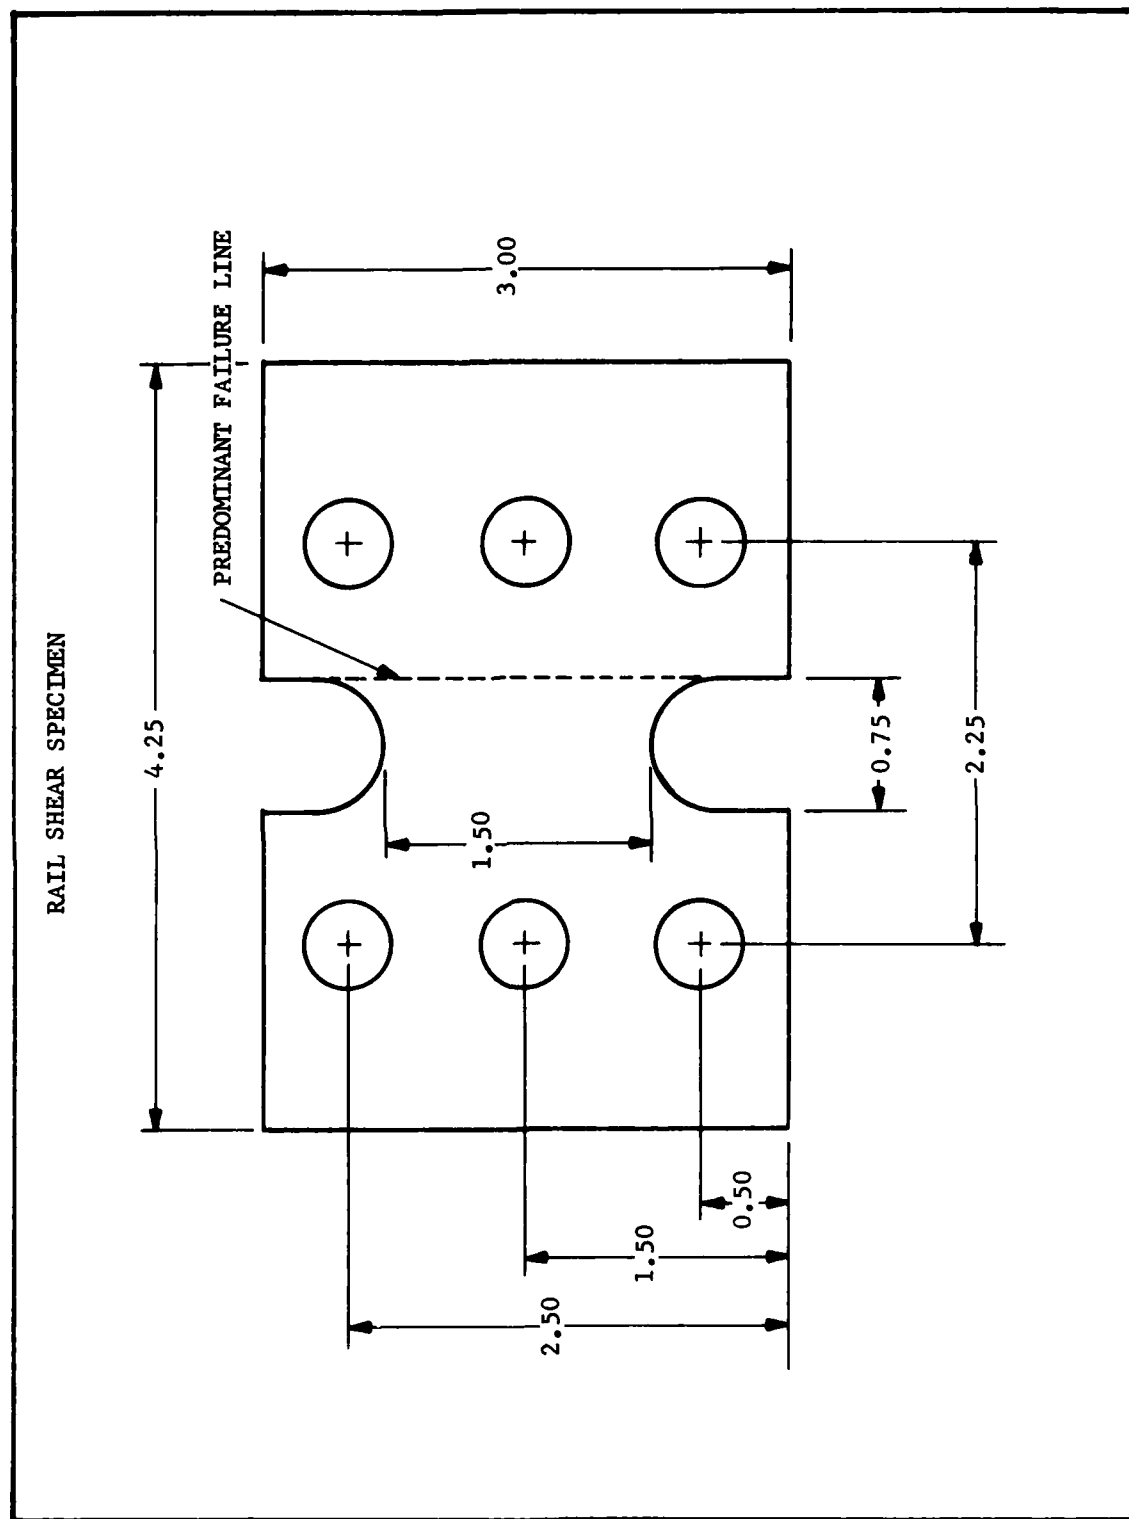
Figure 27. Modified Rail Shear Specimen

test failure loads by notching the previous specimens as seen in Figure 27. Although test results would not reflect pure shear failures, they would give a relative comparison of thermal damage when tested at room temperature and 220°F.

Data obtained in these tests are tabulated in Table 8. Most of these modified specimens failed along the dashed line shown in Figure 27. Visual damage was present in specimen T11-1 through T11-6 which had been subjected to 600°F thermal shock. Yet, test results from comparable specimens SA4-1 and SA4-2 were nearly identical.

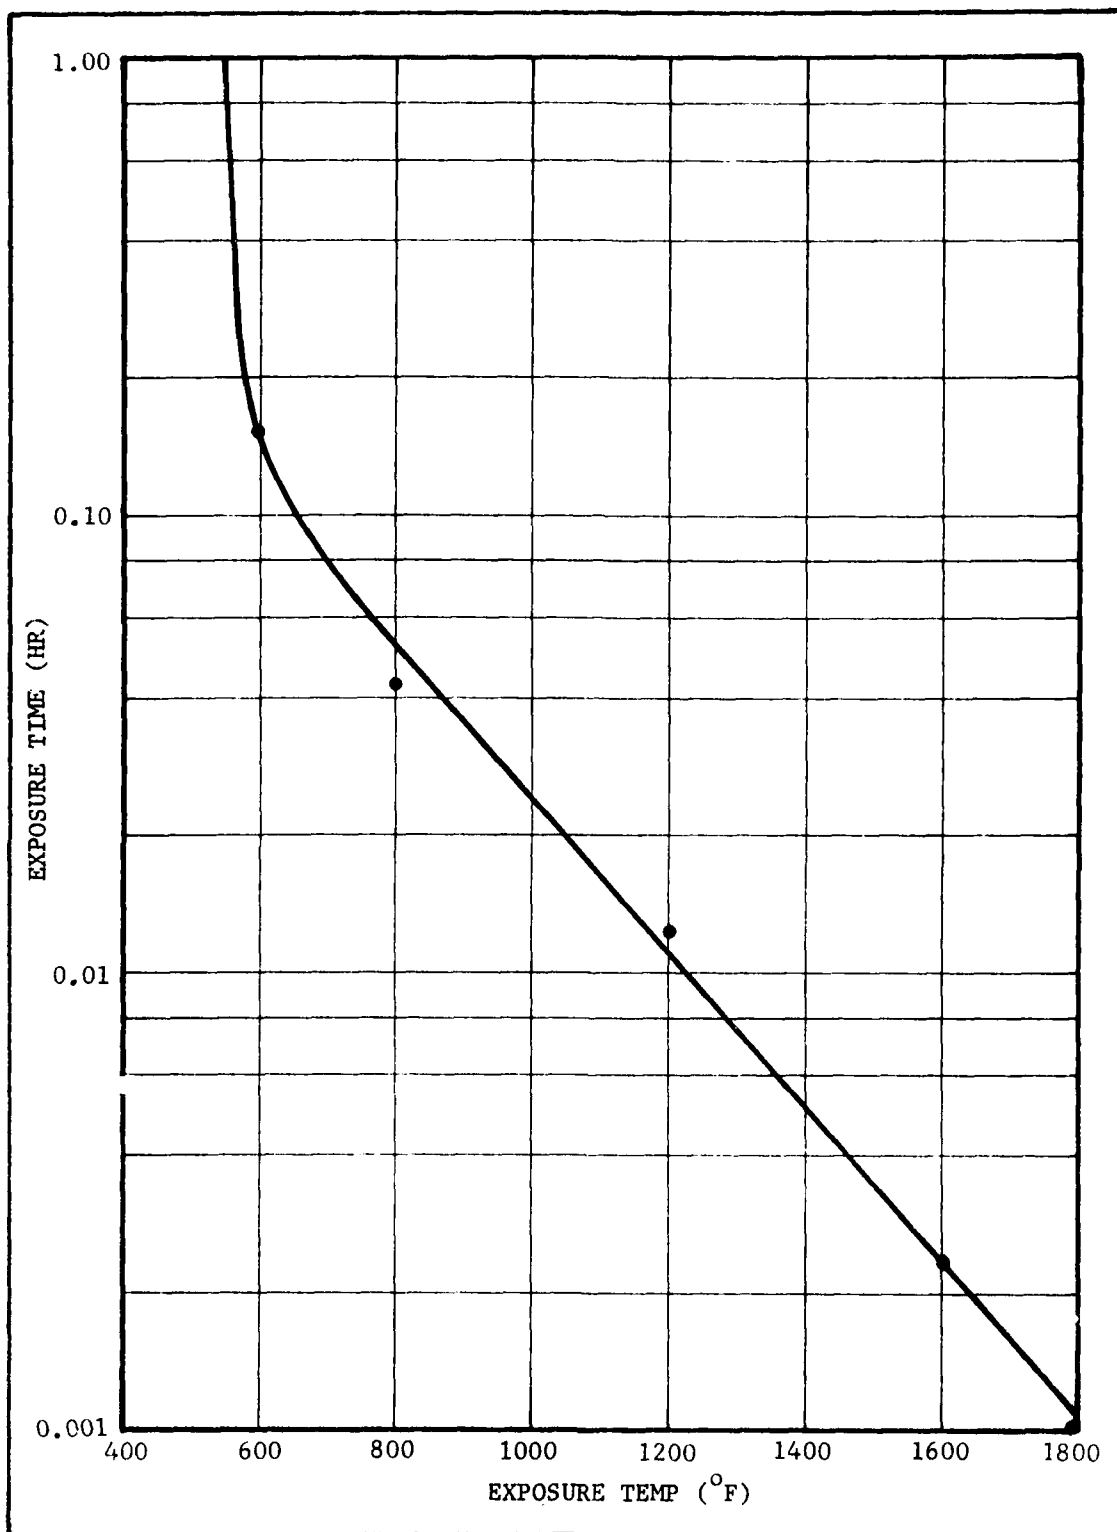
Figure 32. Predicted First-Ply Damage Based on Coating Color Changes for Exposure Time vs Temperature

Review of top coating color changes as a result of thermal exposure on the test coupons shows that, at exposures of 600°F and above, irreversible first-ply damage can be expected with sufficient exposure times. The damage threshold occurs when the top coat color changes to a mauve (pale violet) shading and as the percent of reflected light drops to approximately 80% of the unexposed coat. Color changes from light gull grey through tan through brown do not indicate first-ply damage unless there is evidence of the mauve shading. This mauve color first occurs during 600°F exposures and is found during coating color changes at the higher temperature exposures.

A plot of predicted threshold damage (time/temperature) is presented in Figure 32.
