**KERNODLE LAKE DAM NO. 1**

**JACKSON COUNTY, MISSOURI**

**MO 20140**

**PHASE 1 INSPECTION REPORT  
NATIONAL DAM SAFETY INSPECTION**

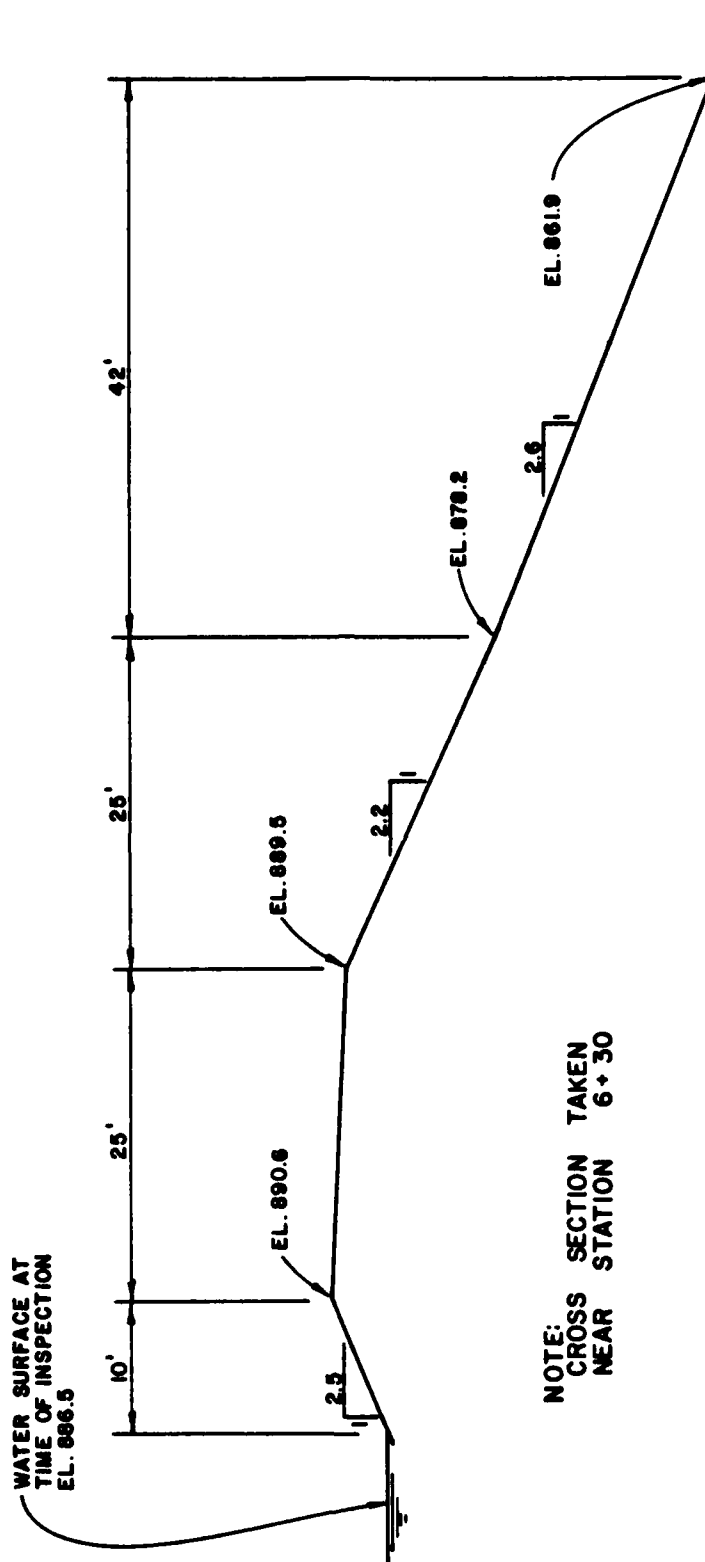
# KERNODLE LAKE NO. 1 EMBANKMENT CROSS SECTION

NOTE: CROSS SECTION TAKEN  
NEAR STATION 6+30

SECTION DATA OBTAINED  
FROM FIELD SURVEY.
