**CAMERON RESERVOIR NO. 2 DAM**

**DEKALB COUNTY, MISSOURI**

**PHASE 1 INSPECTION REPORT  
NATIONAL DAM SAFETY INSPECTION**

PHASE I INSPECTION REPORT  
NATIONAL DAM SAFETY PROGRAM

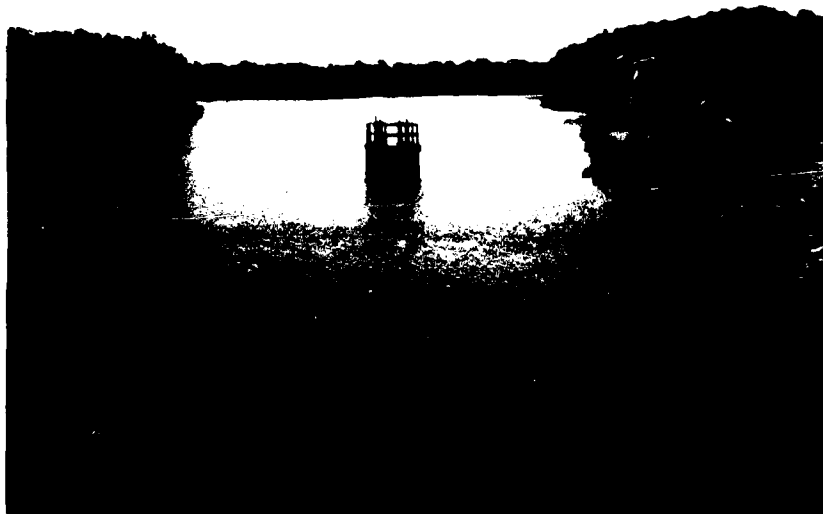
PHOTO 4: INTAKE STRUCTURE
