NATIONAL DAM SAFETY PROGRAM. BUICK MINE TAILINGS DAM (MO 301621)-ETC(U)

# PHASE 1 INSPECTION REPORT NATIONAL DAM SAFETY INSPECTION

| REPORT DOCUMENTATION PAGE | | READ INSTRUCTIONS<br>BEFORE COMPLETING FORM |
|---|---|---|
| 4. TITLE (and Subtitle)<br>Phase I Dam Inspection Report<br>National Dam Safety Program<br>Buick Mine Tailings Dam (MO 30162)<br>Reynolds County, Missouri | | 5. TYPE OF REPORT & PERIOD COVERED<br>9 Final Report |

# BUICK MINE TAILINGS DAM

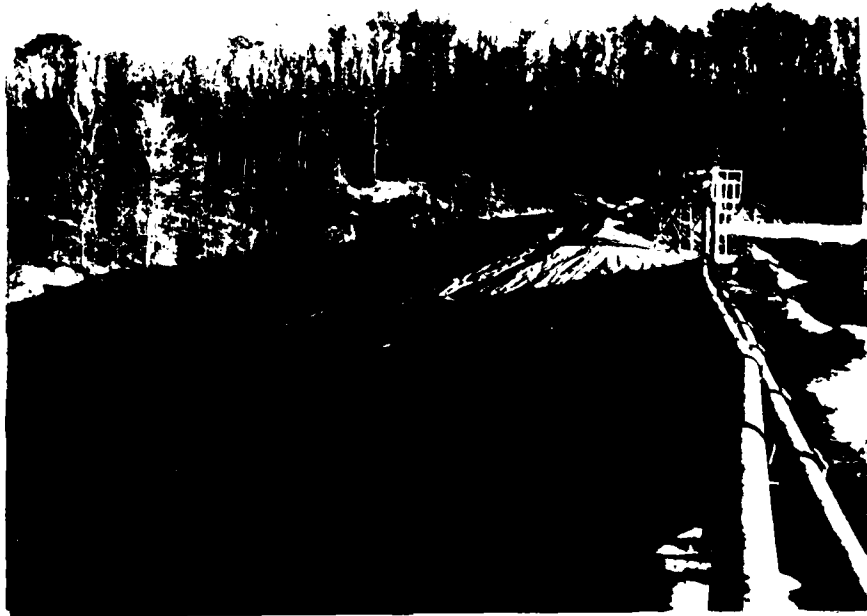
2. Cyclone depositing tailings on the downstream face of the dam. Pipes in the foreground carry unsorted tailings from the mill to the cyclone, and fine tailings from the cyclone to be discharged into the reservoir. Looking southeast along crest of dam.

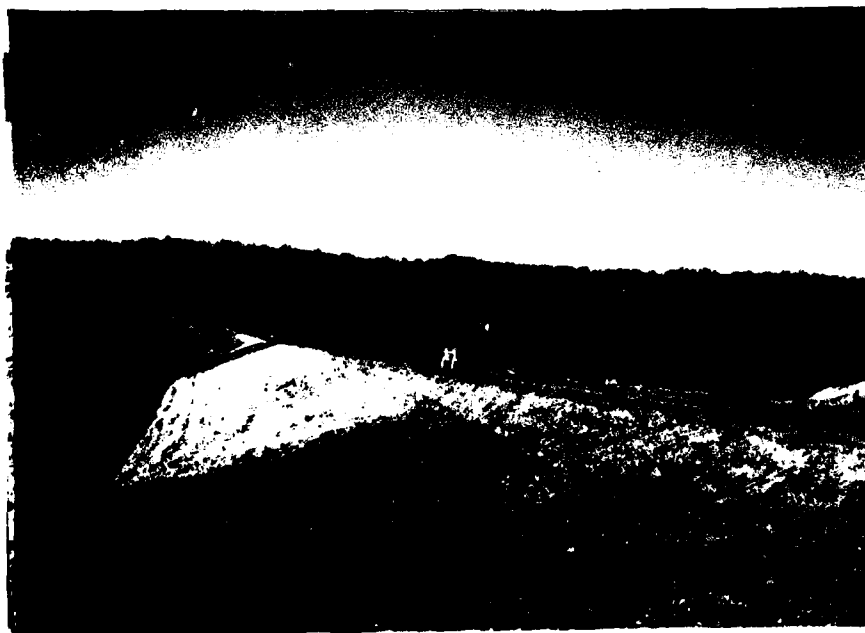
No signs of slope instability such as cracking or slumping were noted. The vertical and horizontal alignment of the dam crest appeared undisturbed (Photo 4). No detrimental settlement or sinkhole development was noted. The tailings surface is barren of vegetation. The rock and soil covered portion has scattered weed and grass vegetation. No animal burrows were noted.

4. View along crest of dam from right abutment. Looking northwest.

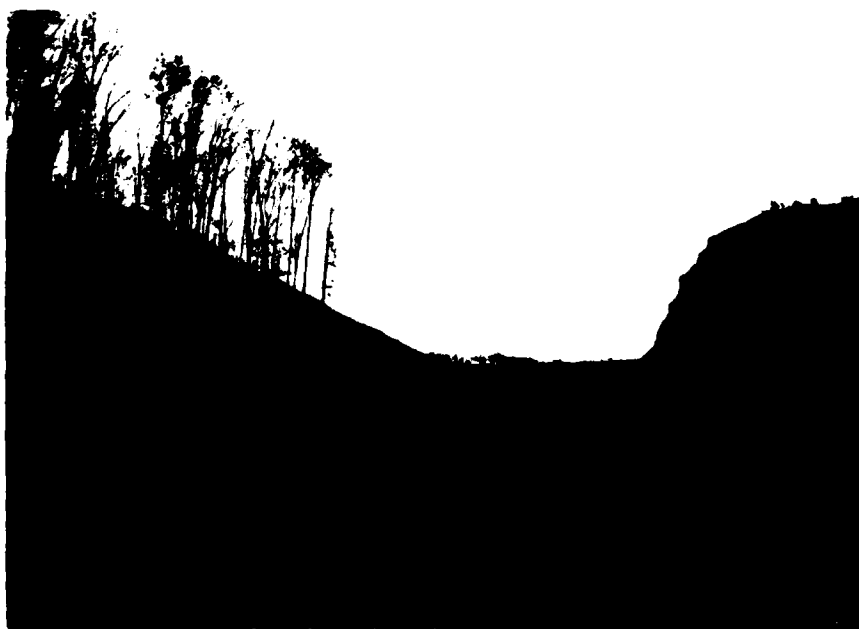
8. Spillway cut through hillside to the south of the dam and reservoir. Soil embankment at far end of (upstream) is 1 ft lower than crest of dam. Decant line runs beneath the fill placed on the floor of this cut. Looking northwest (upstream in spillway channel).

1. Evaluate methods of increasing the height of the dam crest and/or increasing the spillway capacity to store and pass 100 percent of the PMF, without overtopping the embankment. This recommendation may have already been satisfied by the normal construction progress. The spillway should be protected to prevent erosion.

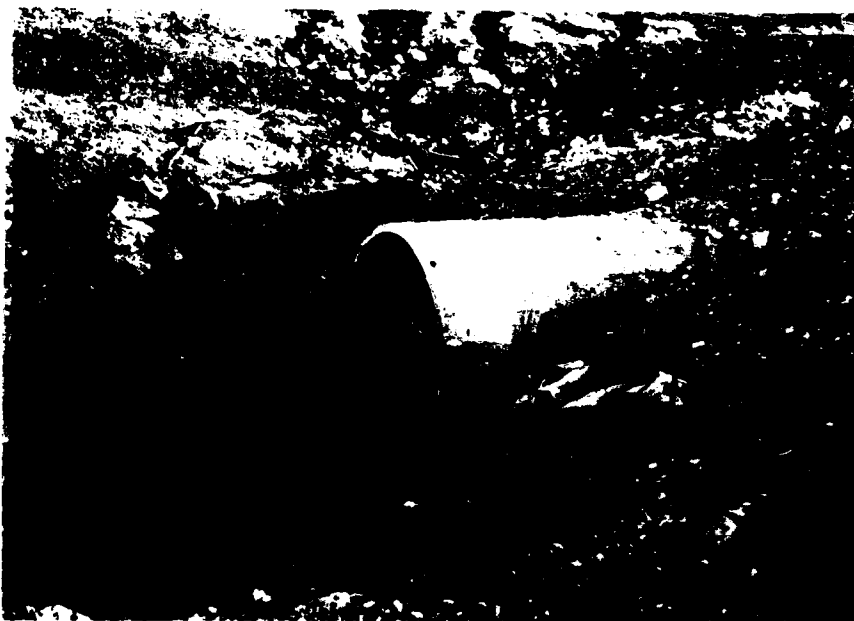
10. Trash rack at inlet to decant line. Looking east.
