SUBJECT: Blackwell Mine Dam (MO 30709) Phase I Inspection Report

**BLACKWELL MINE DAM**  
Washington County, Missouri  
Missouri Inventory No. 30709

**Phase I Inspection Report**  
**National Dam Safety Program.**

PHASE I REPORT  
NATIONAL DAM SAFETY PROGRAM

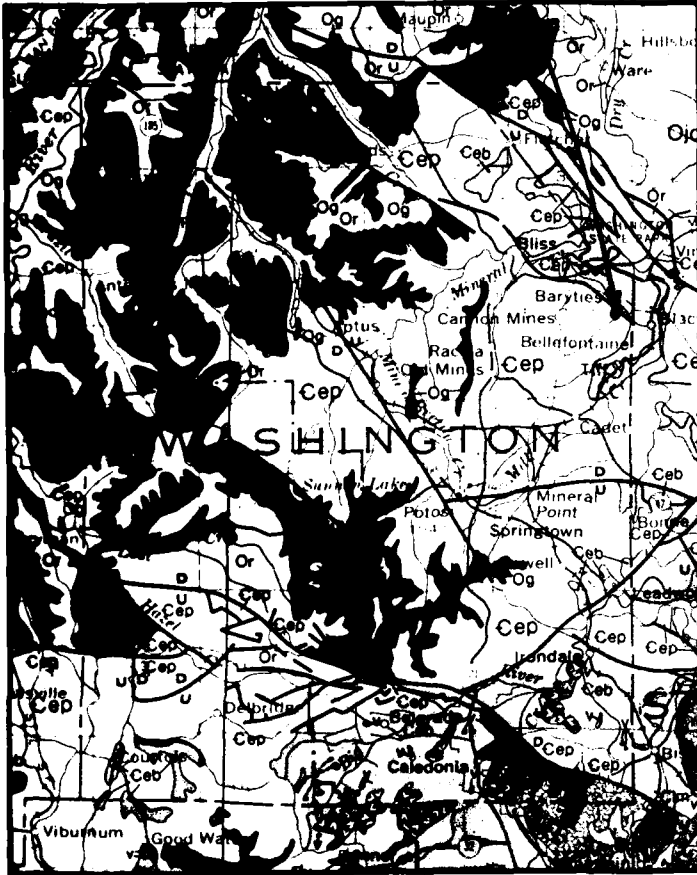
<b>REGIONAL GEOLOGIC MAP</b>	
<b>BLACKWELL MINE DAM</b>	
<b>MO 30709</b>	<b>Fig. 4</b>

The Cruise Mill-Fertile Fault Zone is mapped directly beneath the Blackwell Mine Dam (Fig 4). However, the scale of the map (1 inch equals approximately 8 miles) does not allow for precise location of the fault trace. No evidence of the fault was noted during the field inspection. The fault zone is approximately 6 miles long with a northwest-southwest trend, and may connect with the Richwoods Fault Zone, to the northwest, resulting in a zone approximately 15 miles long. The fault is mapped as northeast side up.

The Cruise Mill-Fertile Fault Zone, like others in the Ozark area, appears confined to the Paleozoic bedrock and is likely Paleozoic in age. The area is not considered seismically active. However, the presence of a fault in the immediate vicinity, and perhaps underlying the dam, suggests further study is necessary to evaluate the potential for groundwater solutioning along the fault in the foundation of this dam.

A study should also be made of the Cruise Mill-Fertile-Fault zone, as described in this report in Section 2.5 Project Geology, to determine the location of the trace of this fault and to evaluate whether or not it represents any unusual hazards to the dam. This study should be undertaken without undue delay. Seepage and stability analyses should be performed by a professional engineer experienced in the design and construction of dams.
