**DESOTO MINING COMPANY**  
**PIT AND PLANT "A" DAM**  
Washington County, Missouri  
Missouri Inventory No. 30468

**Phase I Inspection Report**

**National Dam Safety Program ,**

**PHASE I INSPECTION REPORT  
NATIONAL DAM SAFETY PROGRAM  
DESOTO PIT AND PLANT "A" DAM, MISSOURI INVENTORY No. 30468**

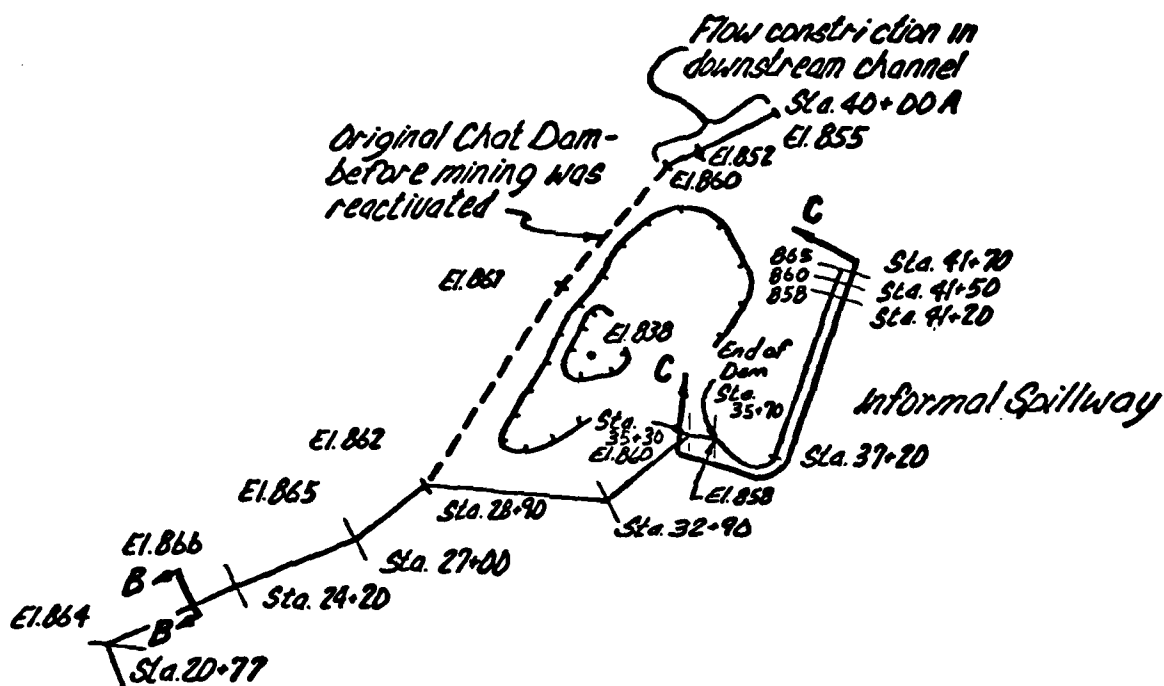
FIG 3A

3. Spillway. There is no formal designed spillway at this facility. The term "informal spillway" has been assigned to the low area to the south of the south end of the dam (see Figs. 3a and 3b). This overflow area has a moderate to high erosion potential as the stoney clay residual soil is only vegetated by grass, brush and small trees. This soil has been observed to be highly erodible when stripped of vegetation and exposed to high flow velocities.

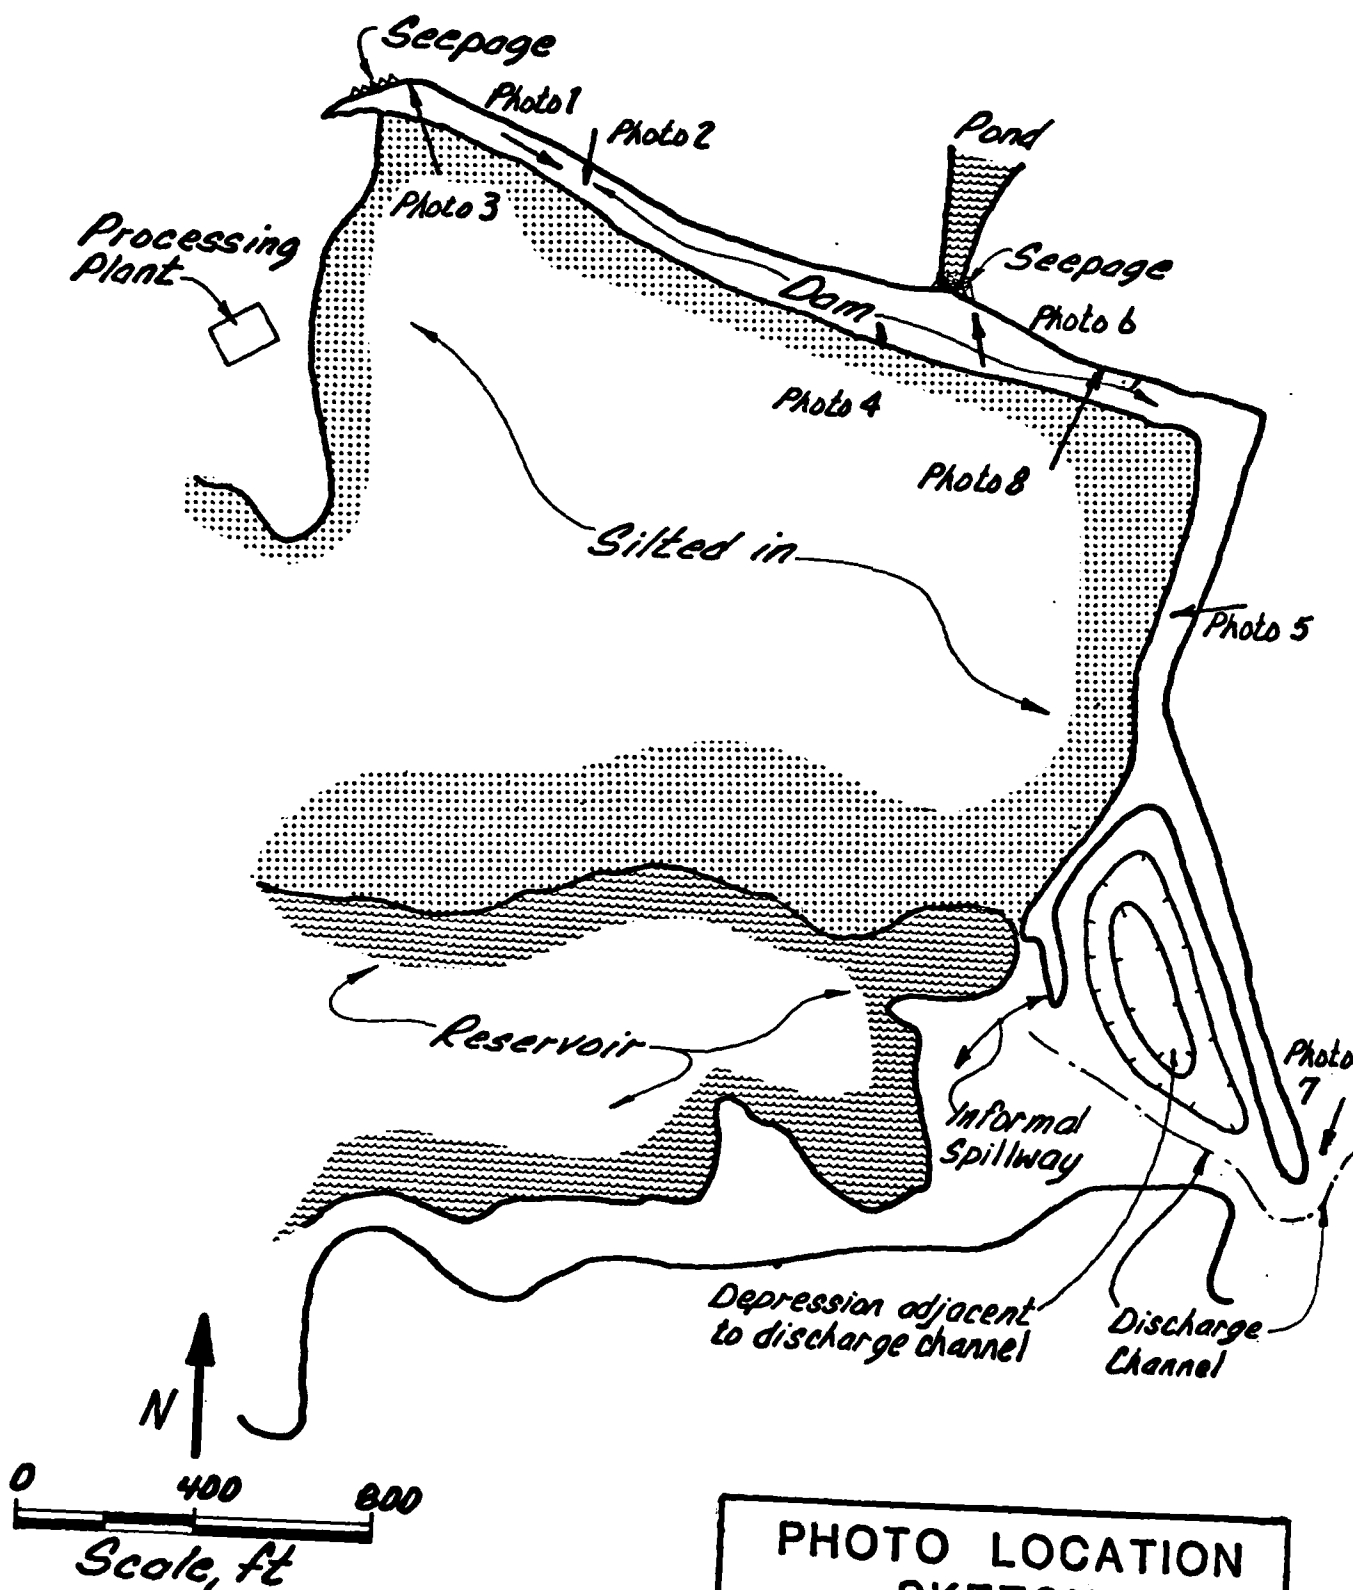
Fig. A-1

Seepage was noted at the two locations shown on Fig. A1, Appendix A. Clear water was observed seeping near the left abutment at approximately 3 to 5 gal/min. The seepage into the pond at the toe of this dam appeared to come from the sides of the pond rather than the dam.
