PHASE I INSPECTION REPORT  
NATIONAL DAM SAFETY PROGRAM

SUBJECT: Desoto Mining Co. Pit & Plant 'B' Dam (MO 30469) Phase I Inspection Report

**DESOTO MINING CO.**  
**PIT & PLANT "B" DAM**  
Washington County, Missouri  
Missouri Inventory No. 30469

**Phase I Inspection Report**  
**National Dam Safety Program .**

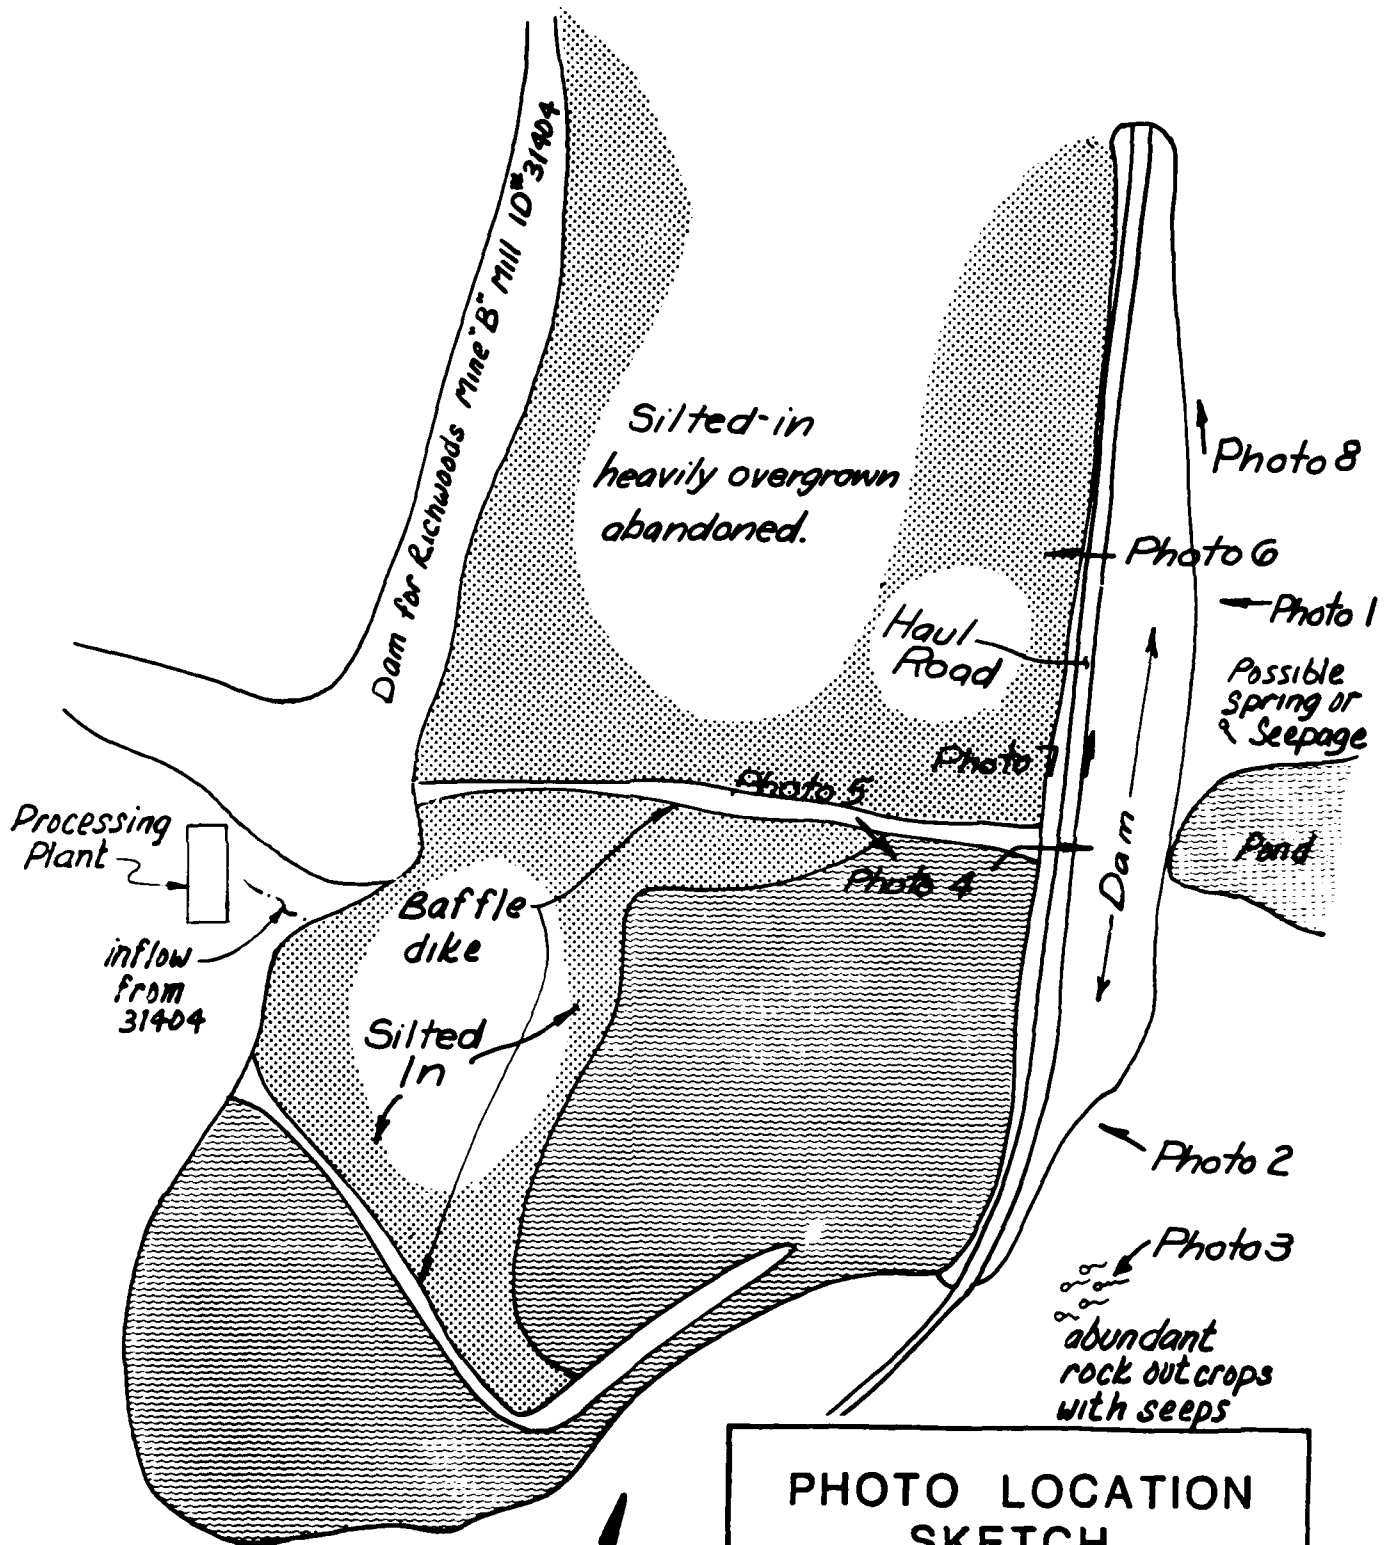
Fig. A-1

Clear seepage amounting to about 10 gal/min was observed about 40 ft from the downstream toe of the right abutment (Fig. A-1 Appendix A). The seepage appeared to be flowing along the residual soil/bedrock contact.
