ARNAULT BRANCH MINE DAM
WASHINGTON COUNTY, MISSOURI
MO 30718

PHASE 1 INSPECTION REPORT NATIONAL DAM SAFETY INSPECTION

ARNAULT BRANCH MINE DAM

Phase I Inspection Report

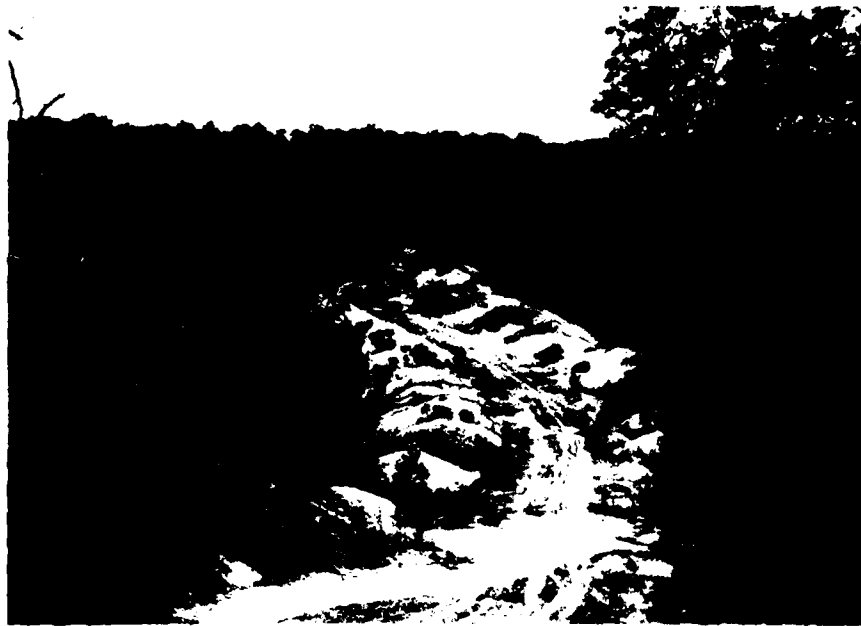
1. View along crest from east abutment.

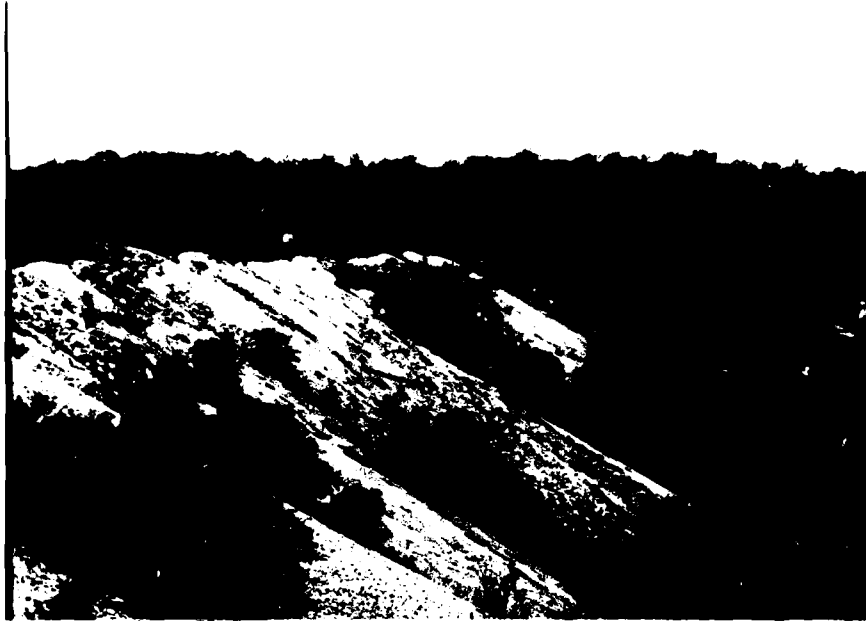
The vertical and horizontal alignment of the dam crest do not appear to be disturbed by deformation. No evidence of detrimental settlement, depressions, cracking or animal burrows were found during the inspection. It must be emphasized, however, that in the general vicinity of the maximum section on this dam, the surface of the dam was unusually uneven possibly due to lax construction control, as compared to most tailings dams in this area. This resulted in a very irregular downstream slope where possible post-construction deformations would be very difficult to detect (Photo 3; Appendix A).

3. Downstream slope from east abutment. Unevenness due to uncontrolled construction. (See Section 3.1.b)
