LEE McLEAN & JOHN Q. HAMMONS LAKE #3
GREENE COUNTY, MISSOURI
MO 20397

**PHASE 1 INSPECTION REPORT
NATIONAL DAM SAFETY INSPECTION**

PHASE I INSPECTION REPORT
NATIONAL DAM SAFETY PROGRAM

Name of Dam: Lee McLean & John Q. Hammons Lake #3
State Located: Missouri
County Located: Greene County
Stream: Tributary to James River
Date of Inspection: 15 May 1979

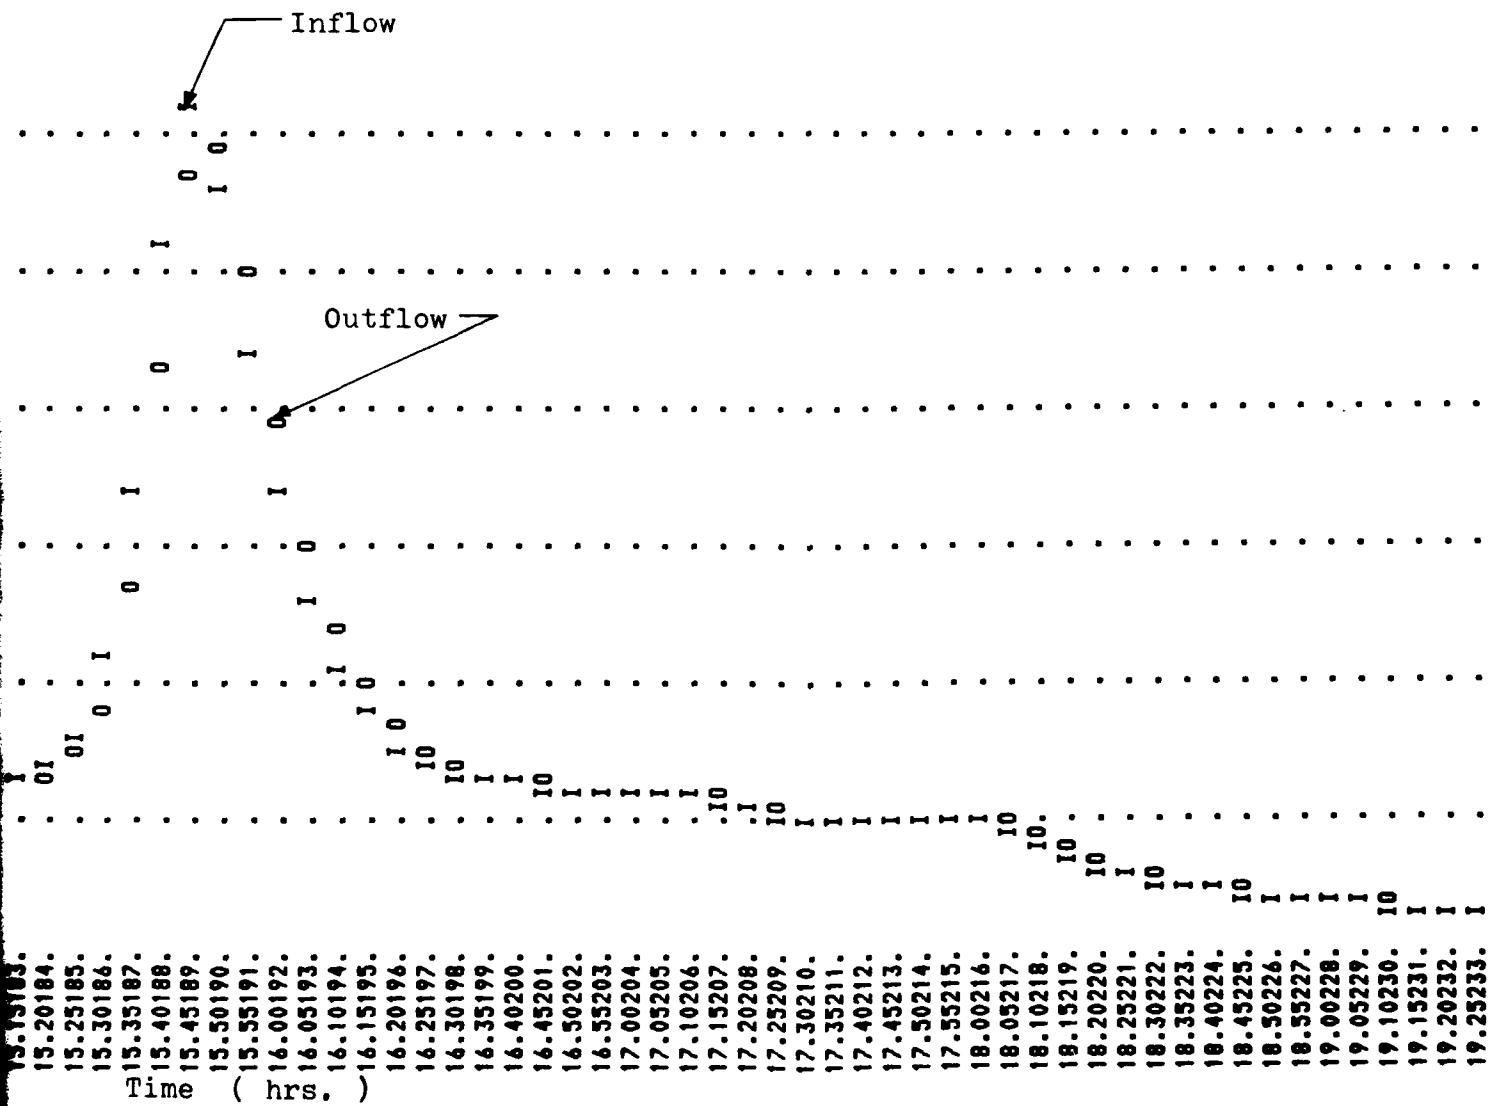
**INFLOW - OUTFLOW
HYDROGRAPH
FOR 100 YRS FLOOD**

Max. Inflow = 6,159 c.f.s.

Max. Outflow = 5,878 c.f.s.

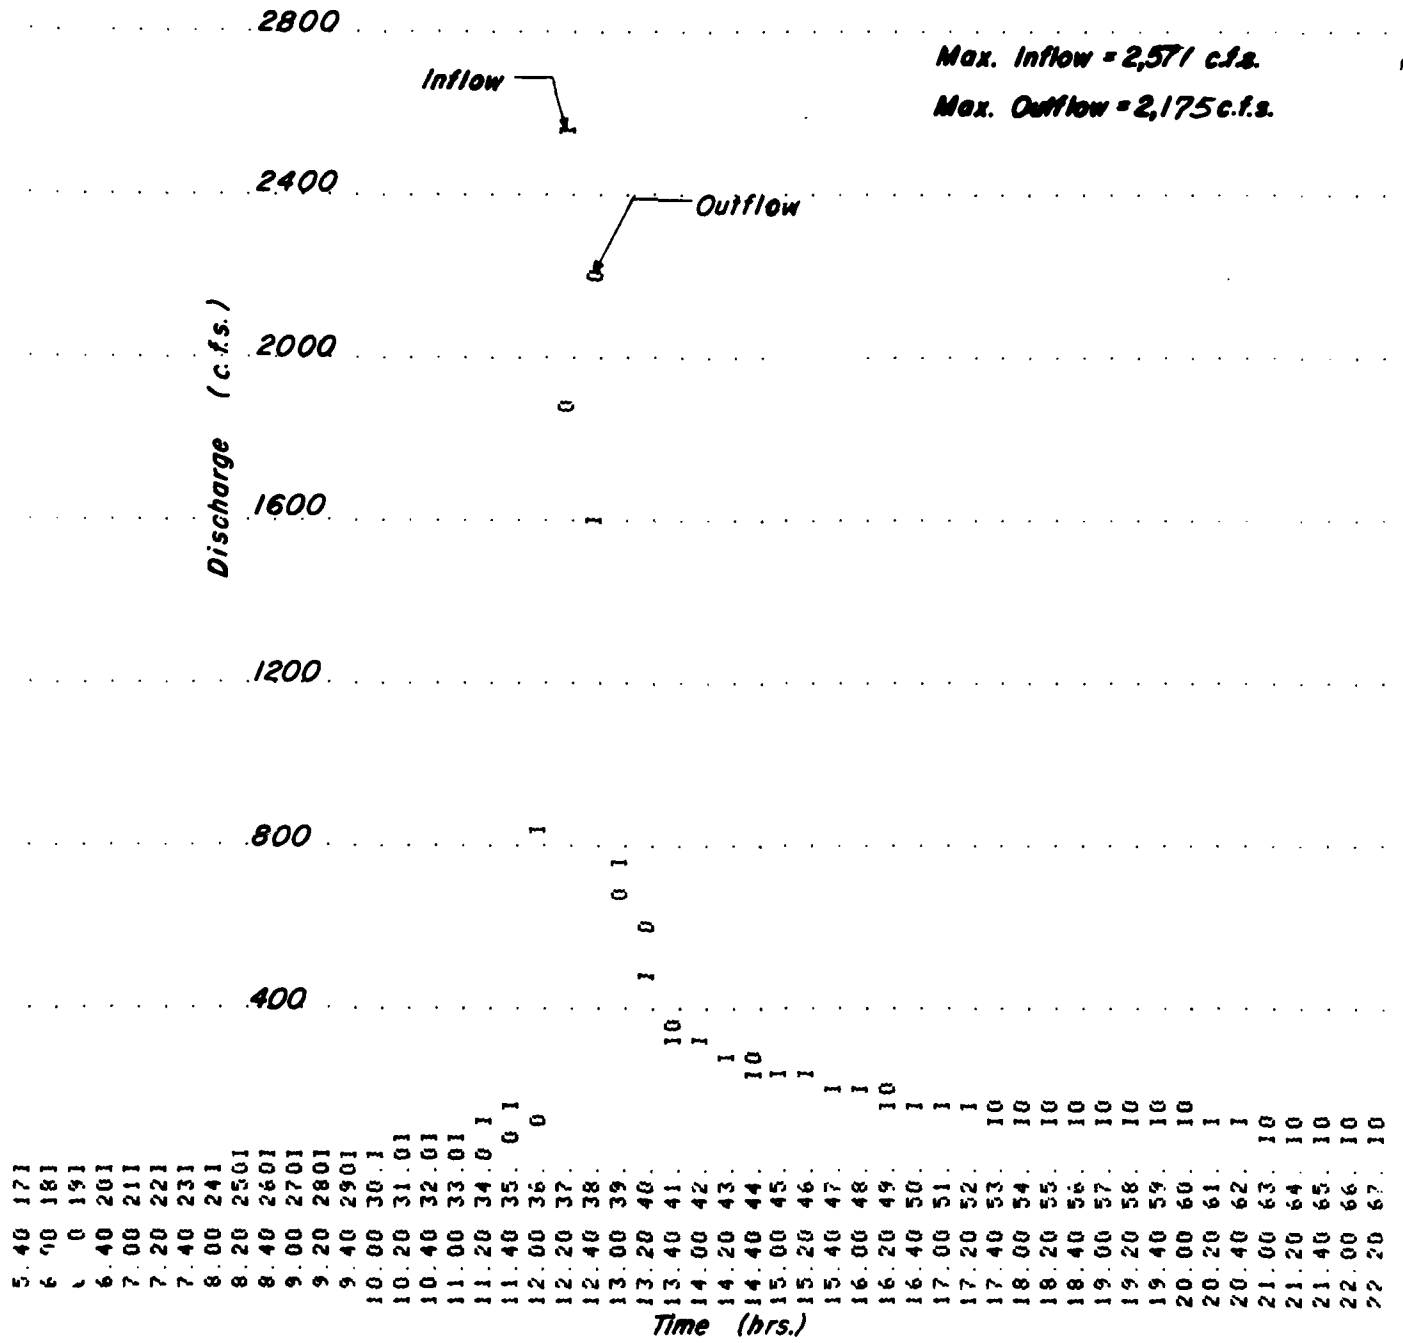
**INFLOW-OUTFLOW
HYDROGRAPH
FOR 10 YRS. FLOOD**

Max. Inflow = 2,571 c.f.s.

Max. Outflow = 2,175 c.f.s.
