SUNRISE LAKE DAM  
JEFFERSON COUNTY, MISSOURI  
MO. 31190

**PHASE I INSPECTION REPORT  
NATIONAL DAM SAFETY PROGRAM**

JULY 1981

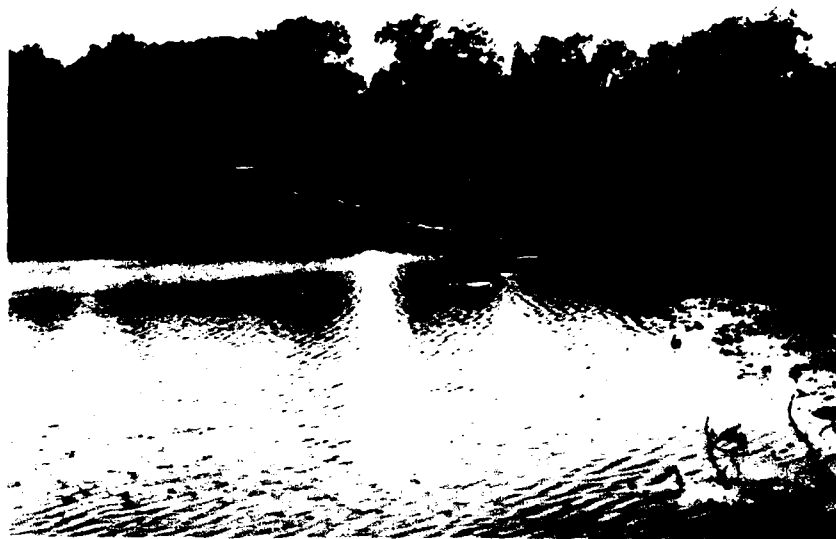
The upstream slope of the dam is not protected by riprap; consequently, some damage due to wave action was observed on the slope. Scarps up to one foot high were observed along the slope at the normal water surface level (see Photo 1). A small bench was observed just below the normal water surface level, which also appeared to have been formed due to wave action. A surficial layer of rock was seen on the slope, but it provided little or no protection. The portion of the slope above the normal water surface was adequately protected against surface runoff by a good vegetative cover ranging from tall grass to a few small bushes. No trees were observed on the upstream slope. The angle of the upstream slope above the normal water surface level did not appear to be indicative of the slope angle below the normal water surface level, which appeared to be flatter. Some shallow surface sloughs were observed on the slope; however, no major depressions, bulges or cracking indicating an instability of the embankment or foundation were apparent on the slope.

5. The erosion due to wave action on the upstream slope does not appear to affect the stability of the dam in its present condition. However, continual erosion of the slope can only be detrimental to the structural integrity of the dam.

Photo 1 - View of the upstream slope from the right abutment.

4. The wave erosion on the upstream slope should be properly repaired and the slope protected from further damage.
5. The brush and saplings on the embankment slopes should be removed from the embankment and regrowth prevented. The grass cover on the embankment, especially on the downstream slope, should be periodically maintained. The grass cover should be retained on the downstream slope to protect it from erosion due to surface runoff and to prevent excessive erosion in the event the dam is overtopped. The trees along the downstream, right abutment/embankment contact should also be removed. Removal of large trees should be under the guidance of an engineer experienced in the design and construction of earth dams. Indiscriminate clearing could jeopardize the safety of the dam.

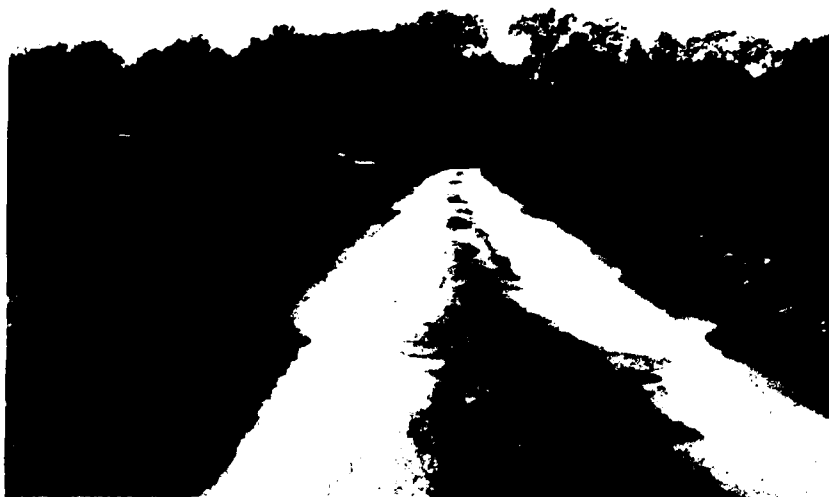
The top of dam supports an asphalt access road used by the local residents to gain access to their homes (see Photo 2). The road provides excellent protection for the top of dam; however, the asphalt surfacing showed some signs of deterioration. No depressions or cracks indicating a settlement of the embankment were apparent. The variation in elevation across the top of dam did not appear to be due to an instability of the embankment. No significant deviation in the horizontal alignment was apparent, except for the change in the alignment of the dam, which appears to have been constructed this way. According to Mr. Shy, the dam has never been overtopped and no evidence indicating the contrary was observed.

Photo 2 - View of the top of dam from the right abutment.

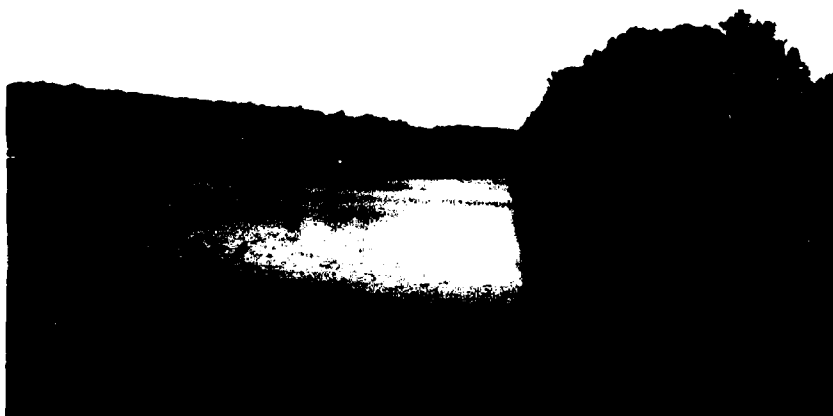
The rim appeared to be stable with no erosional or stability problems observed (see Photo 10). The land around the reservoir slopes gently upward from the reservoir rim and is mostly wooded with grass-covered slopes. Several houses are built around the reservoir rim. No evidence of excessive siltation was observed in the reservoir on the day of the inspection.

Photo 10 - View of the reservoir and rim.
