NO NAME 880 DAM
PIKE COUNTY, MISSOURI
MO 31011

**PHASE I INSPECTION REPORT
NATIONAL DAM SAFETY PROGRAM**

NO NAME 880 DAM
PIKE COUNTY, MISSOURI
MISSOURI INVENTORY NO. 31011

Name of Dam: No Name 880 Dam
State Located: Missouri
County Located: Pike County
Stream: Mud Creek
Date of Inspection: 29 September 1978

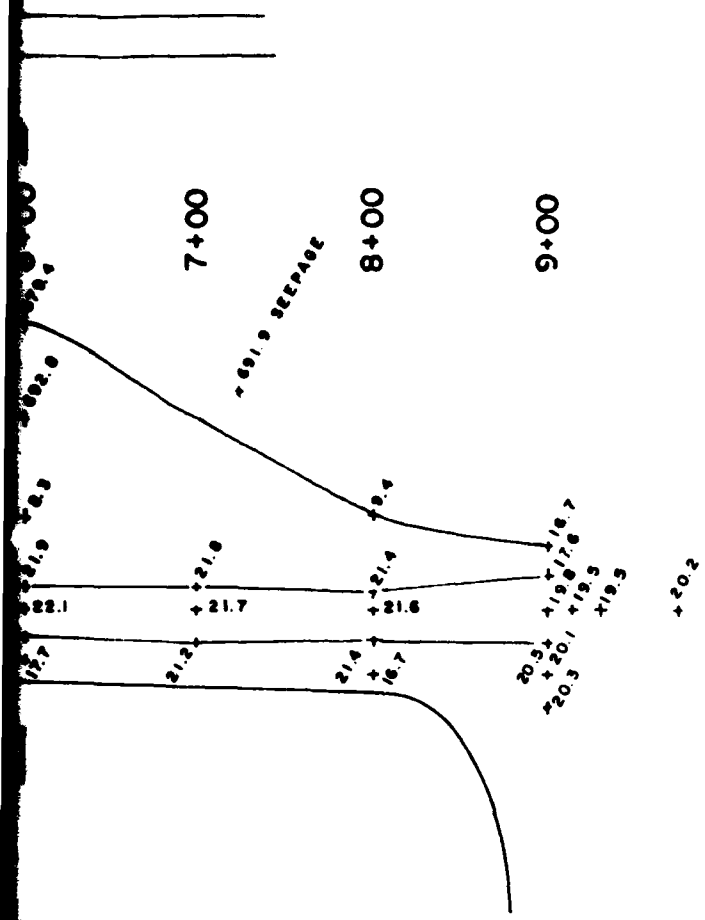
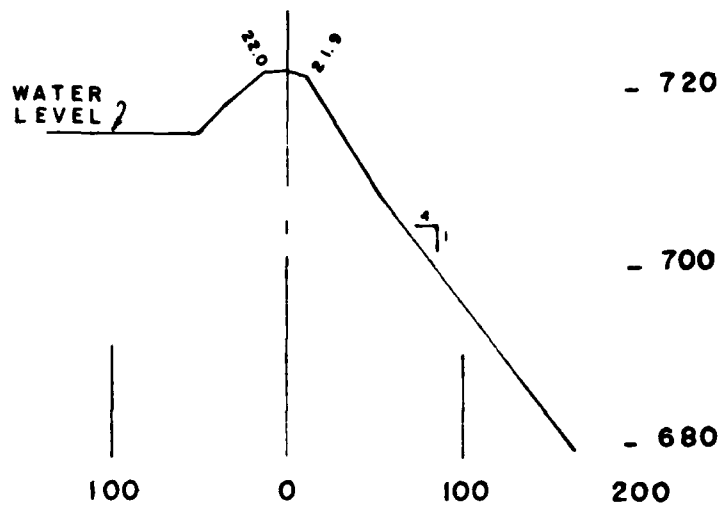
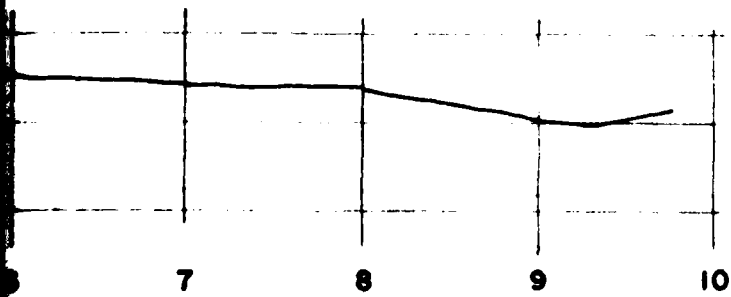
Sheet 2, Appendix A

Pertinent data about the dam and reservoir are presented in the following paragraphs. Sheet 2 of Appendix A is a plan of the embankment and spillway with a profile of the dam.

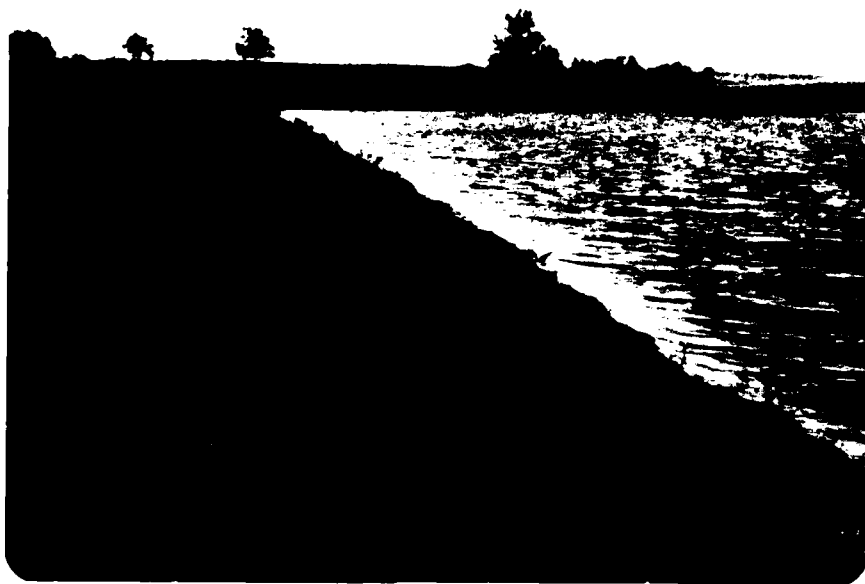
The horizontal alignment was good. A depression in the embankment was noted near the south end of the dam. No surface cracking or unusual movement was observed. The absence of riprap has allowed some erosion of the upstream face of the dam.

Upstream Face of Embankment - Looking South

Minor erosion noted at the contact of the south abutment, if left uncontrolled or uncorrected, could lead to serious problems in the future. Wave protection should be provided for the upstream face of the dam.
