**NO NAME 550 DAM
WASHINGTON COUNTY, MISSOURI
MO 30711**

**PHASE 1 INSPECTION REPORT
NATIONAL DAM SAFETY PROGRAM**

NO NAME 550 DAM
WASHINGTON COUNTY, MISSOURI

PHASE I INSPECTION REPORT
NATIONAL DAM SAFETY PROGRAM

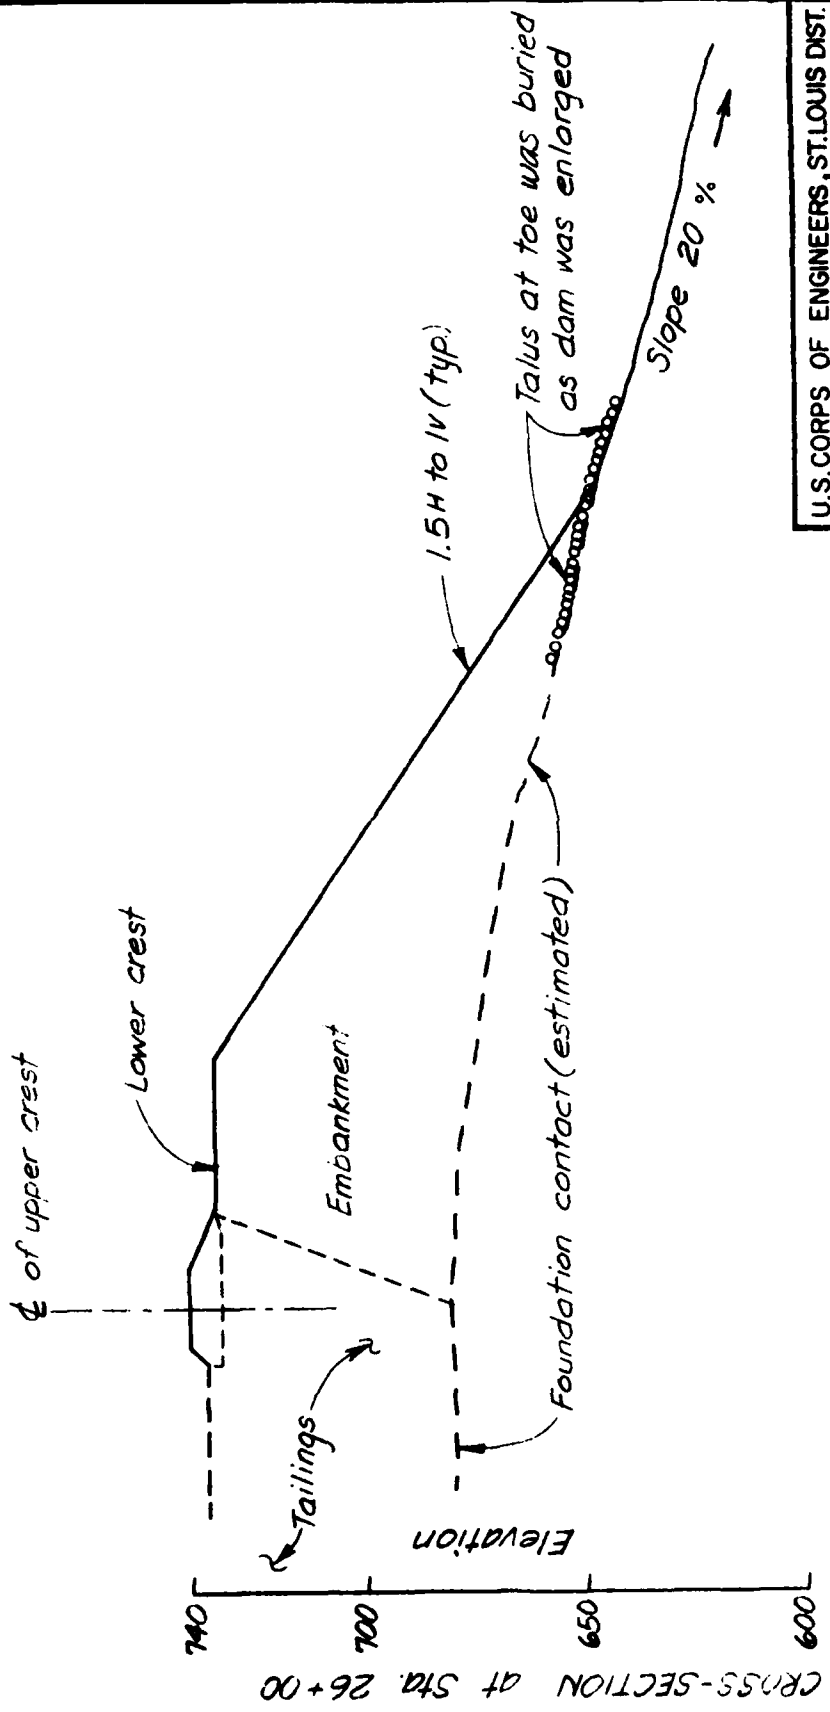
U.S. CORPS OF ENGINEERS, ST. LOUIS DIST.	
PHASE I INSPECTION OF DAMS	
NO NAME 550 DAM I.D. NO. 30711	
SECTION AT STA. 26+00	
DESIGNED BY	INSPECTED BY
DRAWN BY W.K.V. RICHMOND	DATE JUNE 1979
CHECKED BY	APPROVED BY

The exposed ground below the foundation of the dam near Stations 24+00 to 27+00 is sloping at approximately 20 percent in a downstream direction. Review of the USGS 7.5-minute Tiff Quadrangle dated 1937 indicates that the original ground underneath the embankment slopes approximately 20 percent in a downstream direction. An interpretive section at Station 26+00 is shown on Plate 9.

Evidence of steep (20 percent) downstream foundation slopes under embankment Stations 24+00 to 27+00 was indicated by field observations and a review of original topographic data presented in the 1937 USGS 7.5-minute Tiff Quadrangle. Further study of embankment stability in this area is needed to determine the magnitude of this potential problem.

e. Stability and Seepage Analyses. These analyses should be performed by an engineer experienced in the design and construction of tailings dams. The effect of the foundation slope on stability of dam sections between Stations 24+00 and 29+00 should be evaluated. Also, the upstream construction method used to raise the embankment to its final height should be considered in the stability analysis. The embankment is a relatively porous granular structure above the tailings surface. If the impoundment water level were to rise above the tailings surface, there could be significant seepage through the embankment which could adversely affect the stability of the dam. Included in these analyses, therefore, seepage and stability computations should also be performed with the reservoir water surface set at the top of the dam. Based on the results of these studies, remedial measures may be necessary. Remedial work should be done under the direction of an engineer experienced in tailings dam design and construction.
