CITY LAKE DAM

CASS COUNTY, MISSOURI

**PHASE 1 INSPECTION REPORT
NATIONAL DAM SAFETY INSPECTION**

Name of Dam	City Lake Dam
State Located	Missouri
County Located	Cass County
Stream	Town Creek
Date of Inspection	12 April 1979

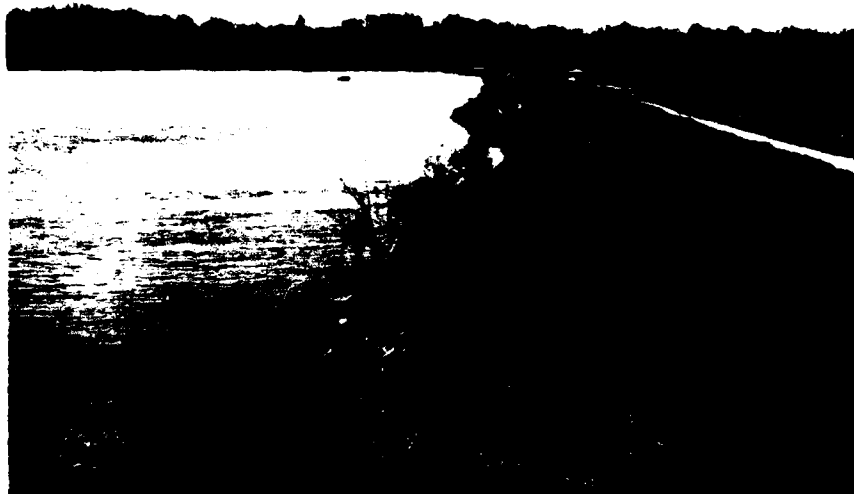
PHOTO 1: UPSTREAM FACE OF DAM LOOKING SOUTH

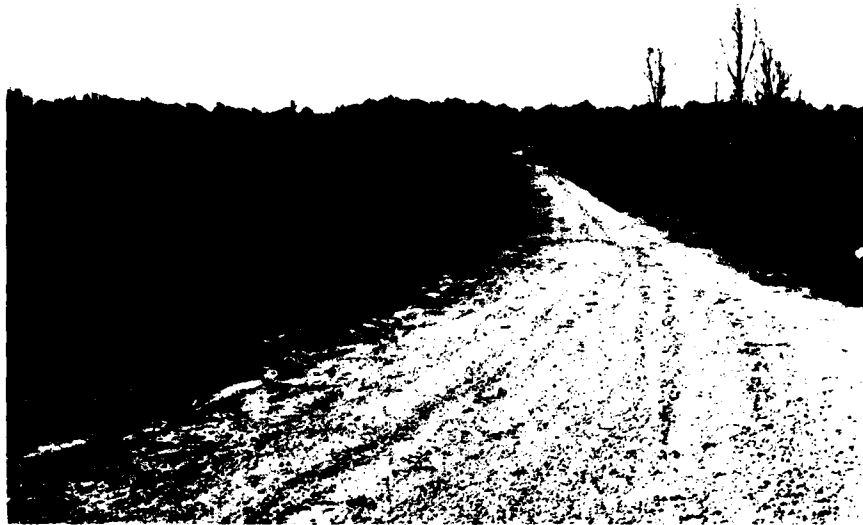
PHOTO 3: BACK SLOPE OF DAM LOOKING SOUTH

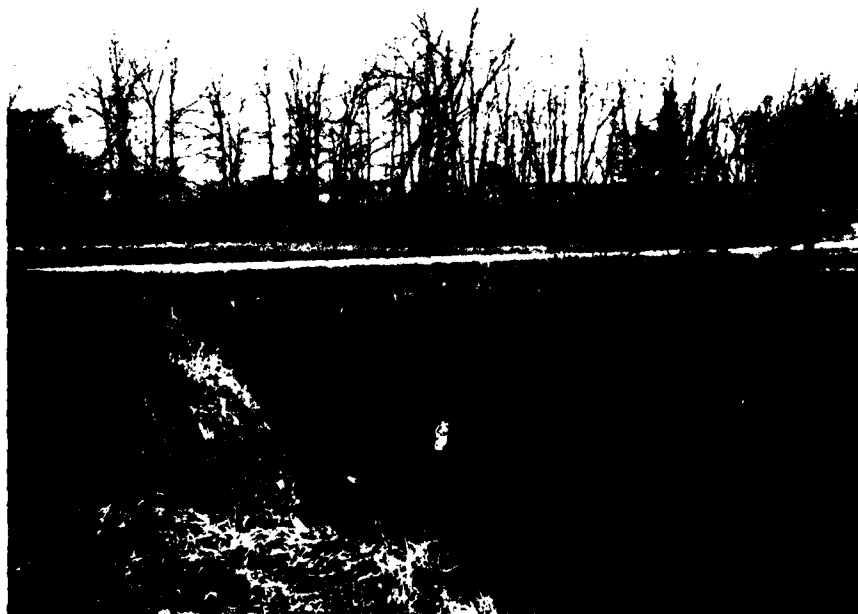
PHOTO 8: LOW AREA AT RIGHT ABUTMENT

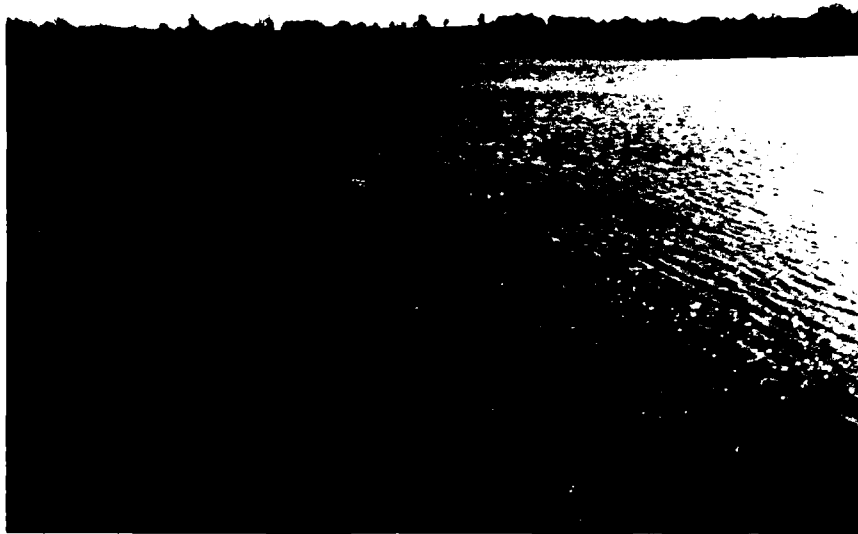
(2) No facilities are available which could serve to draw down the pool. A concrete intake structure is visible in the lake. The Black & Veatch 1947 drawing shows an 8-inch water line connected to this structure. This line was not observed during the inspection.

PHOTO 9: WATER SUPPLY INTAKE STRUCTURE

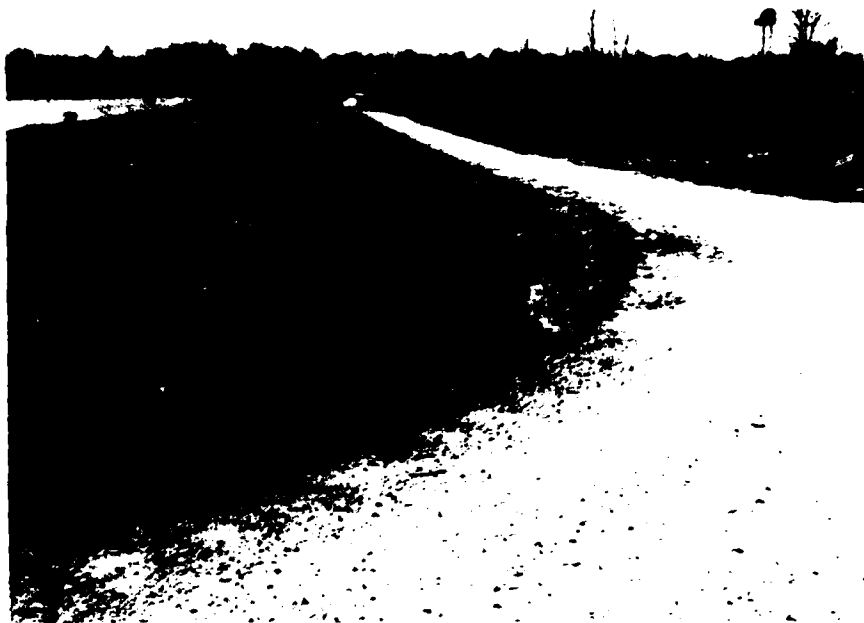
(2) The drainage ditch along the toe of the dam has caused erosion of the embankment material which has resulted in sloughing and sliding of the back slope of the dam. The lack of slope protection on the back slope will result in continued erosion of the embankment material.

PHOTO 11: DRAINAGE DITCH AT TOE OF SLOPE RIGHT END OF DAM

(3) Slope protection, such as good stand of grasses, should be developed on the back face of the embankment. The roadway and drainage ditch around the north end of the dam should be realigned to allow for a flatter back slope on the dam where sloughing has occurred. The erosion and sloughing should be repaired.

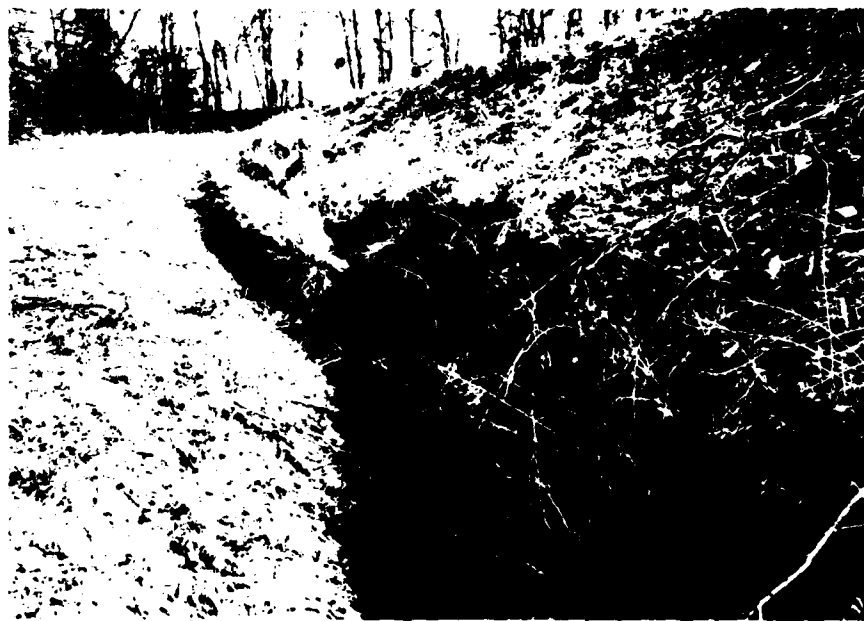
PHOTO 12: SLOUGHING OF EMBANKMENT AT DRAINAGE DITCH RIGHT END
