CRANCER LAKE DAM
WARREN COUNTY, MISSOURI
MO 10764

**PHASE 1 INSPECTION REPORT
NATIONAL DAM SAFETY PROGRAM**

CRANCER LAKE DAM
MISSOURI INVENTORY NO. 10764
WARREN COUNTY, MISSOURI

PHASE I INSPECTION REPORT
NATIONAL DAM SAFETY PROGRAM

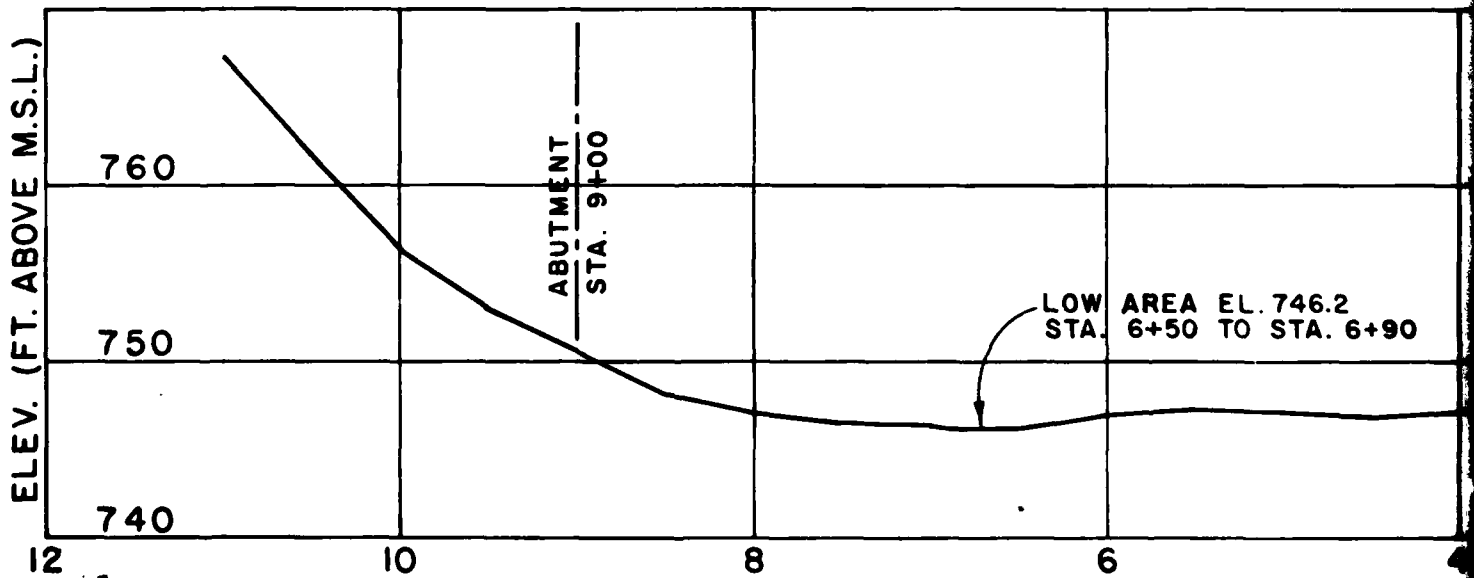
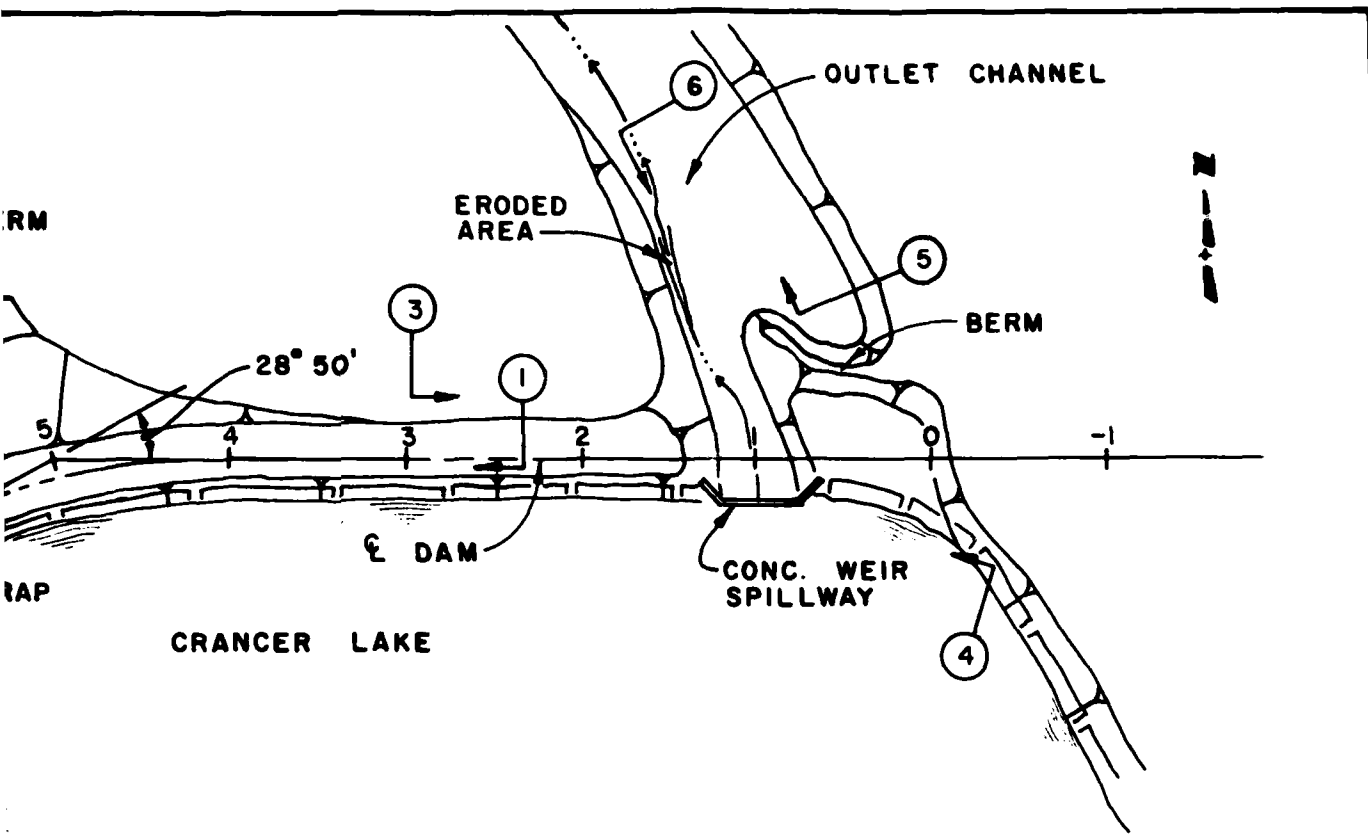
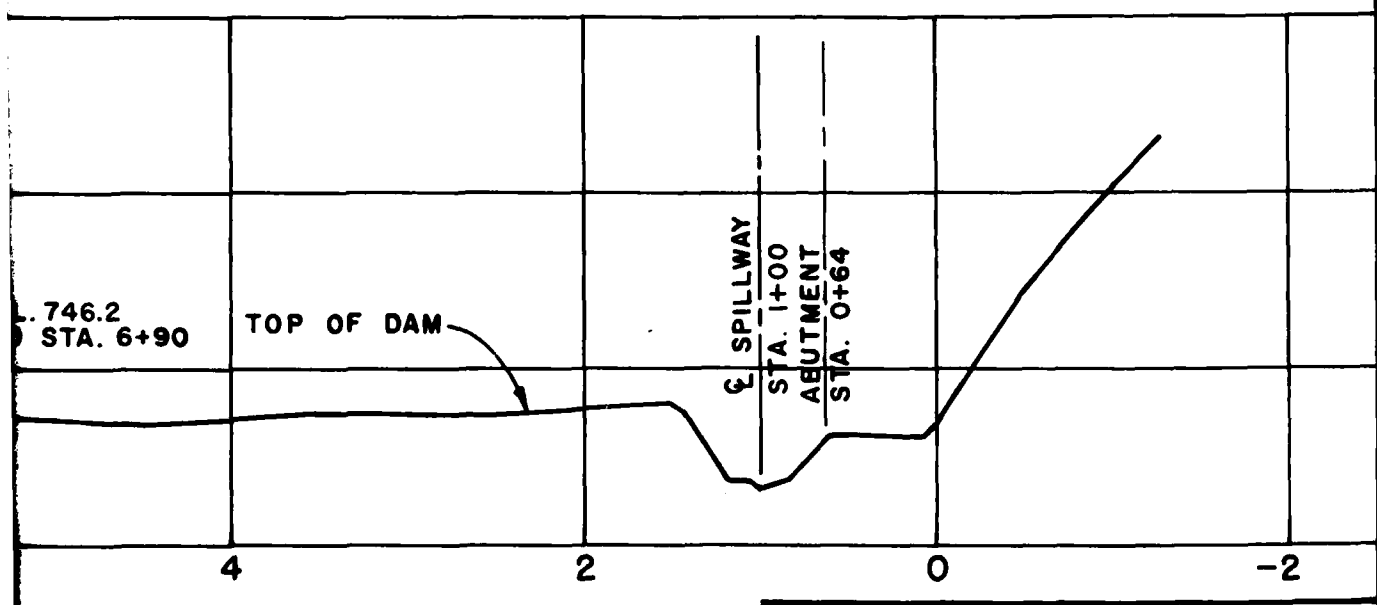
**CRANCER LAKE
 DAM PLAN & PROFILE**

4. The dam, according to survey data obtained during the inspection, appears to have settled, perhaps as much as 1.0 foot, in the vicinity of the original stream crossing. The crest of the dam should be uniform throughout without low areas that reduce dam freeboard and penalize spillway capacity.

According to survey data obtained at the time of the inspection, the lowest part of the dam crest was found to be between station 6+50 and 6+90, about the location of the original stream on which the dam was constructed. The top of dam at this location was found to be approximately 1.0 foot lower than the top of dam at locations 100 feet, or so, either side of this location. It would appear, based on these elevations, that the dam has settled at the location of the original stream crossing.

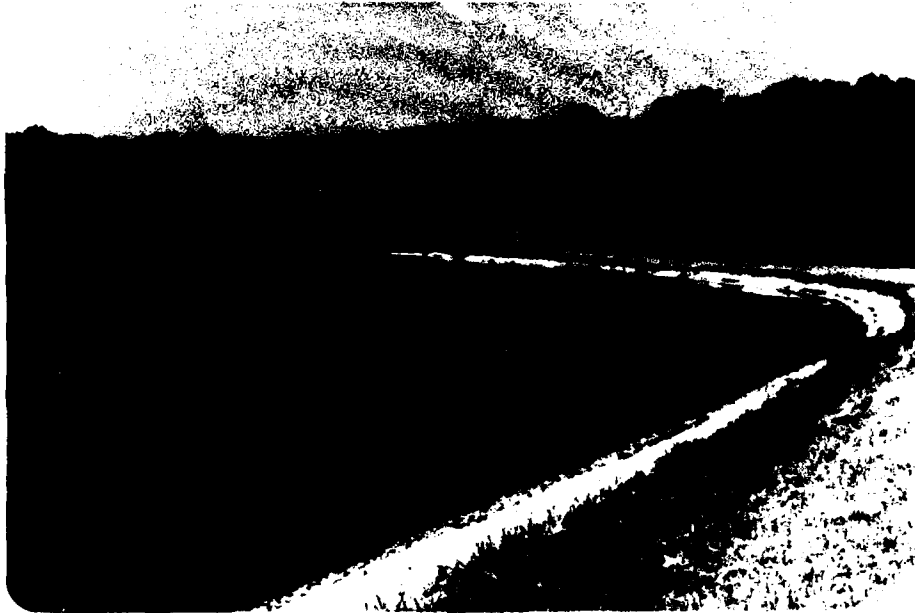
c. Dam. The visible portions of the upstream and downstream faces of the dam as well as the dam crest (see Photos 1 through 3) were inspected and appeared to be structurally sound. However, erosion gullies, apparently due to surface runoff, were observed along the junction of the downstream face of the dam and the right abutment below both the upper and lower berms. The dam was well covered with a good stand of grass, and no trees or brush were noted on the dam proper.

NO. 1: CREST AND UPSTREAM FACE OF DAM

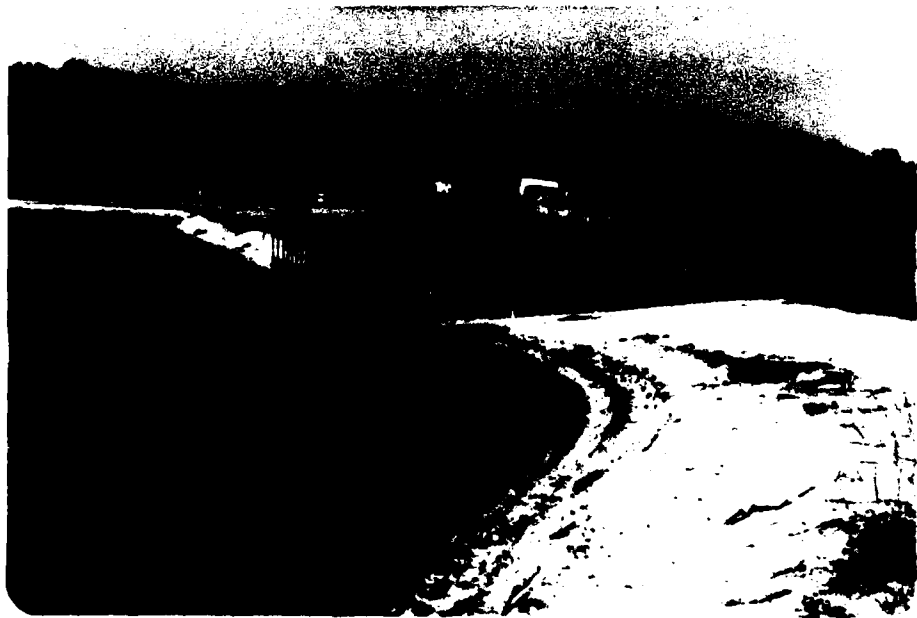
The concrete weir (see Photo 4) at the spillway outlet channel was found to be in good condition without evidence of cracking or spalling of the surface. The outlet channel below the weir (see Photo 5) was generally in good condition, with a substantial turf cover. However, at the downstream end of the outlet channel, an erosion gully (see Photo 6) was noted. A low berm, extending partially across the spillway outlet channel downstream of the weir, was also noted. The berm appeared to concentrate flow in the channel toward the left bank, resulting in erosion of the channel invert.

NO. 4: CONCRETE WEIR SPILLWAY
