ROBERT L. BISHOP DAM

DELAWARE COUNTY, NEW YORK  
INVENTORY No. NY 534

# PHASE I INSPECTION REPORT NATIONAL DAM SAFETY PROGRAM

NEW YORK DISTRICT, CORPS OF ENGINEERS  
MAY 1981

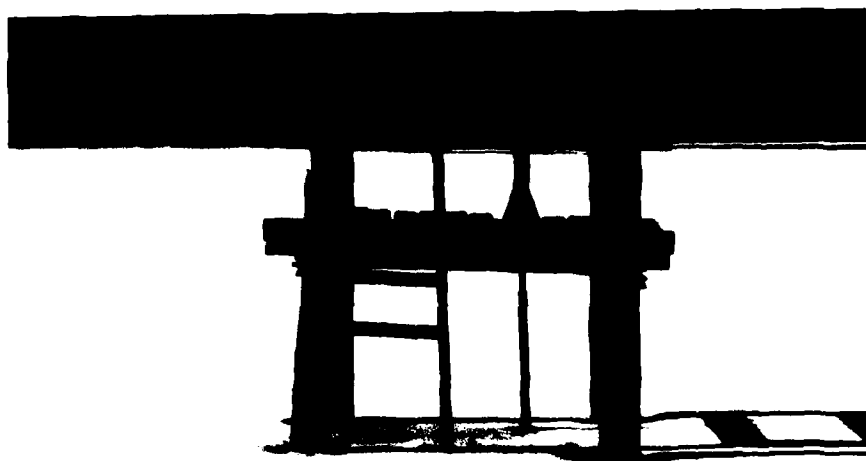
The drop inlet is a 30 inch corrugated metal pipe (CMP) with an anti-vortex baffle plate. The drop inlet structure appeared to be in good condition at the time of the inspection; however, it has rusted somewhat (See Photo No. 10). The gate stem for the low level reservoir drain was observed but not operated during the inspection (See Photo No. 11).

PHOTO #11: Impoundment drain operating gate
