BURTON-DUENKE DAM #5  
CAMDEN COUNTY, MISSOURI  
MO 31608

## PHASE 1 INSPECTION REPORT NATIONAL DAM SAFETY PROGRAM

PREPARED BY:  
BLACK & VEATCH  
CONSULTING ENGINEERS  
KANSAS CITY, MISSOURI

APRIL 1981

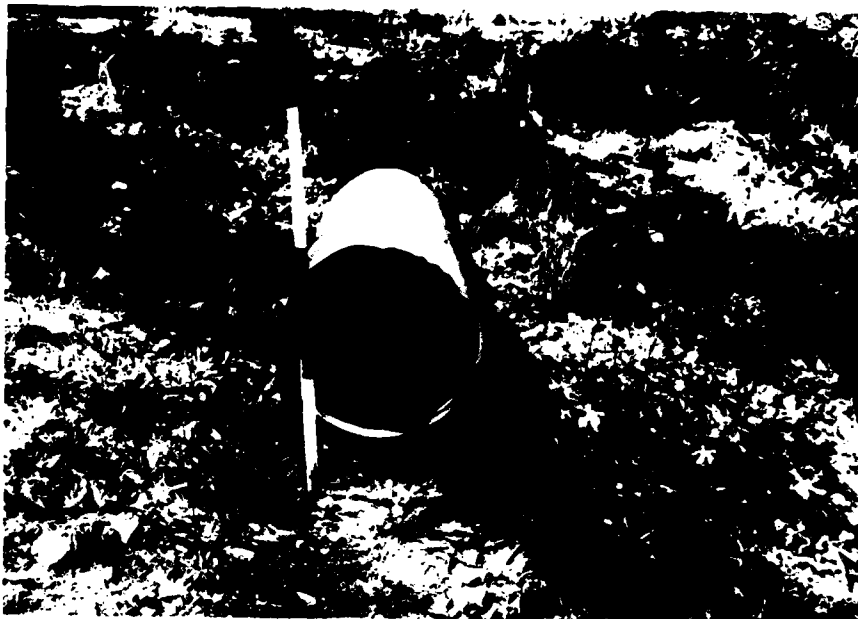
c. Appurtenant Structures. The spillway was the only appurtenant structure observed by the inspection team. The alignment of the spillway pipe was viewed from the upstream end. The pipe bends to the right at

about the midpoint and is crimped at the bend. There was no trash rack at the pipe inlet. The outlet end is approximately 95 percent filled with dumped earth material. About 3 to 4 feet of the outside of the pipe was observed from the upstream end. No pipe collars were observable. The pipe appears to be in good condition with no rust observed. There is no evidence of leakage into, out of, or around the pipe. The spillway pipe discharges into a ditch which is approximately 2 feet wide and 2 feet deep. The ditch ends about 60 feet below the pipe outlet where discharge is released to the hillside. Minor erosion has taken place downstream of the pipe outlet.

PHOTO 7 : SPILLWAY PIPE INLET

(5) It is recommended that a debris baffle or trash rack be installed at the spillway pipe inlet.

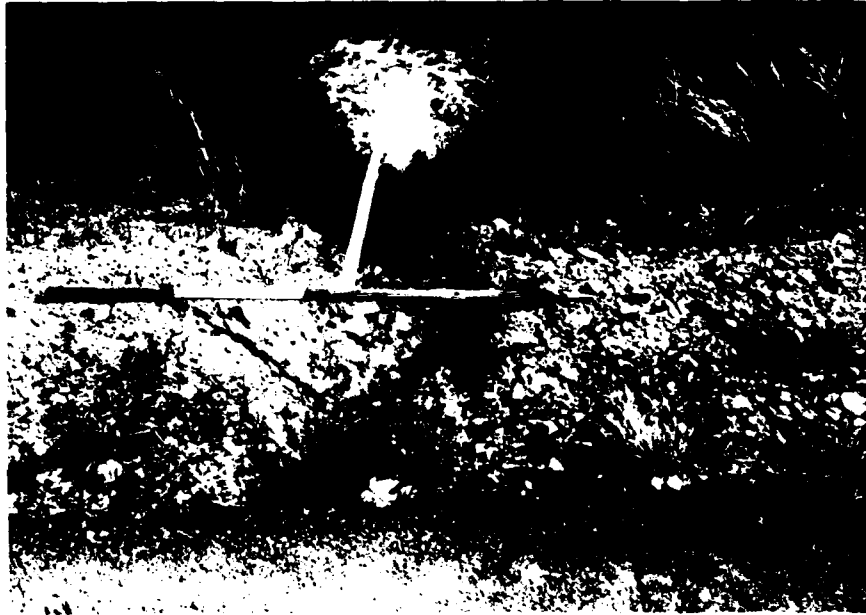
Erosion of silty clay material is occurring on the upstream and downstream slopes and at the interface of the right abutment and the upstream slope. Runoff from the crest has caused the gullies on the upstream slope. Poor drainage of the crest between the golf cart path and the top of the downstream slope had resulted in standing water from rain on the day previous to the inspection. New material has been dumped over the principal spillway pipe, but this was assumed to be repair of erosion caused by local runoff from the hillside above the left abutment. Approximately one dump load of this material has been deposited on the dam crest. There is no evidence to indicate that the embankment has ever been overtopped.

PHOTO 11: EROSION OF UPSTREAM FACE AND WELL DISCHARGE PIPE
