NO NAME 548 - PFIZER INC. DAM  
WASHINGTON COUNTY, MISSOURI  
MO 30705

**PHASE I INSPECTION REPORT  
NATIONAL DAM SAFETY PROGRAM**

**JUNE 1979**

PREPARED BY  
INTERNATIONAL ENGINEERING COMPANY, INC.  
CONSULTING ENGINEERS  
SAN FRANCISCO, CALIFORNIA

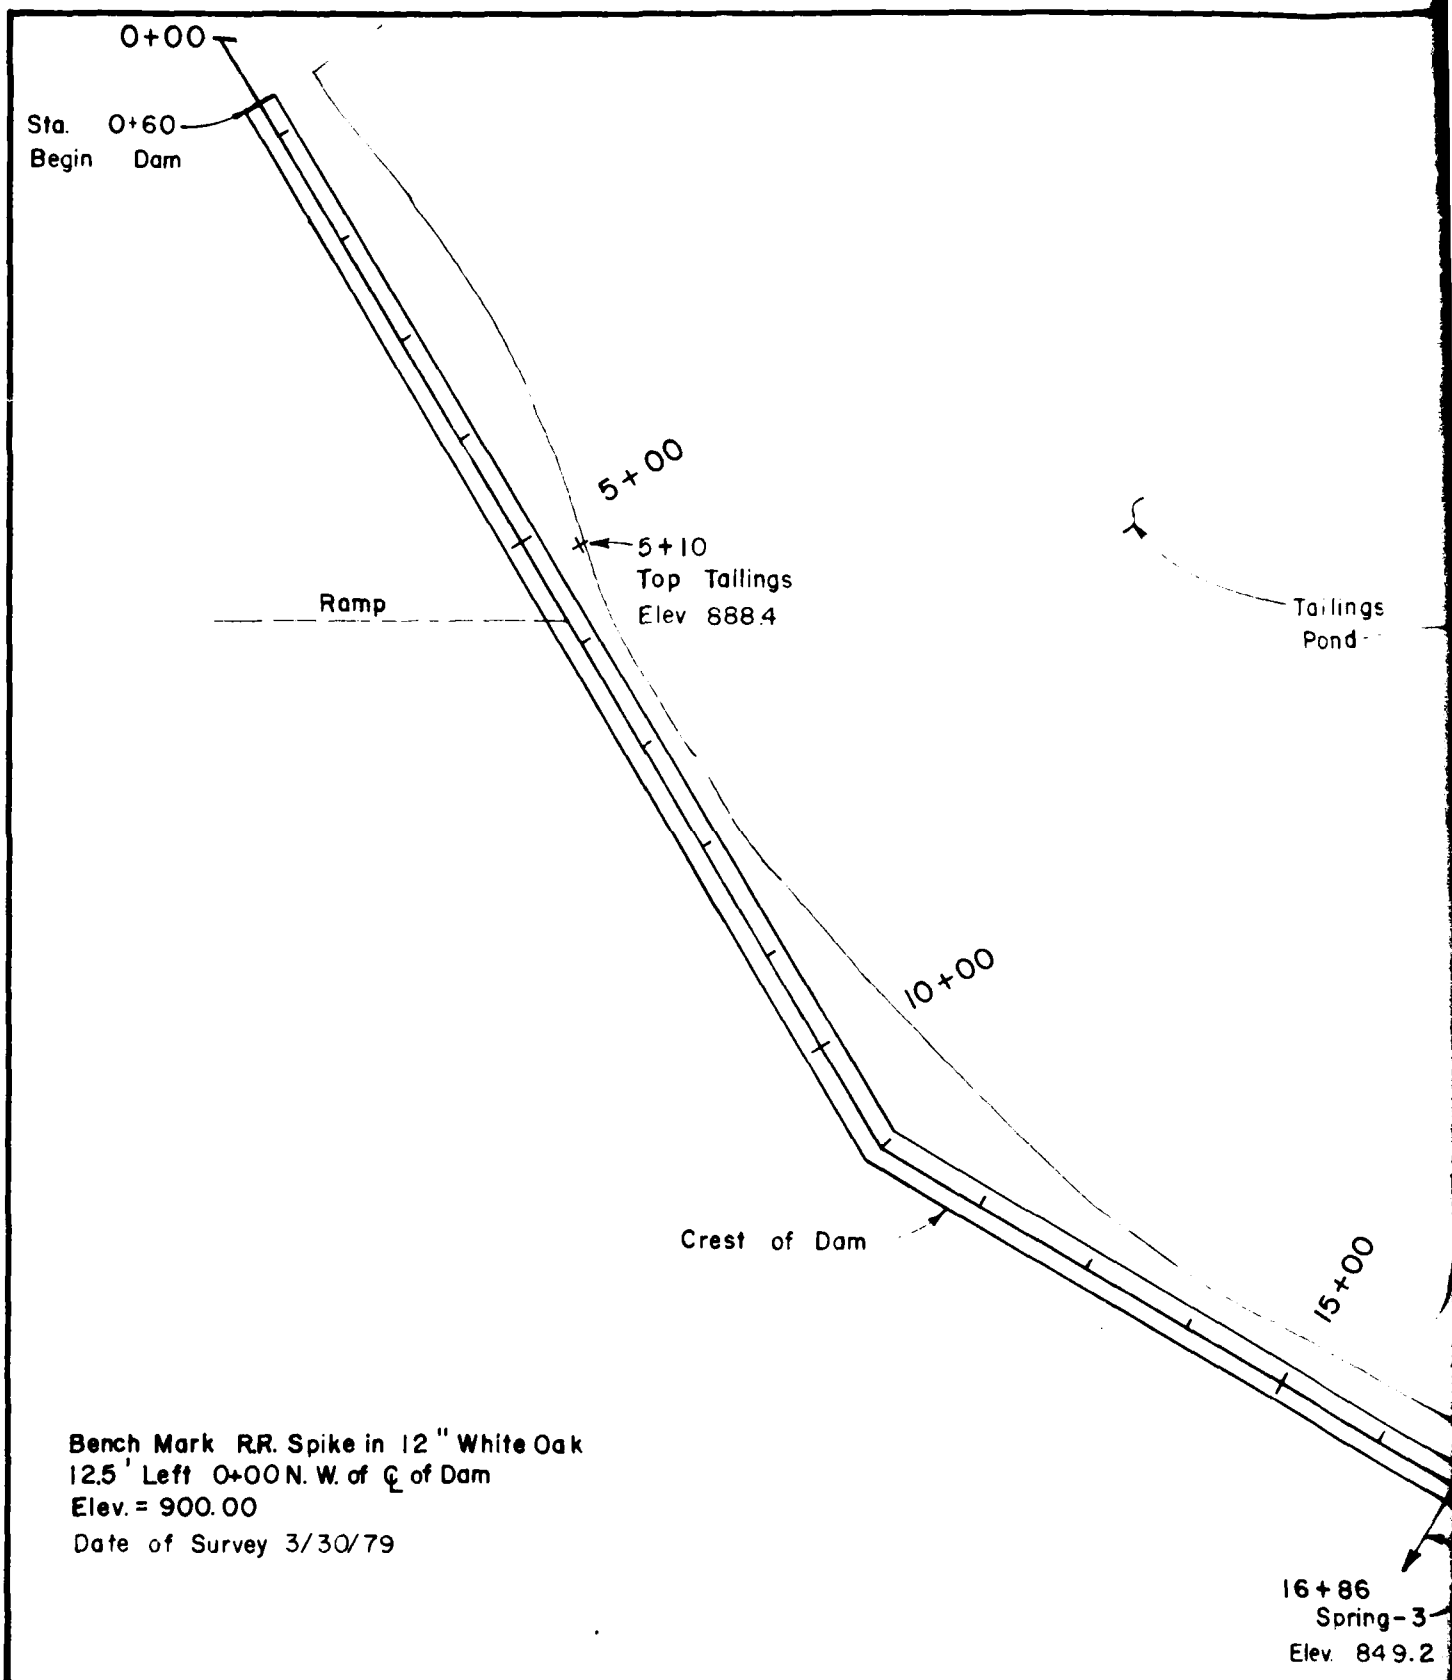
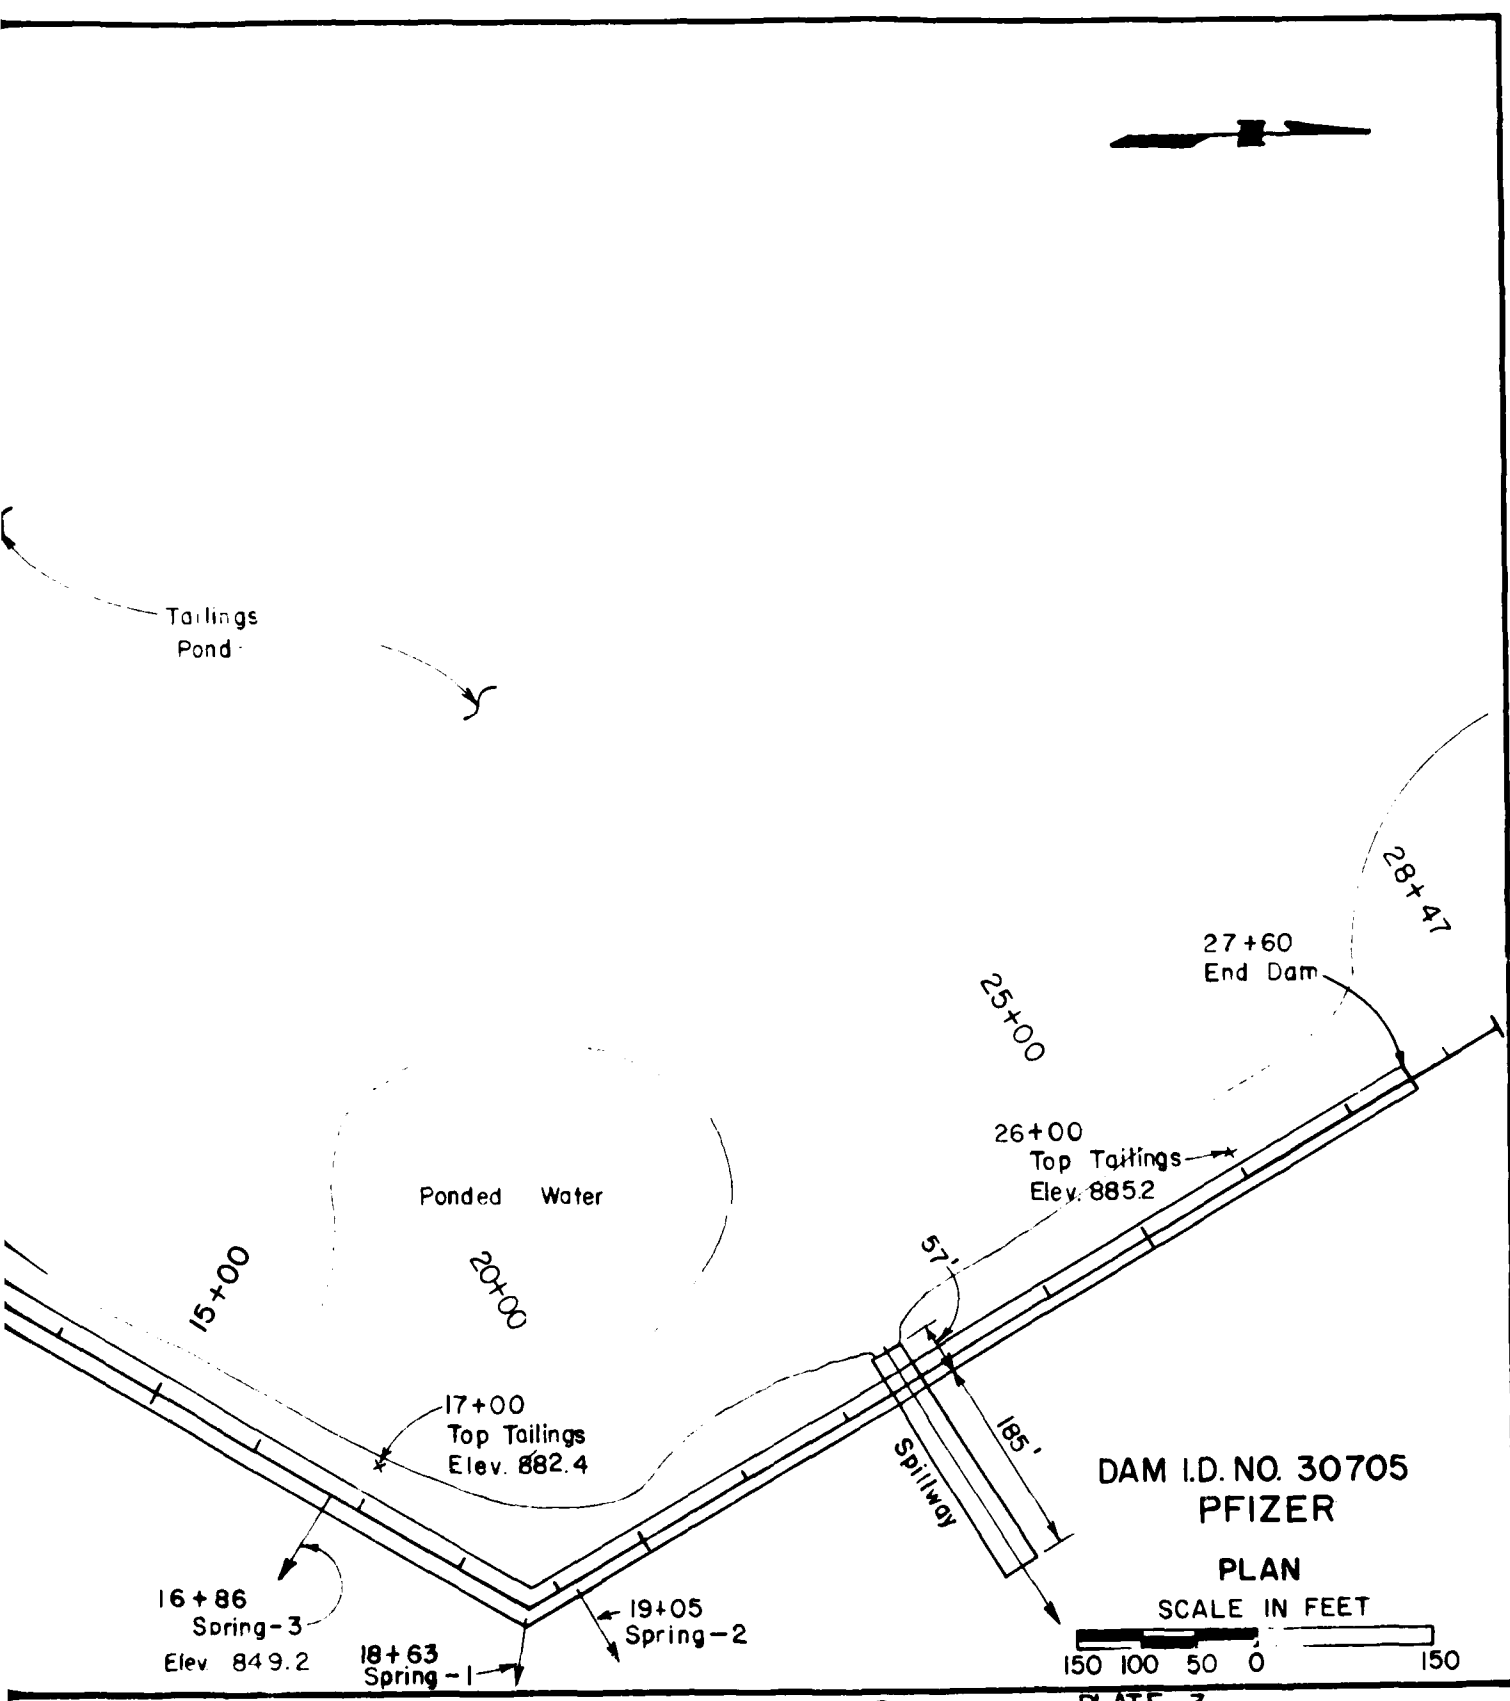
PLATE 3

Three springs were observed to be emerging from the toe of the dam. These springs are located immediately to the south of the spillway, as shown in Plate 3. Spring Nos. 1 and 2 were observed on the date of inspection on 20 March, and Spring No. 3 was noted during a brief visit on 27 March. It was observed during the brief visit that the ponded water on the tailings surface had encroached on the upstream gravel face of the dam due to rain which fell between 20 and 27 March. Spring No. 3 was located at the downstream toe, immediately opposite the ponded water. This spring was apparently being fed by the ponded water. The flow from all three springs was clear. The ground surface at Spring No. 1 was soft. The estimated quantity of flow from the springs is as follows:
