MISCELLANEOUS PAPER GL-81-8

# EVALUATION OF MEMBRANE INTERLAYERS FOR PREVENTION OF CRACK REFLECTION IN THIN OVERLAYS

Philip J. Vedros, Jr.

October 1981

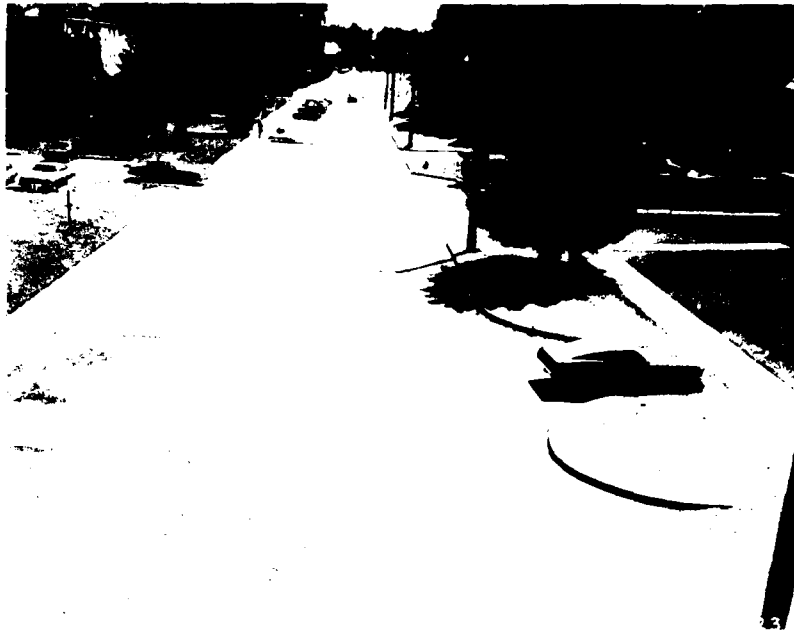
Photo 3. View of U. S. Rubber chip area, Second Division Drive, June 1981

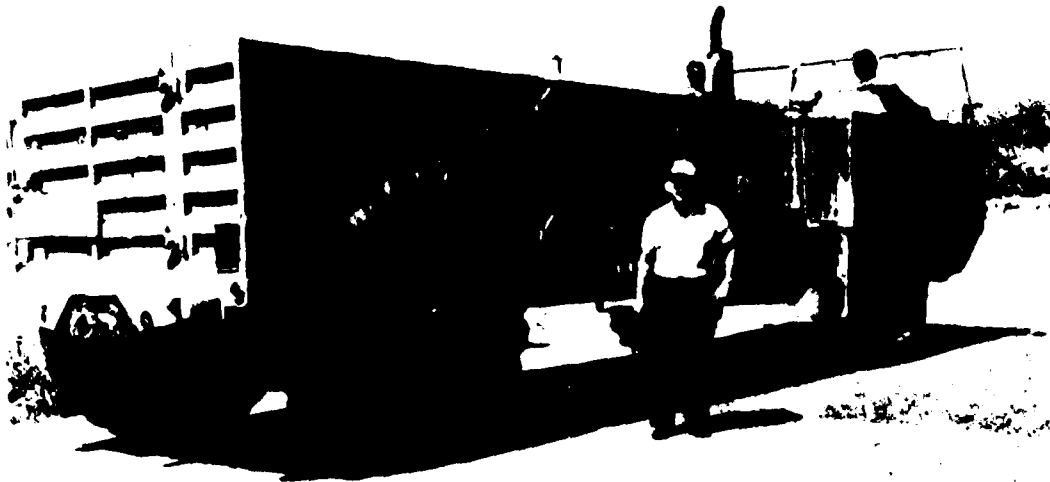
23. Wilderness Road is used frequently by trucks hauling explosives from the ammo storage area located adjacent to the road (Photo 54). The large trucks broke the pavement surface along the edges (Photo 55) and thus narrowed the width of the roadway to about 20 ft. The area between the white stripes (Photo 56) was essentially left intact during the repair work, and the edges were widened 2 ft on each side with gravel shoulders (Photo 57). As shown in Figure 5, there were 12 test sections, two for each type of material. Photos 58 through 69 indicate the crack pattern that existed in the selected photographic areas before placement of test materials and the progression of reflection cracking through these materials to the end of the last inspection in June 1981. These photographs also show that the alligator-type cracking along the edge of the roadway is the same condition as shown in Photo 56 that was left intact in the repair work. The initial length of cracking in each section was not measured before placement of the test materials.

Photo 54. Vehicle used to haul explosives  
from ammo storage area
