**CHRISTIANSEN LAKE DAM
JACKSON COUNTY, MISSOURI
MO 20145**

**PHASE 1 INSPECTION REPORT
NATIONAL DAM SAFETY PROGRAM**

Name of Dam	Christiansen Lake Dam
State Located	Missouri
County Located	Jackson County
Stream	Blue Branch of Sni-a-Bar Creek
Date of Inspection	25 July 1980

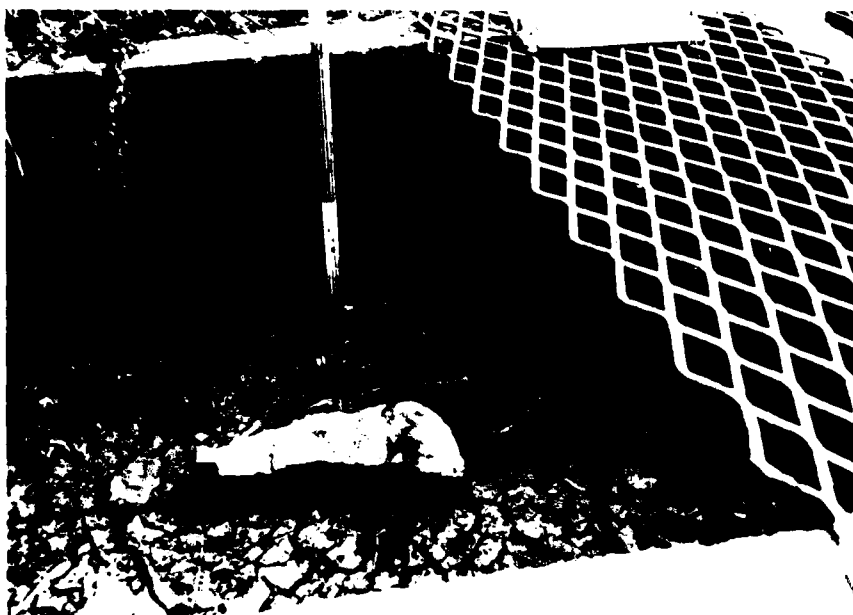
hole caused by a break in the discharge line was located just downstream of the toe of the embankment. The discharge pipe was also exposed in the low washed-out area near the outlet end. During full pipe flow, water will be lost to overland flow through these openings. It should be noted that a flow (trickle) of 2 to 3 gallons per hour was observed at the spillway pipe outlet even though the lake water surface was about one foot below the entrance level of the drop inlet. The spillway pipe at the drop inlet was found to be about 1/4 full of silt.

PHOTO 6: PRINCIPAL SPILLWAY PIPE INLET END

(4) The principal spillway pipe should be repaired.

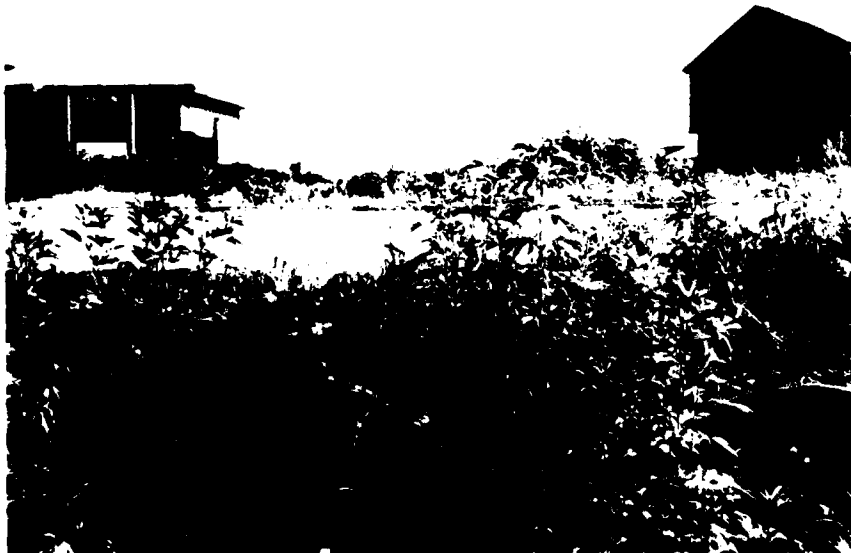
PHOTO 8: CULVERT UNDER MORELAND SCHOOL ROAD
BELOW PRINCIPAL SPILLWAY OUTLET

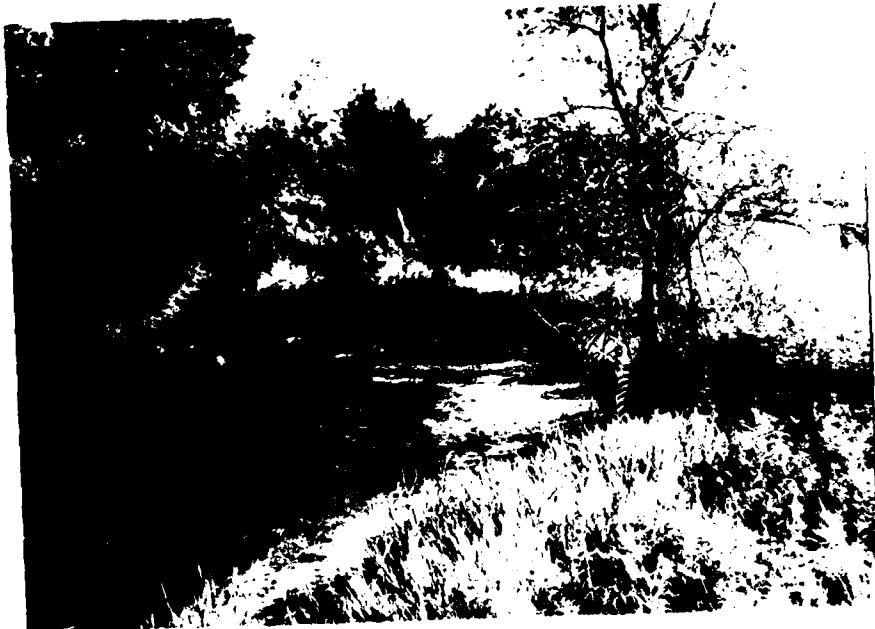
(2) The emergency spillway channel is poorly defined but shows no evidence of erosion. The emergency spillway channel is lined with extremely dense and tall grass. Growth of trees and brush in the spillway channel will cause some restriction to flow.

PHOTO 9: EMERGENCY SPILLWAY

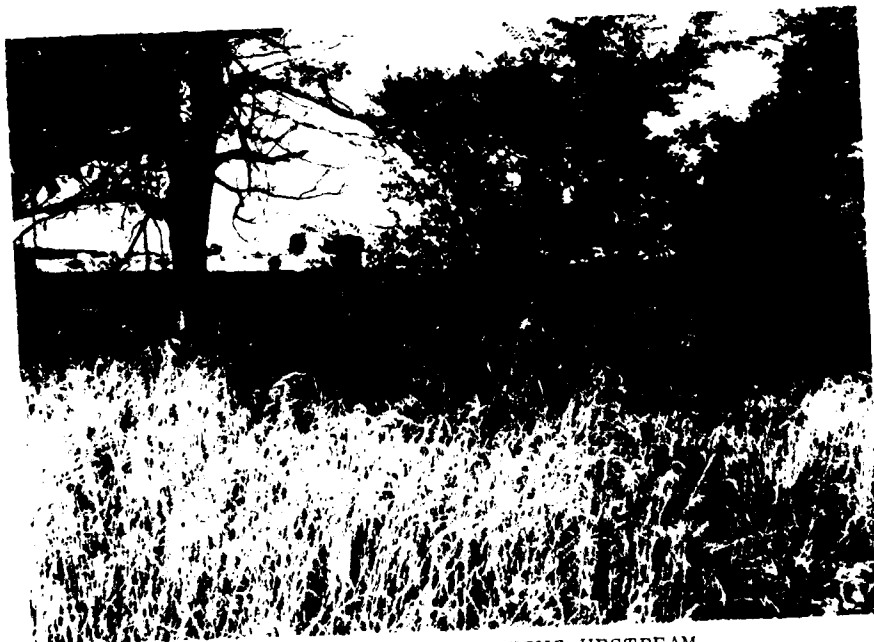
PHOTO 10: EMERGENCY SPILLWAY LOOKING UPSTREAM

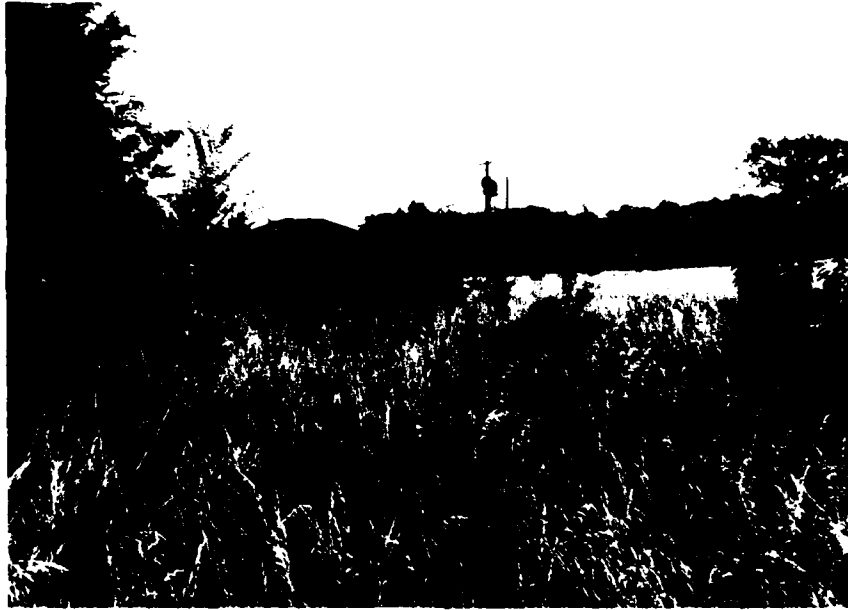
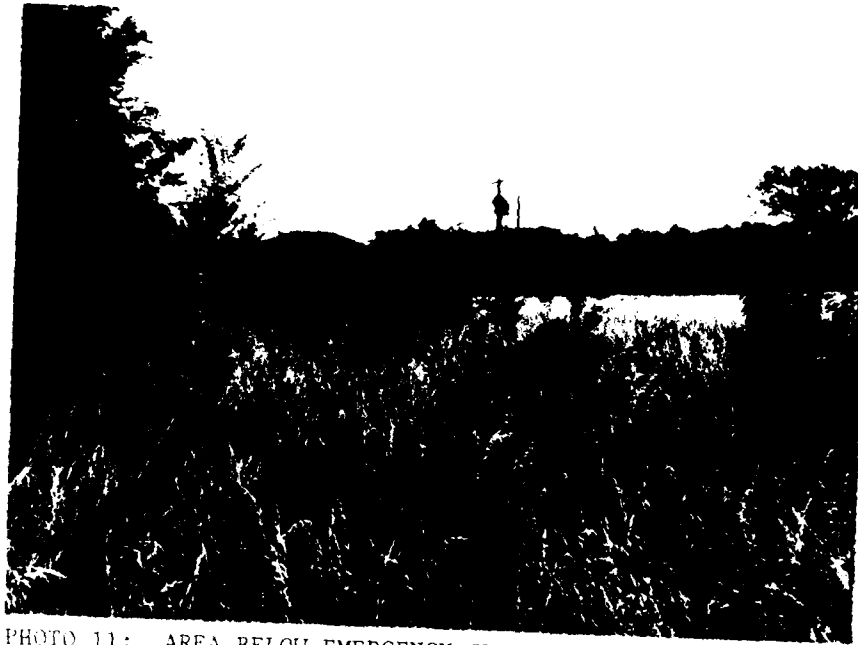
PHOTO 11: AREA BELOW EMERGENCY SPILLWAY LOOKING DOWNSTREAM

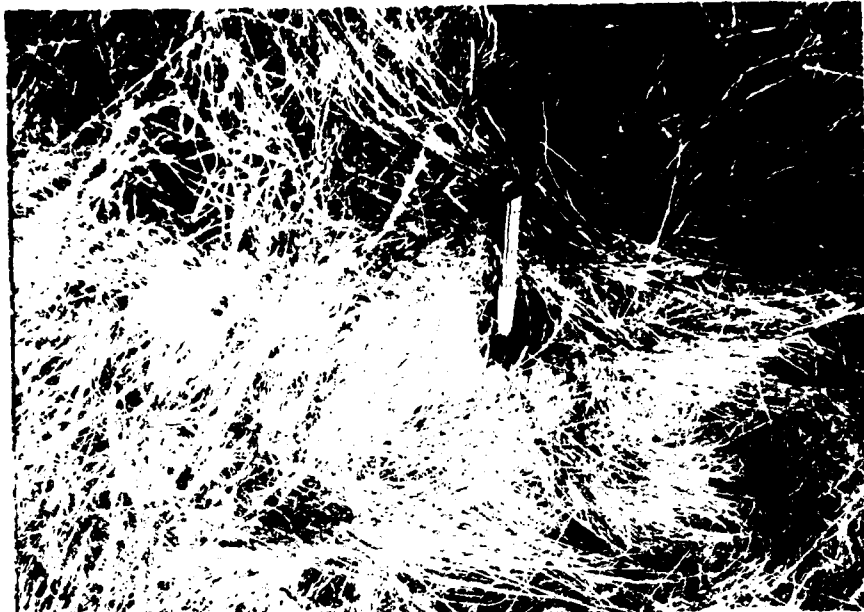
PHOTO 13: ANIMAL BURROW ON CREST OF DAM
