EVALUATION OF MEMBRANE-TYPE MATERIALS FOR STREAMBANK EROSION PROTECTION

MISCELLANEOUS PAPER GL-81-4

Dewey W. White, Jr.

August 1981

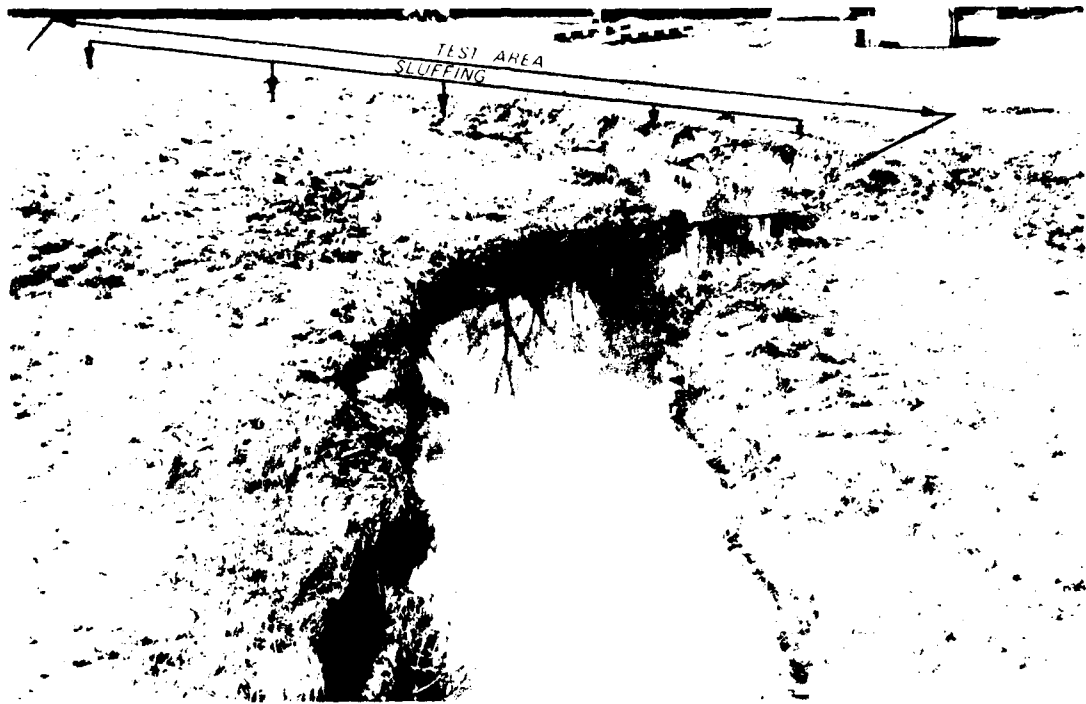
14. The area selected for test purposes along Durden Creek had been eroded previously by high-water stages and streamflows as shown in Photos 5 and 6. The creek test area was subject to being covered by water after heavy rains, and high-water conditions had been observed for periods up to 8 hr as shown in Photo 7. Since the water level fluctuated as much as 7 ft during periods of heavy rain and these conditions were found to have occurred many times in the past, this site was selected for evaluation of experimental materials and construction techniques.

Photo 5. General view (looking downstream) of installation area for installation of test material.

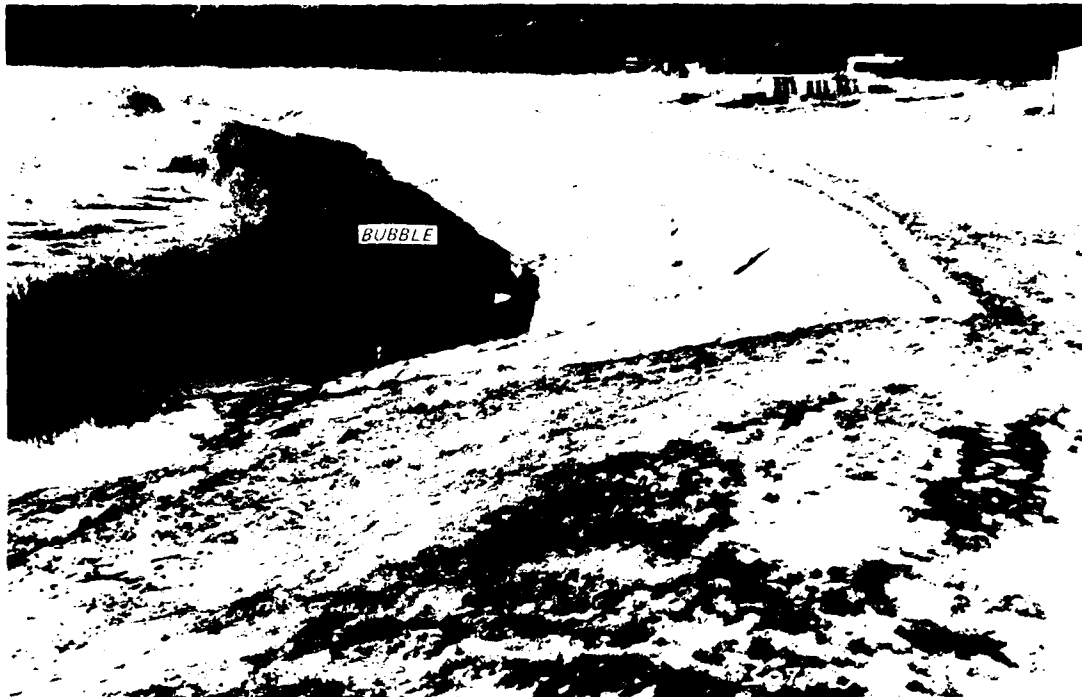
23. Experimental materials used as test items at Durden Creek performed satisfactorily during the period reported. During this period, the water level in the creek varied from the toe of materials to near top bank (Photo 34) a minimum of 50 times. The water level fluctuated as much as 7 ft within a 4-hr period as the result of heavy rains, which caused high-water levels for periods up to 8 hr. Maximum stream velocities of 3.9 fps and discharges up to 280 cfs were recorded.

Photo 34. View (looking downstream) of test area during high water.

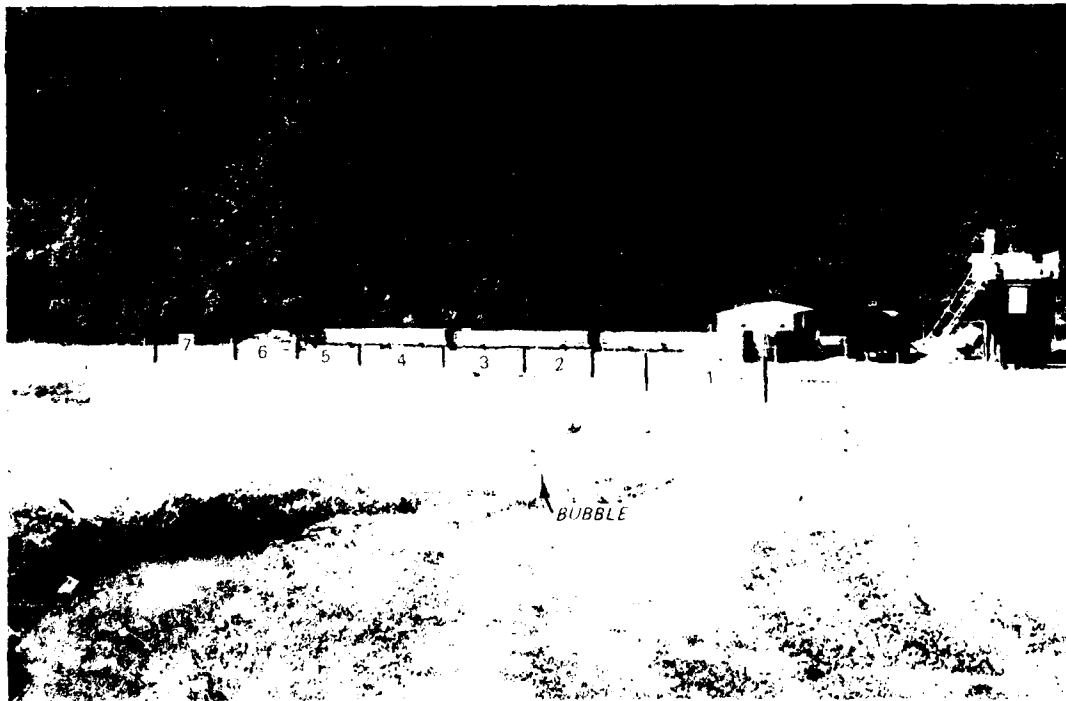
24. There were only two problem areas observed with the use of the test materials. One of these was with the T15 membrane used as the second step of the stepped MESL item (Item 1), which "ballooned" after placement (Photo 35). This condition caused by air entrapped beneath the membrane occurred after the water had risen in the creek several times. The ballooned area was observed to increase and decrease with ambient temperatures, and it was approximately 3 ft wide and 8 ft long (Photo 36) near the end of observations recorded for this report. No damage to Item 1 was observed, and the ballooning had not affected the performance of adjacent test items. The other problem involved sandbags used for ballast in anchor ditches and on the membranes. The bags made of burlap material deteriorated (Photo 37); as a result, rains and streamflows leached the sand from the bags. When construction began at the Big Black River test site, the first problem, ballooning, was

Photo 35. View (looking downstream) of test area after water had been on materials

eliminated by stretching the membrane taut on each step and placing ballast of sacked concrete at the face of each step to prevent ballooning of the membrane. The second problem was also solved by using sacked concrete mix in anchor ditches and in other areas where ballast was required. The original sandbags used at Durden Creek were replaced during October 1980 with bagged concrete mix, and ballast consisting of sacked concrete mix was placed at the face of each step of the stepped MESL item (Item 1). The air observed to be entrapped beneath the membranes (Items 5 and 6, Photo 38) during high-water levels in the creek did not cause any noticeable effects on these materials. In fact, this condition helped to raise the height of the top bank and prevented flood waters of the creek from overtopping the bank in this area. As the high water receded, the membrane returned to its original position on the slope of the bank. The bank in the test area of Durden Creek remained stable as a result of the protection provided by test materials.

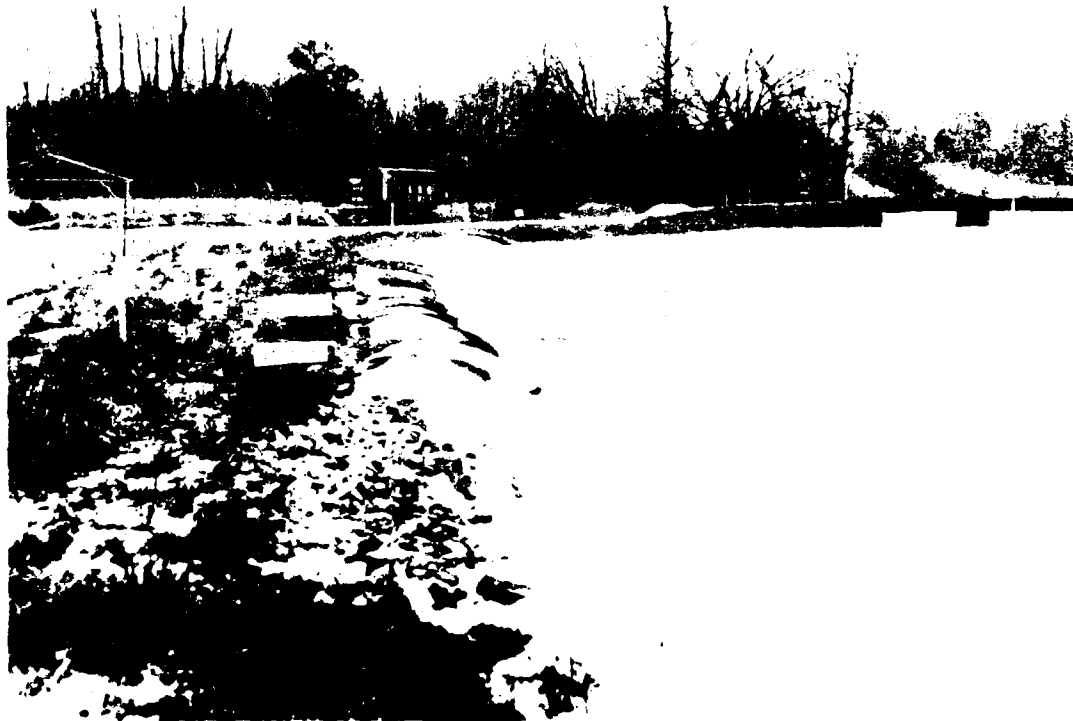
Photo 37. Typical view of deteriorated sandbags

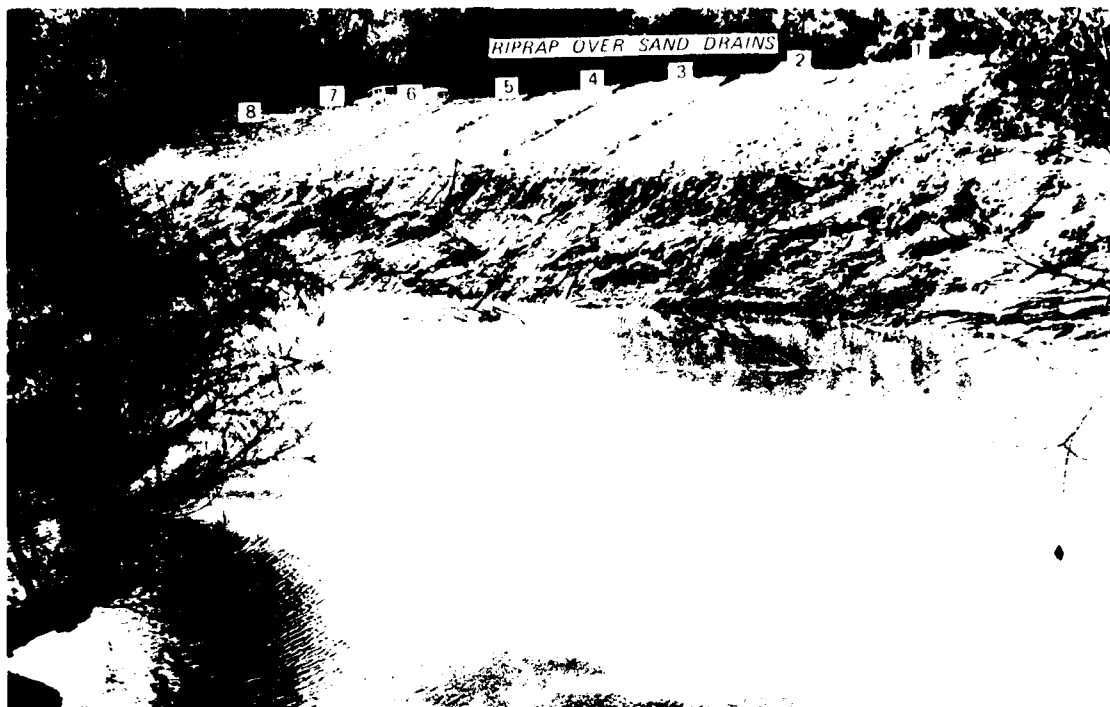
Photo 38. View (looking upstream) of test area during high water level in creek (note membrane raised on Items 5 and 6 due to air entrapped beneath the membrane)

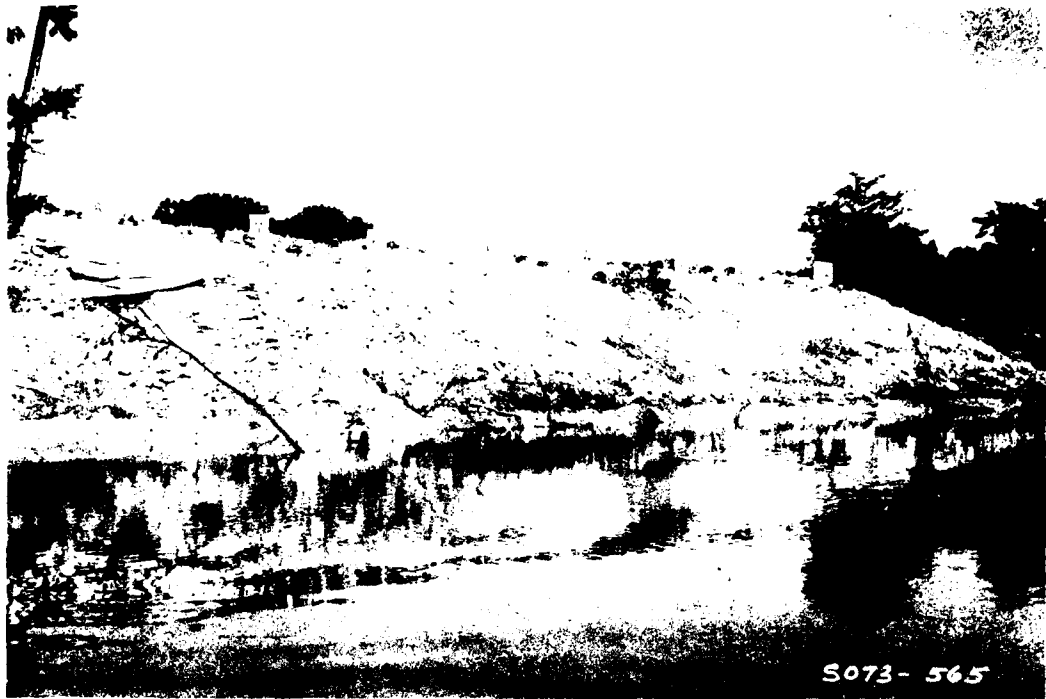
(60-hr period). Photo 73 presents the condition of the test area on 12 May. The test materials on all items were damaged and torn (Photos 74-76) because of bank failure. Since March, the bank behind the test materials had been saturated with water, and then the sudden drawdown caused the bank to fail, resulting in the failure of the test materials. The riprap on Item 7 (standard for comparison) also settled and shifted. Sliding and shifting of the bank also occurred upstream (Photo 77) and downstream (Photo 78) of the test area.

Photo 78. View (looking downriver) of bank adjacent to the downriver edge of the test area which had failed due to the rapid drop in water level, 12 May 1980

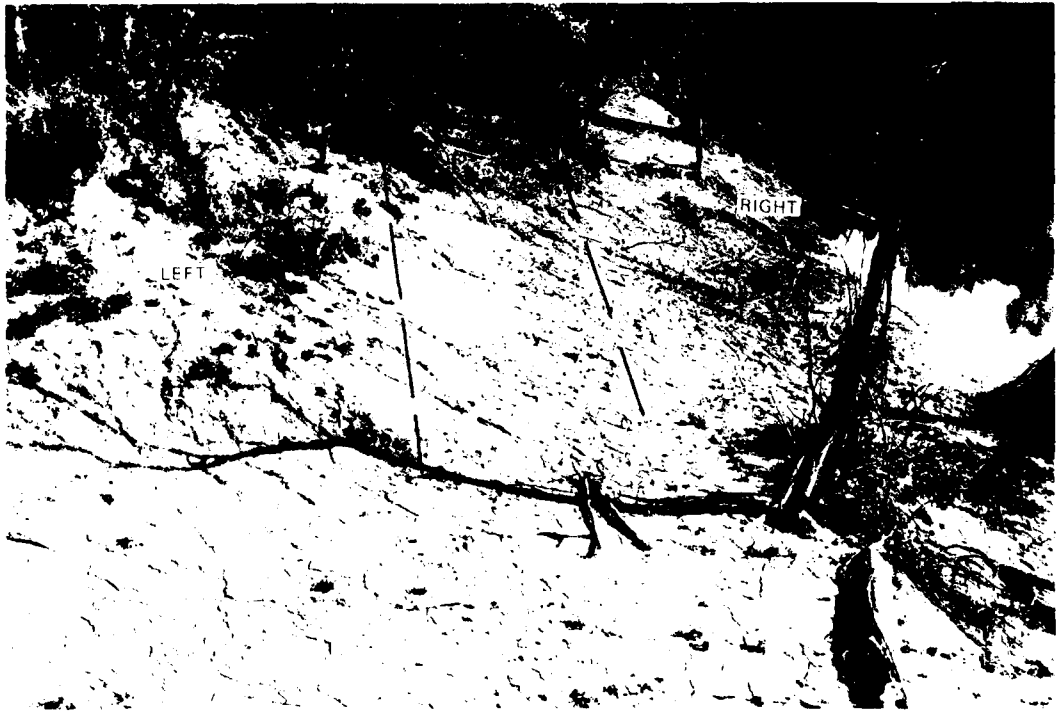
38. The shifting and sliding of bank areas (paragraphs 34-37) that occurred upstream and downstream in areas not associated with the test area also occurred throughout the river basin. Photos 84 through 86 are the views of the riverbank approximately 3 miles downstream from the test area where the bank failed as a result of long periods of high water

followed by rapid drawdowns of the water level. This condition occurred during the same period that the bank at the test site failed and caused damage to test items. Dashed lines have been drawn on Photos 84 and 85 to illustrate the location of the tree line before bank failure occurred. The trees and bank area shown to the left of the lines drawn on Photo 84 are shown after bank failure and displacement in Photos 85 and 86. Some of the trees remained on the lower slope of the bank, whereas others slid into the river. When this drawdown condition on the river occurred, soil was eroded from around a bridge pier immediately downstream and adjacent to the area described above. Photo 87 shows the condition of the bridge pier located on Mississippi Highway 27.

Photo 84. View of riverbank downstream of test area where sliding and slumping occurred as a result of the sudden drops in the water level of the river
