# Sneak Circuit Analysis of F-4C Flight Control System

DOCUMENT NO. D2-118545-1

MODEL NO. F-4C CONTRACT NO. F33657-74-C-0686

SEPTEMBER 17, 1974

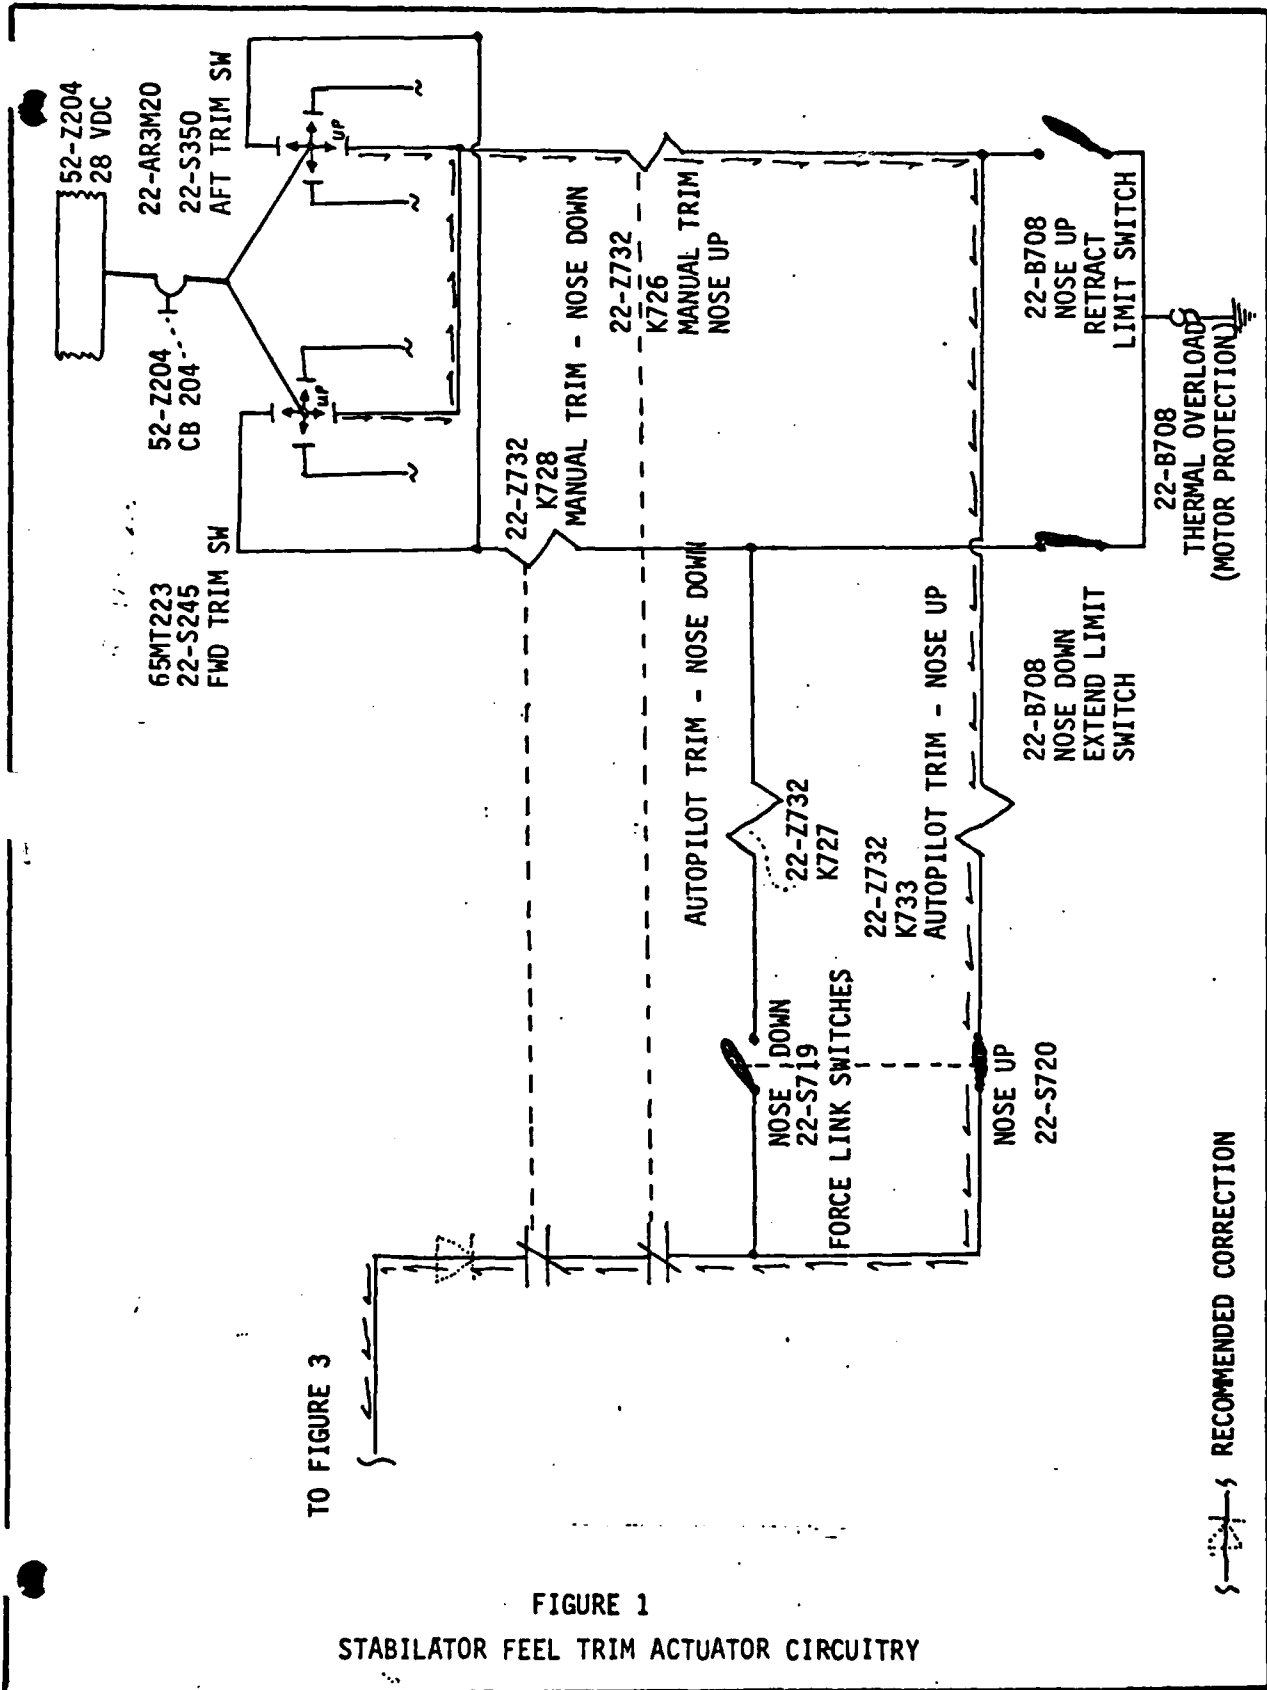
FIGURE 1  
 STABILATOR FEEL TRIM ACTUATOR CIRCUITRY

The Altitude Hold Circuitry and Roll and Pitch Channels of the Autopilot may be powered while AFCS is disengaged. There may be damage to AFCS relays due to relay chatter.

Add a diode in the location shown in Figures 1 and 2.

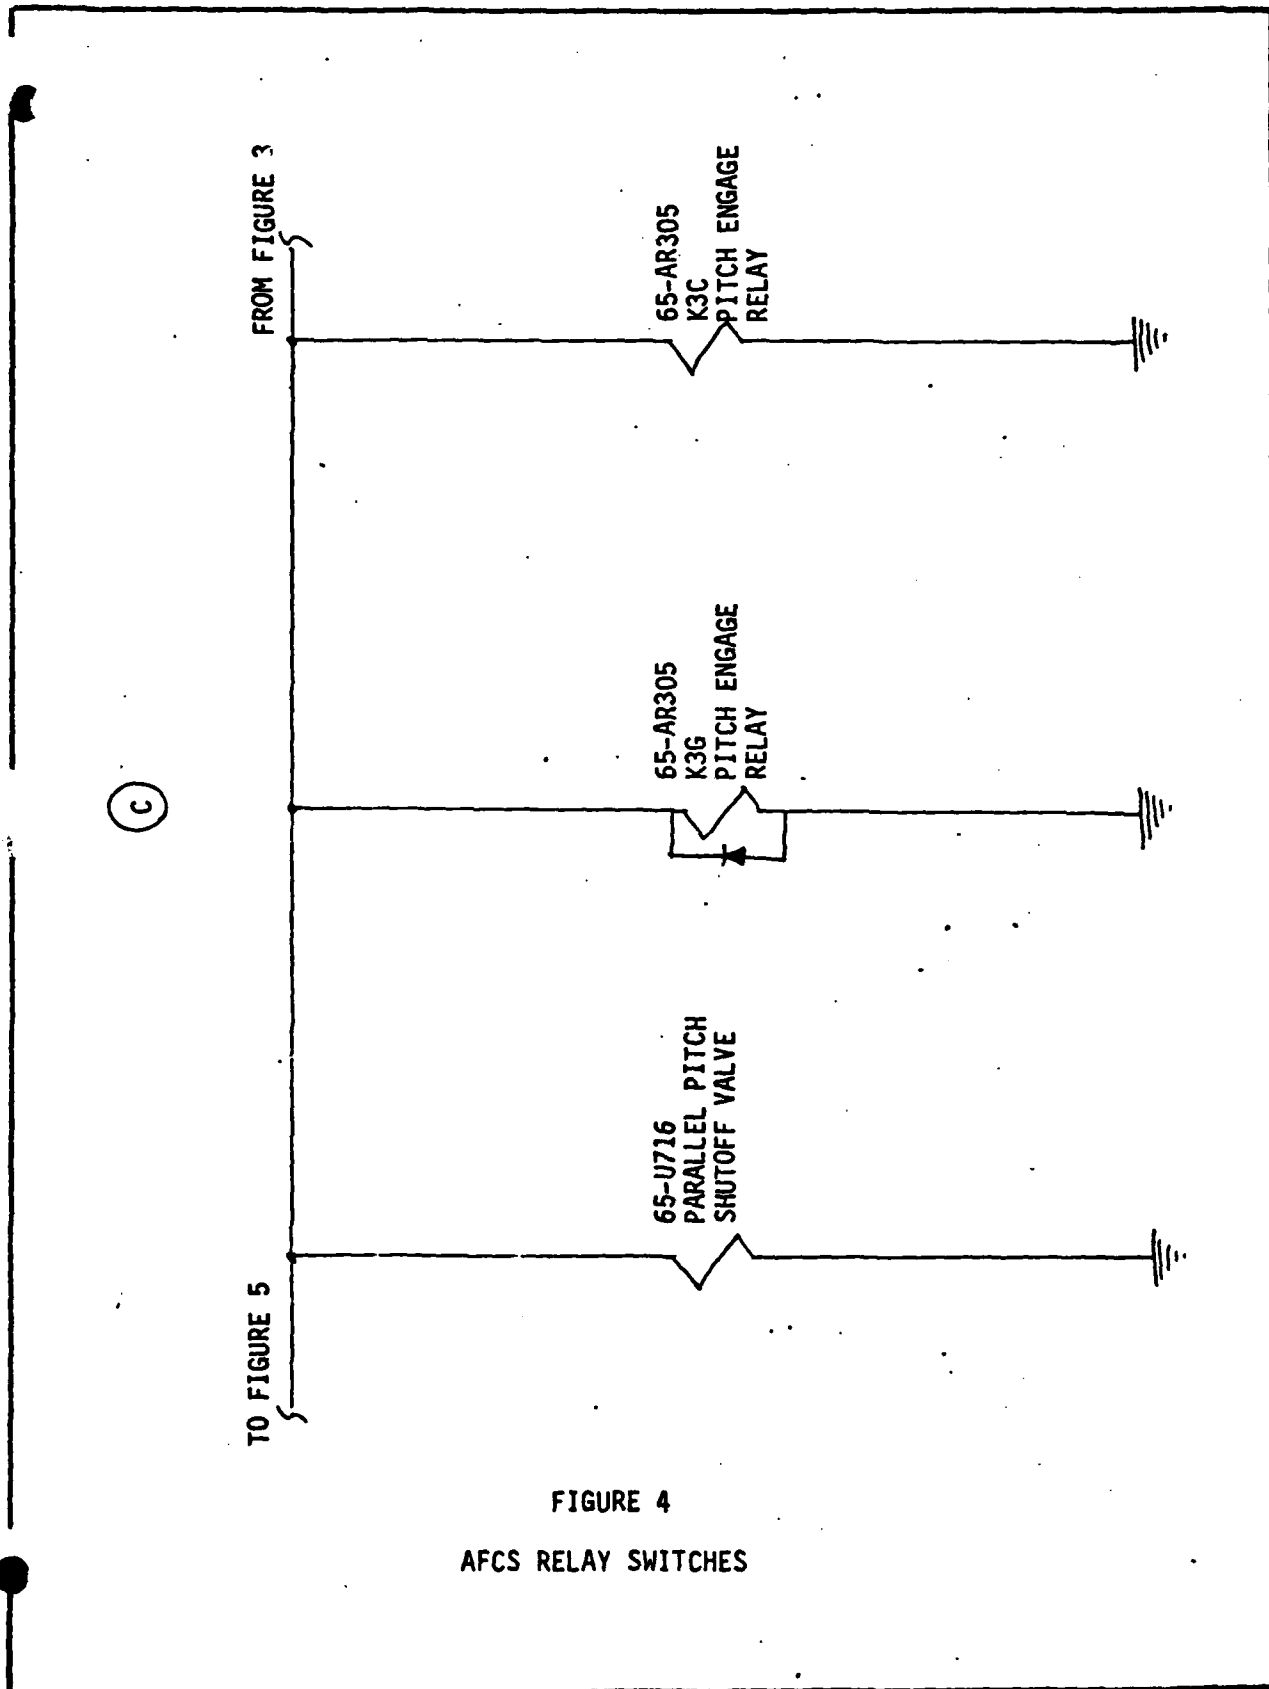
FIGURE 4  
AFCS RELAY SWITCHES

- Path C. As shown in figure 4, power can flow to the Parallel Pitch Shutoff Valve in ref. des. 65-U716 and to the Pitch Engage Relays (K3G and K3C) in ref. des. 65-AR305. This could cause the Pitch Channel of AFCS to be enabled even though AFCS is disengaged.

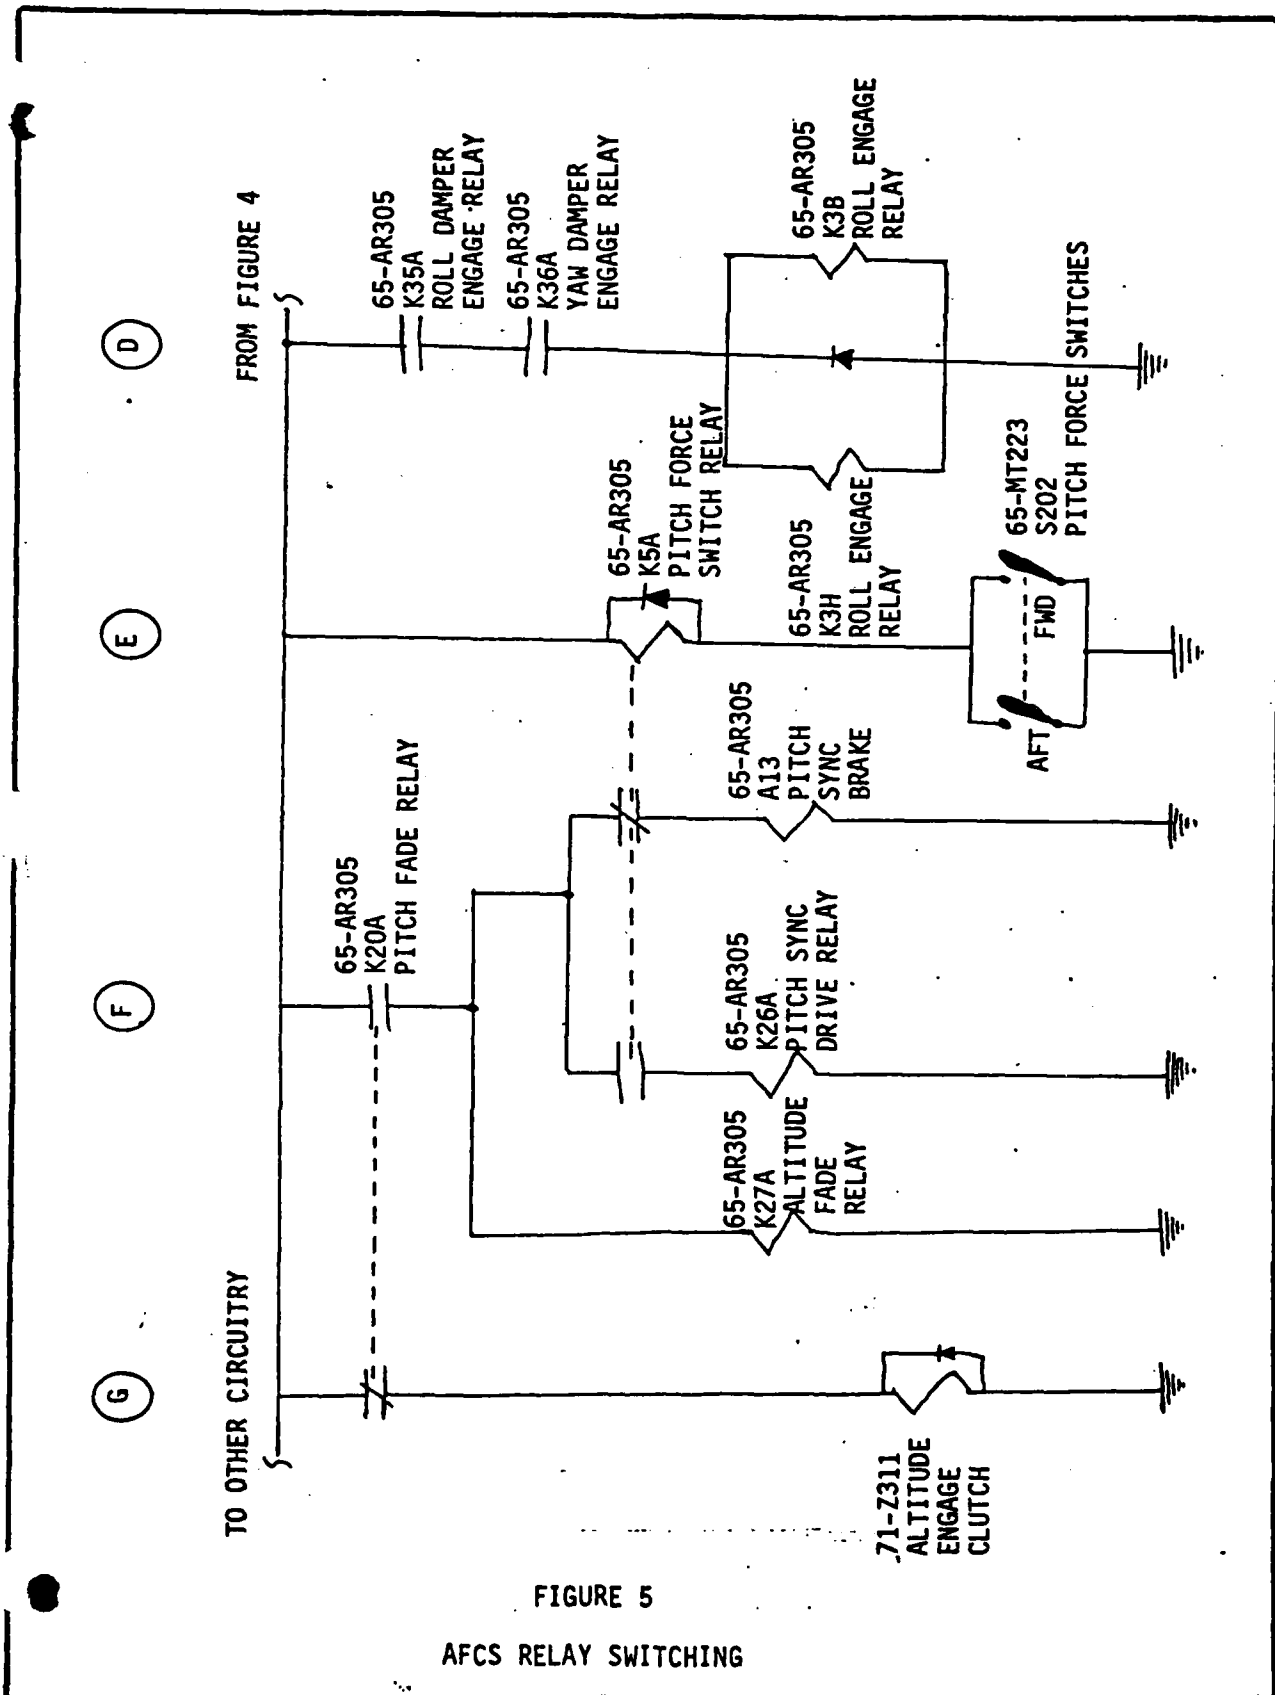
FIGURE 5  
AFCS RELAY SWITCHING

- Path E. As shown in figure 5, if the FWD or AFT Pitch Force Switch (S202) in ref. des. 65-MT223 is thrown, the Pitch Force Relay (K5A) may be energized. If it energizes, it would cause relay chatter since its contacts in figure 3 are between it and the power source.

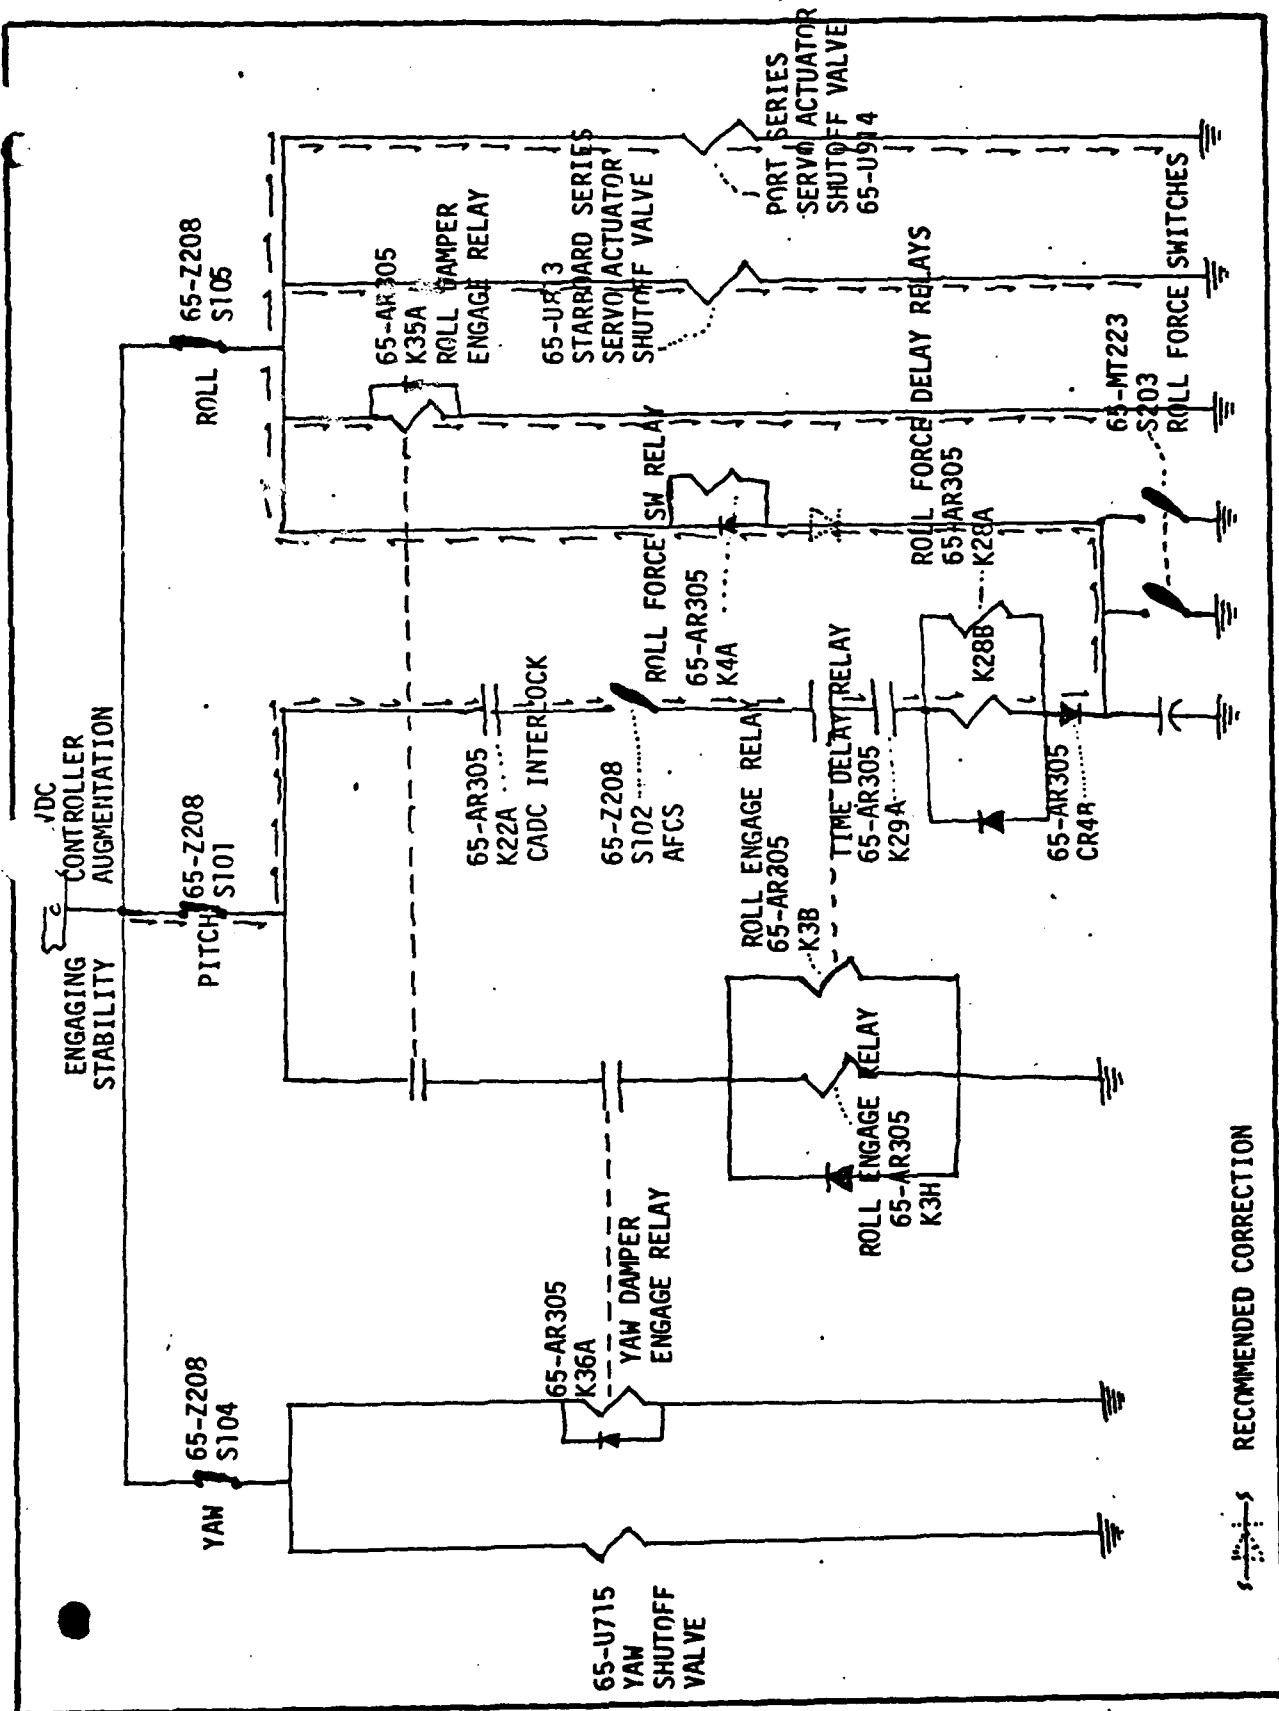
RECOMMENDED CORRECTION

Some of the Roll Stabilator Augmenter circuitry will continue to be powered after the Roll Stability Augmentation Switch (S105) is opened. Due to the brief period of existence this condition likely would not be detected by the pilot.

Add a diode in the location shown.

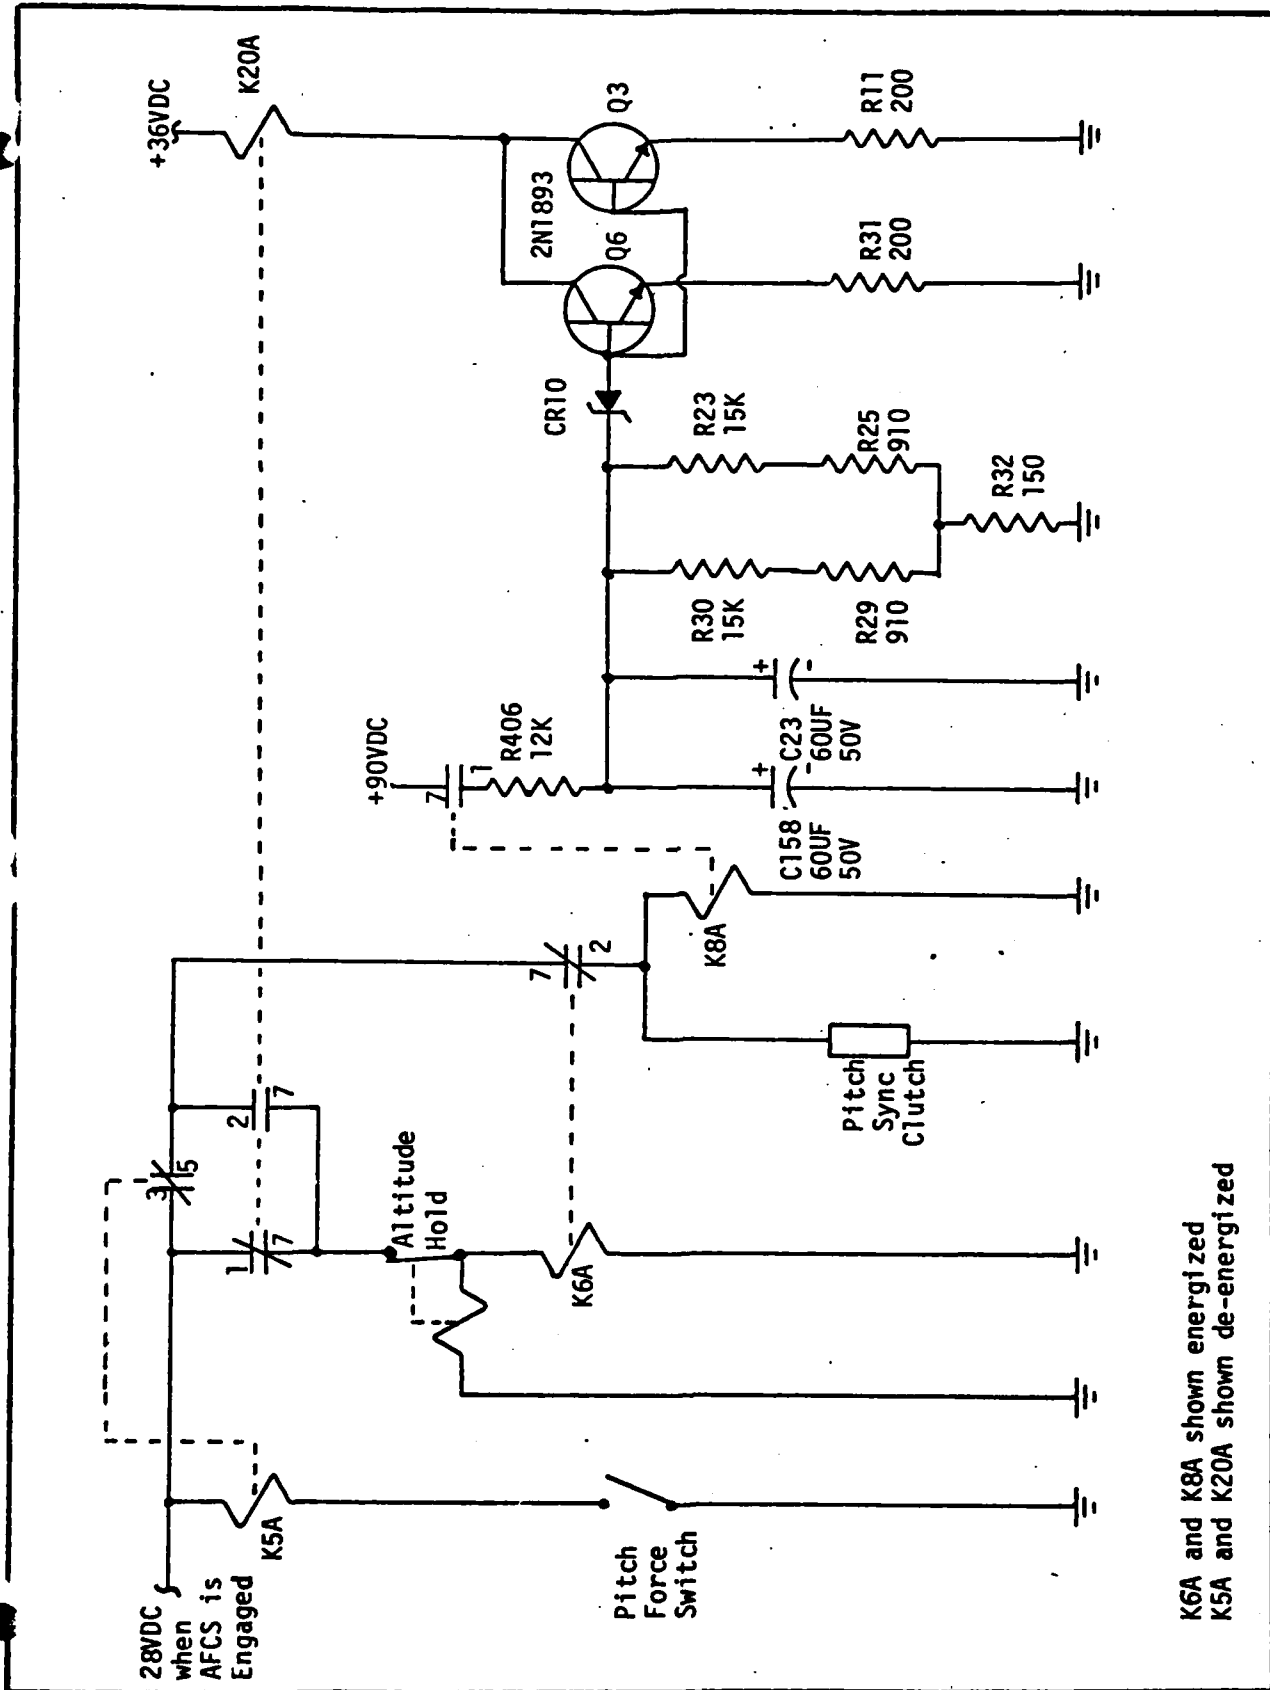
If Pitch Force Switch is opened before Altitude Hold drops out, the Air Data Computer error signal will cause the aircraft to return to the reference altitude.

The connections of K20A normally closed contact pins 1 and 7 and normally open contact pins 2 and 7 should be reversed.

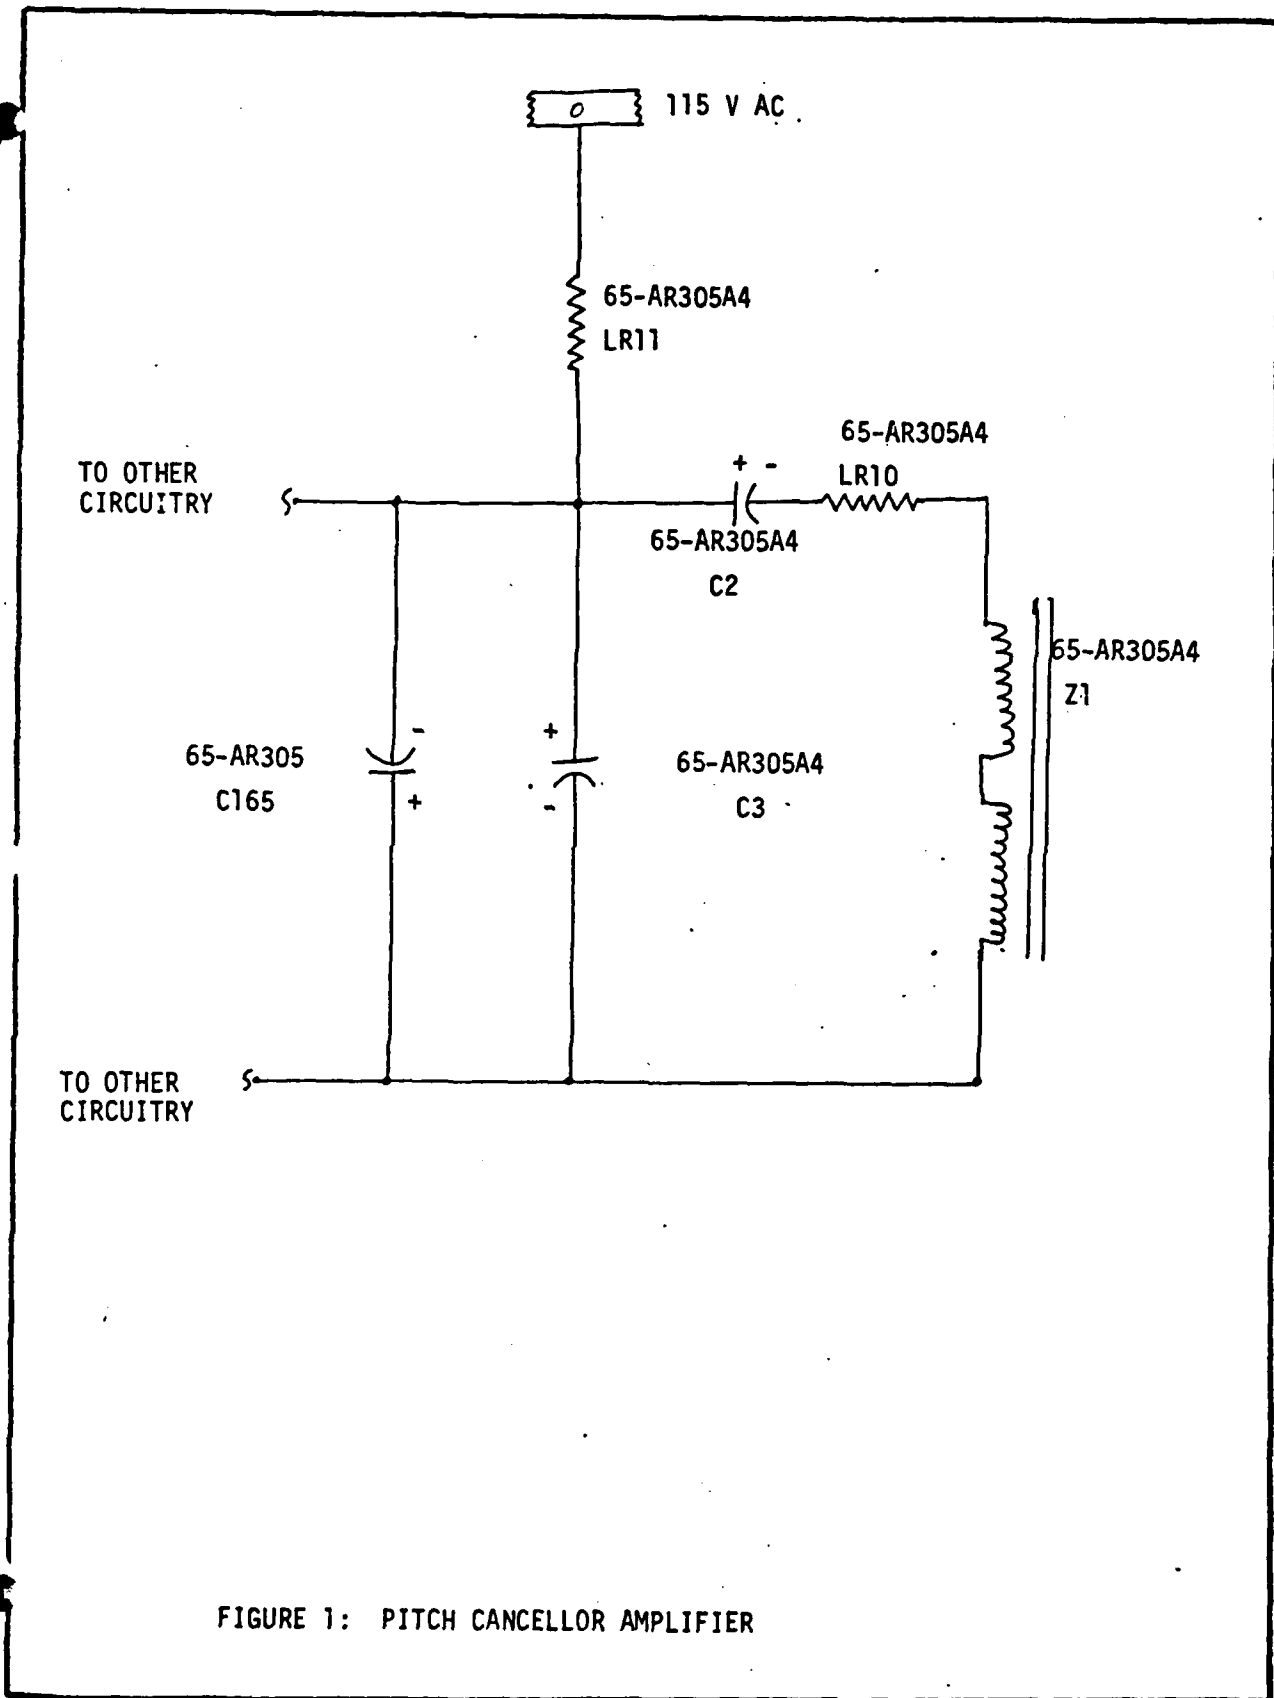
FIGURE 1: PITCH CANCELLOR AMPLIFIER

Capacitor C165 in ref. des. 65-AR305 is wired in parallel with capacitor C3 in ref. des. 65-AR305A4. The drawings in references 2 and 3 above show these capacitors wired with opposite polarity as shown in Figure 1. If these are electrolytic capacitors, one of them may burn out.

Either capacitor C165 or C3 may burn out.

Reverse polarity of capacitor C165.

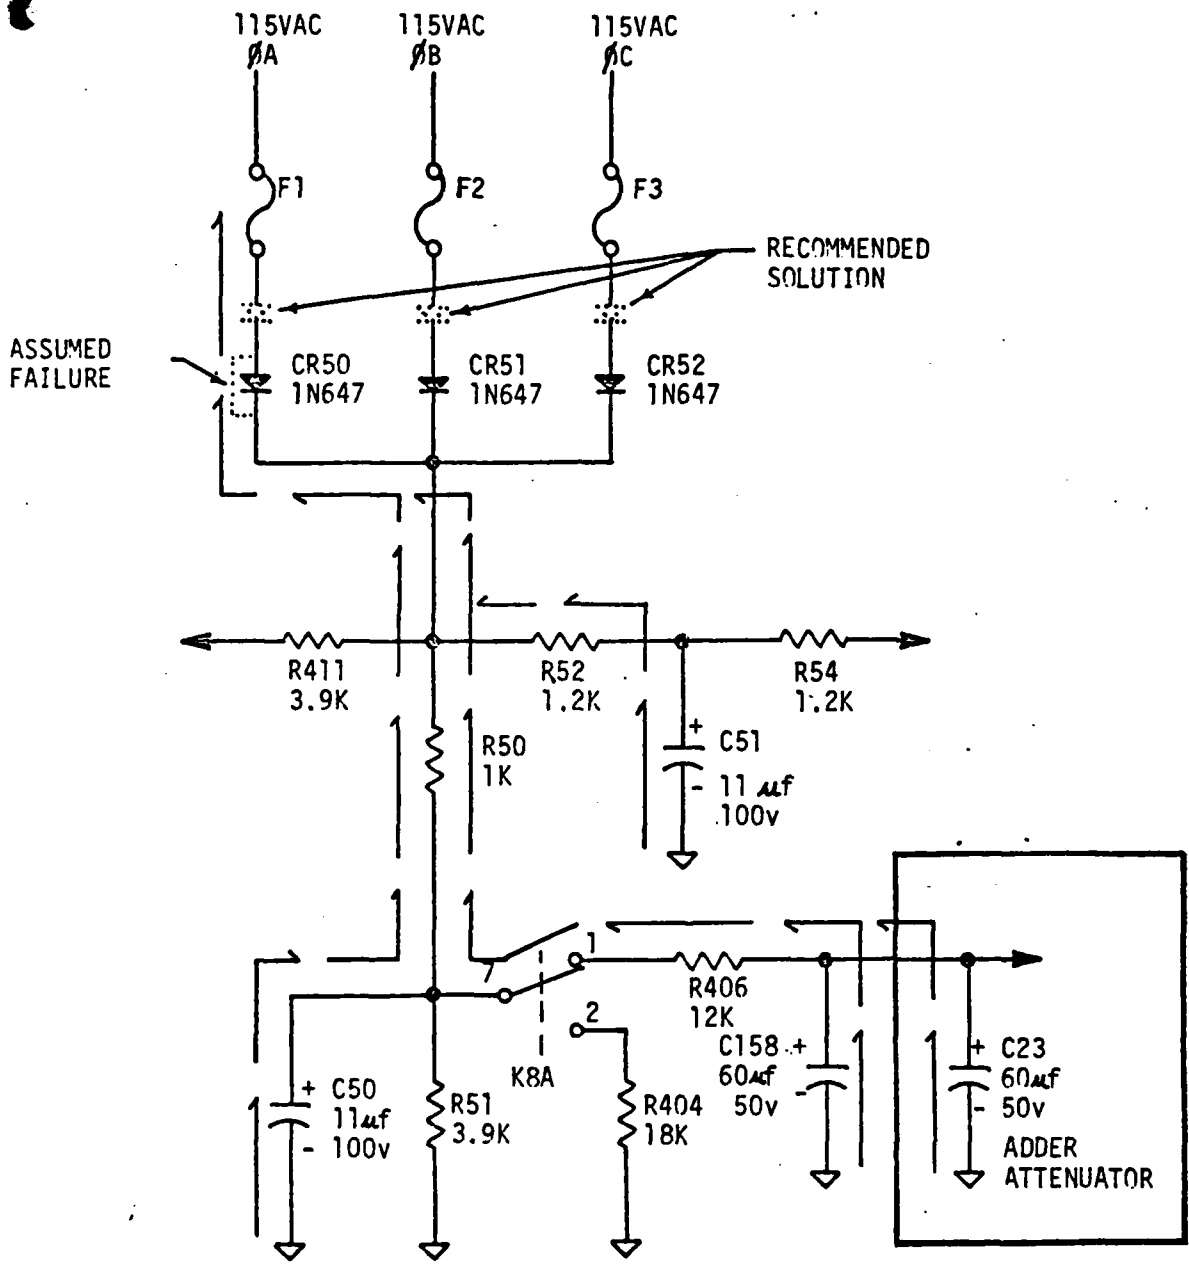
DESIGN CONCERN REPORT F-4C-7

Diodes CR50, CR51 and CR52 rectify the incoming 115VAC, 400 Hz, 3 phase power to provide 135 VDC to the Adder Attenuator and Electronic Switch Monitor. This voltage is filtered by capacitors C50, C51, C158 and C23. C23 is located in the Adder Attenuator Module. The remaining capacitors are chassis mounted components. Should any of the diodes fail in the shorted mode (then fail open) each of the four capacitors will be subjected to reverse current during the negative portion of the cycle for the phase containing the shorted diode. Per reference 4 these capacitors are of the Tantalum Sintered-Slug type. Per MIL-STD-198C, Section 802, paragraph 2.1.2 these capacitors cannot withstand any reverse voltage.

Capacitors may fail immediately or be damaged to the extent that they will fail later - possibly in flight. Capacitor C51 failure will prevent AFCS from being engaged. Capacitor C158 or C23 failure results in the loss of the pitch fader effect. Capacitor C50 failure results in the loss of both pitch and roll fader effects.

Add one additional diode in series with CR50, CR51 and CR52 as shown in the attached figure.

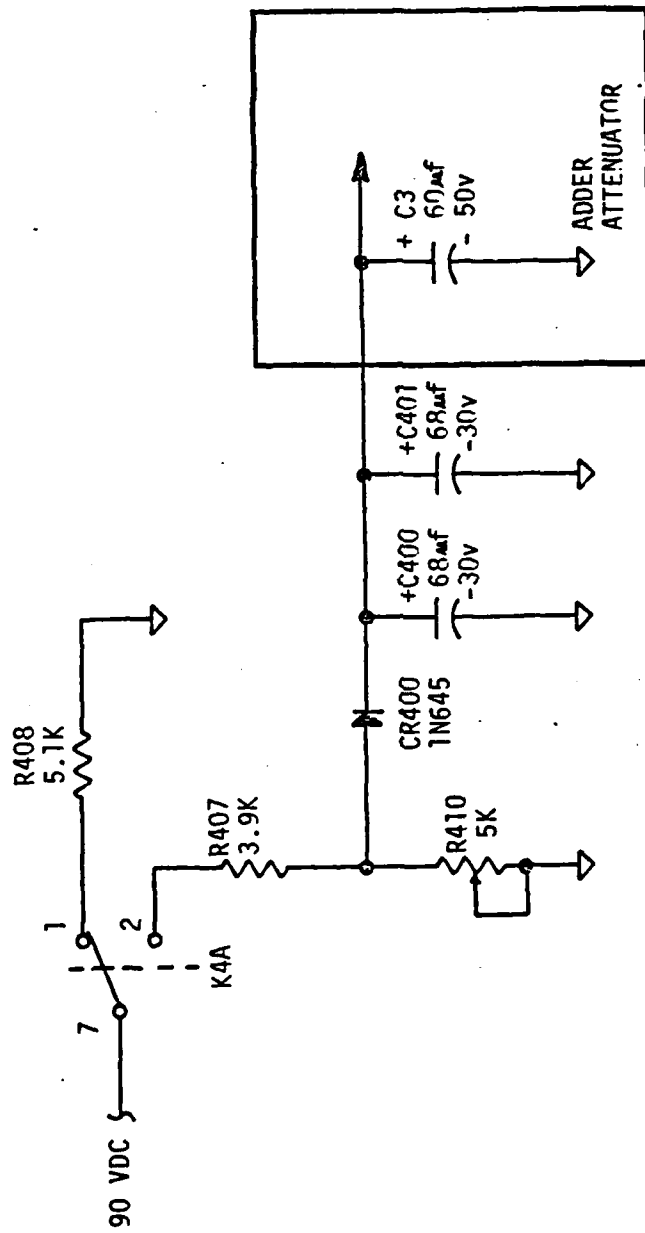
DESIGN CONCERN REPORT F-4C-8

Capacitors C400, C401 in the chassis wiring and capacitor C3 in the Adder Attenuator are connected in parallel as shown in the attached figure. The working voltage for C400 and C401 is 30 volts and for C3 is 50 volts. Per reference 2, the nominal voltage across these capacitors is 31.9 volts. Depending upon the setting of R410 this can be as high as 39.8 volts. In either case, the working voltage for C400 and C401 is exceeded. This is in violation of MIL-STD-198C, Section 802, Paragraph 2.7.2.

Capacitor failure which in turn results in the loss of the roll fader effect in the Adder Attenuator module.

Replace C400 and C401 with capacitors with sufficient working voltage to withstand the applied voltages.

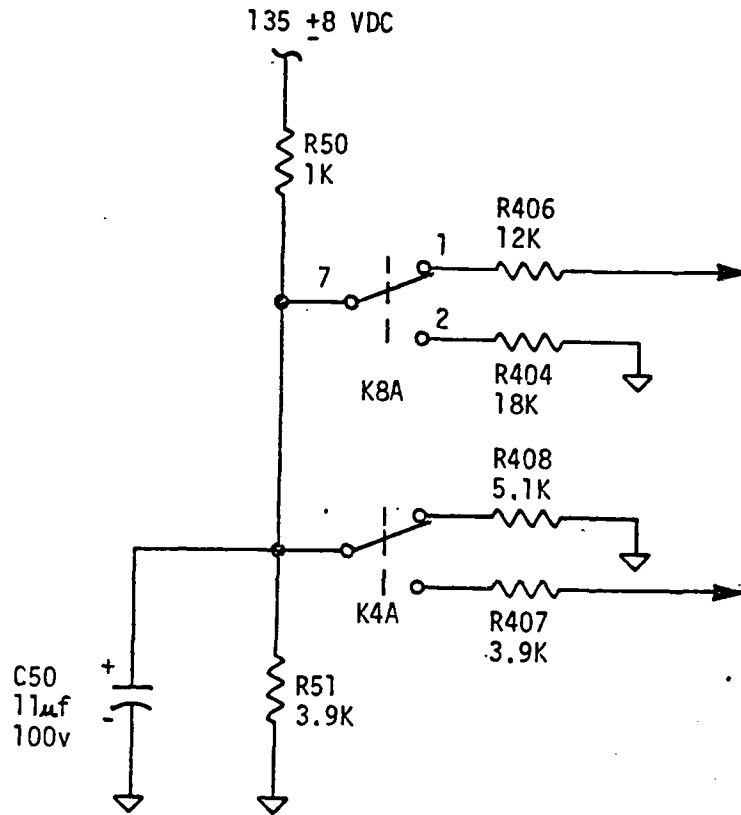
DESIGN CONCERN REPORT F-4C-9

Capacitor C50 filters the 90 VDC used to control the Pitch and Roll faders in the Adder Attenuator module. During the switching time of relay K4A the voltage applied to C50 is 109 VDC due to the loss of the 5.1K $\Omega$  load impedance. This exceeds the rated working voltage of the capacitor in violation of MIL-STD-198C, paragraph 6.5(d).

Capacitor failure which in turn results in the loss of the pitch and roll fader effects in the Adder Attenuator.

Replace capacitor C50 with a capacitor with sufficient working voltage to withstand the applied voltage.

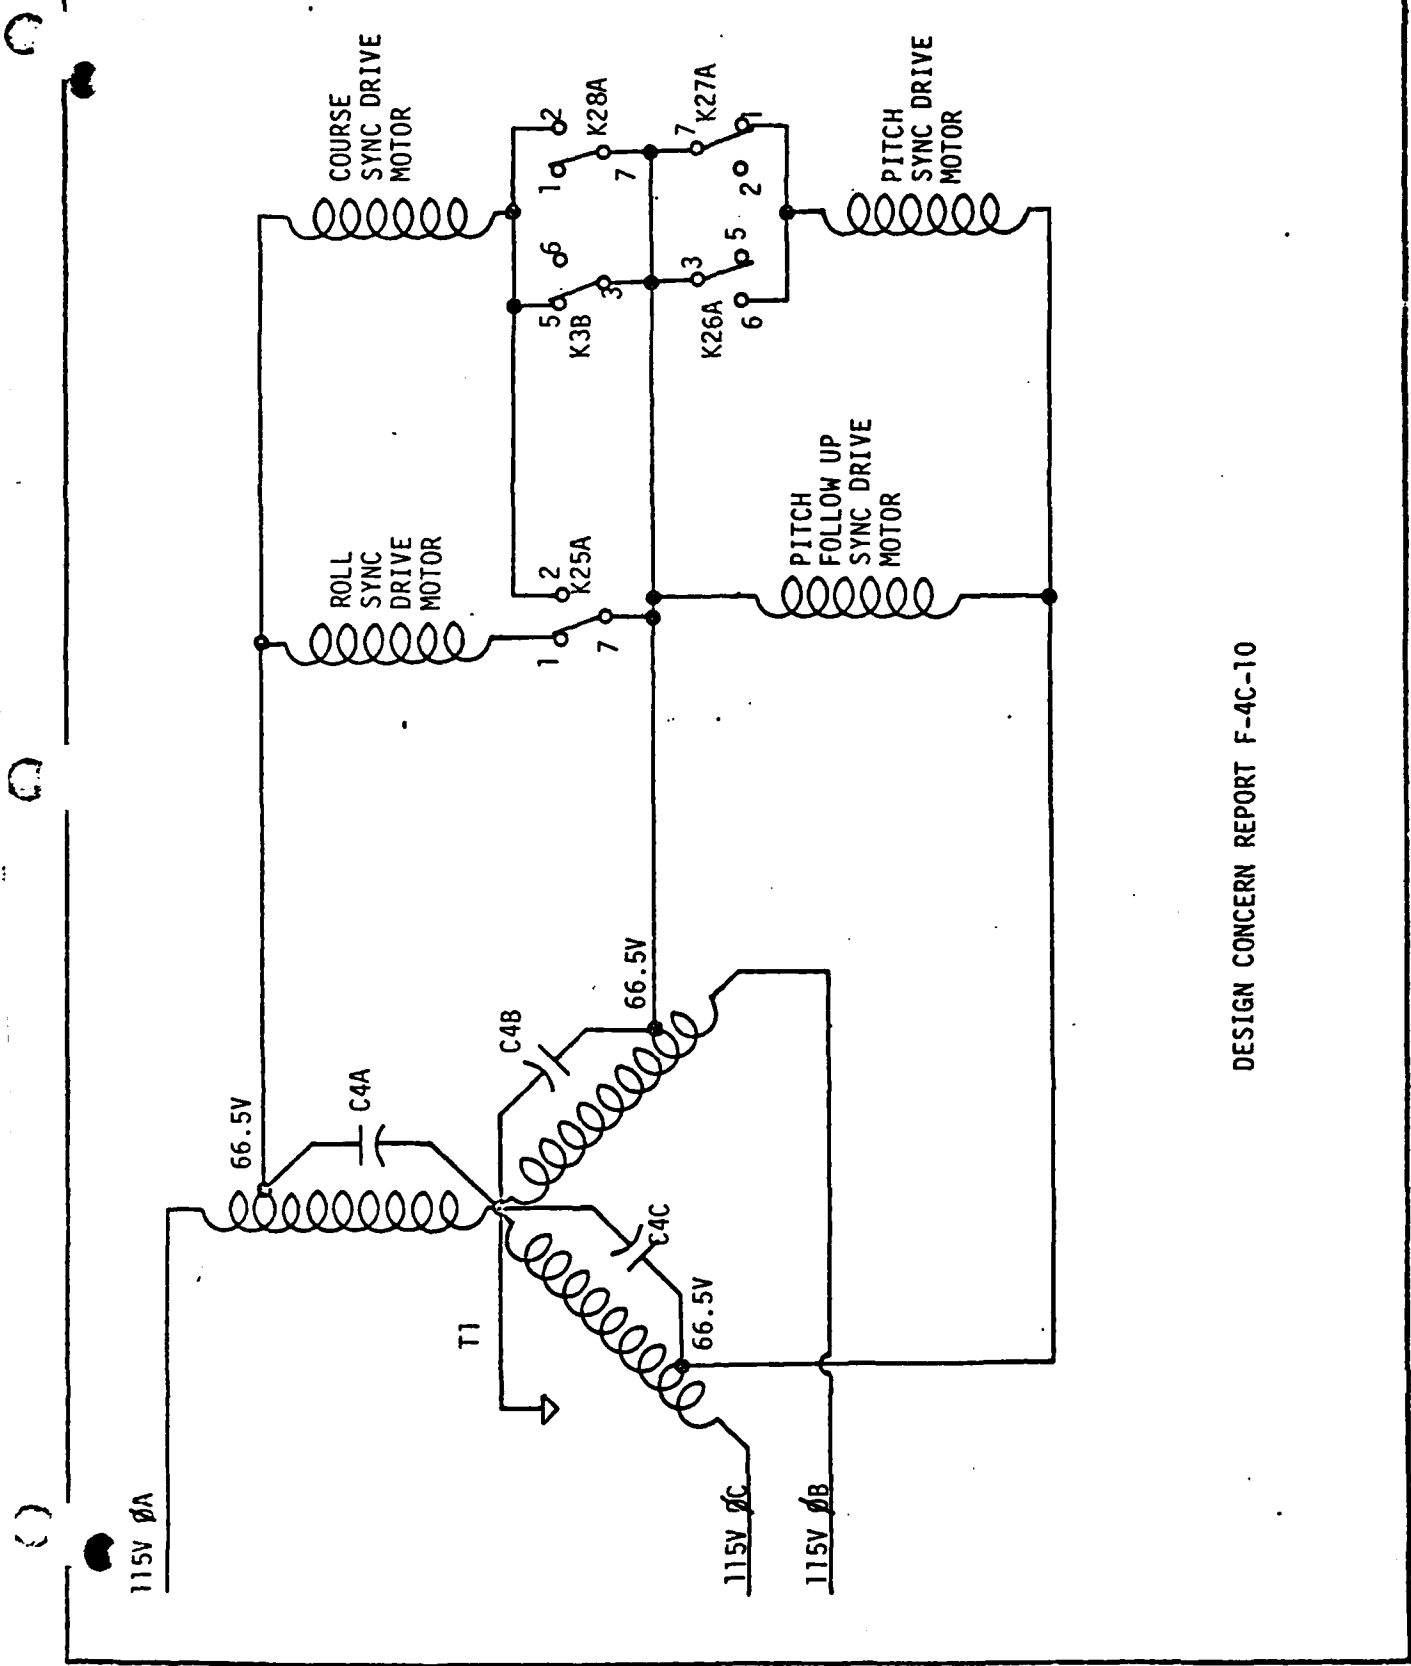
DESIGN CONCERN REPORT F-4C-10

Capacitors C4A, C4B and C4C, P/N CK06BX103M, are Fixed, Ceramic dielectric devices rated at .01  $\mu$ f, 200 VDCW. These capacitors are used to both tune the circuit and suppress transients caused by opening the circuits to the fixed phase winding of the Pitch, Roll and Course Sync Drive Motors as shown in the attached figure. Per reference 3, paragraph 4.7.5.1 these capacitors must withstand 500 VDC without a dielectric failure. Considering the high failure rate of these capacitors, it is probable that the induced voltage transients exceed the dielectric breakdown voltage thus causing capacitor failure.

Replace capacitors with devices that will withstand the induced voltage transients without dielectric breakdown.

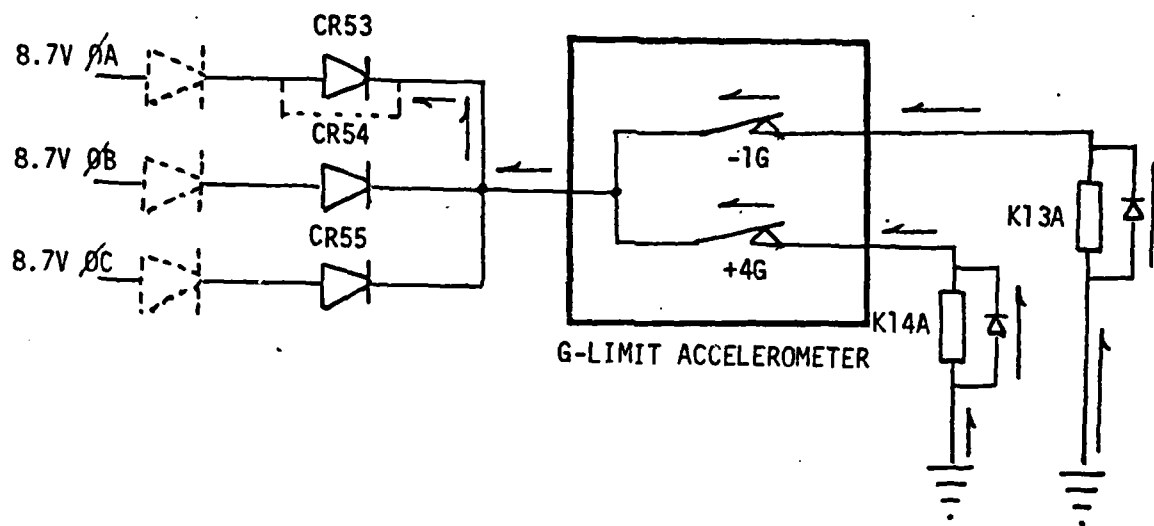
FIGURE 1 G-LIMIT ACCELEROMETER AND RELAYS

Diodes CR53, CR54, and CR55 rectify the incoming 8.7 VAC 400 Hz, 3-Phase voltage to provide 9.5 VDC to the G-limit relays through the G-limit accelerometer switches as shown in the attached Figure 1. If any of the three diodes fail in the shorted mode, the voltage to the G-limit accelerometer will be driven negative during the negative cycle of the phase containing the shorted diode. This will cause current flow through the suppression diodes of K13A and K14A in the forward direction, as shown, causing them to fail open. Also, during the negative portion of the shorted phase, the two remaining diodes will supply excessive current, causing one or both to fail open. The negative voltage at the input to the G-limit accelerometer will have the same effect as opening the G-limit switches: De-energizing of K13A and K14A and disengaging AFCS (AFCS engage logic is shown in Attached Figure 2).

AFCS will not remain engaged after failure of any of the diodes in shorted mode.

Add an additional diode in series with each of the three diodes as shown in Figure 1.

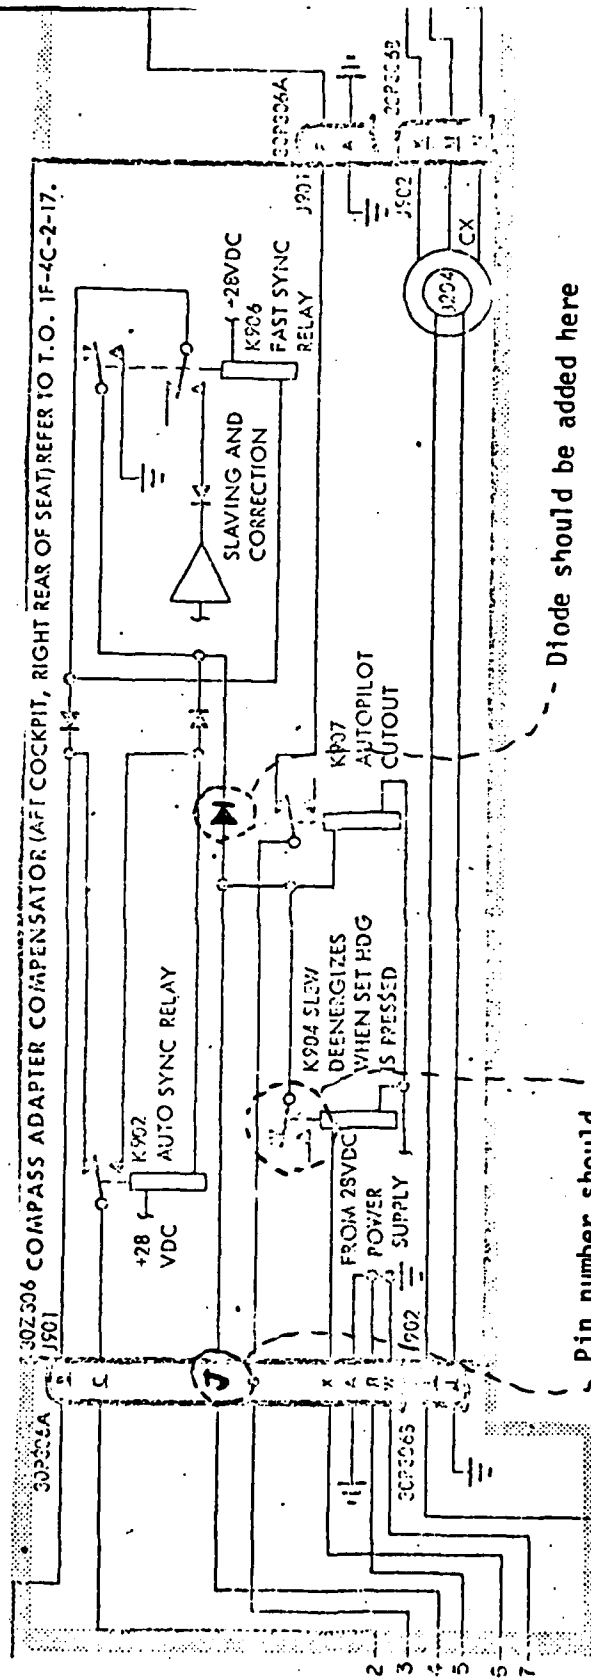
Diode should be added here

Errors in this switch reported in Drawing Error Report #2
