# Sneak Circuit Analysis of F-4C Flight Control System

DOCUMENT NO. D2-118545-1

MODEL NO. F-4C CONTRACT NO. F33657-74-C-0686

SEPTEMBER 17, 1974

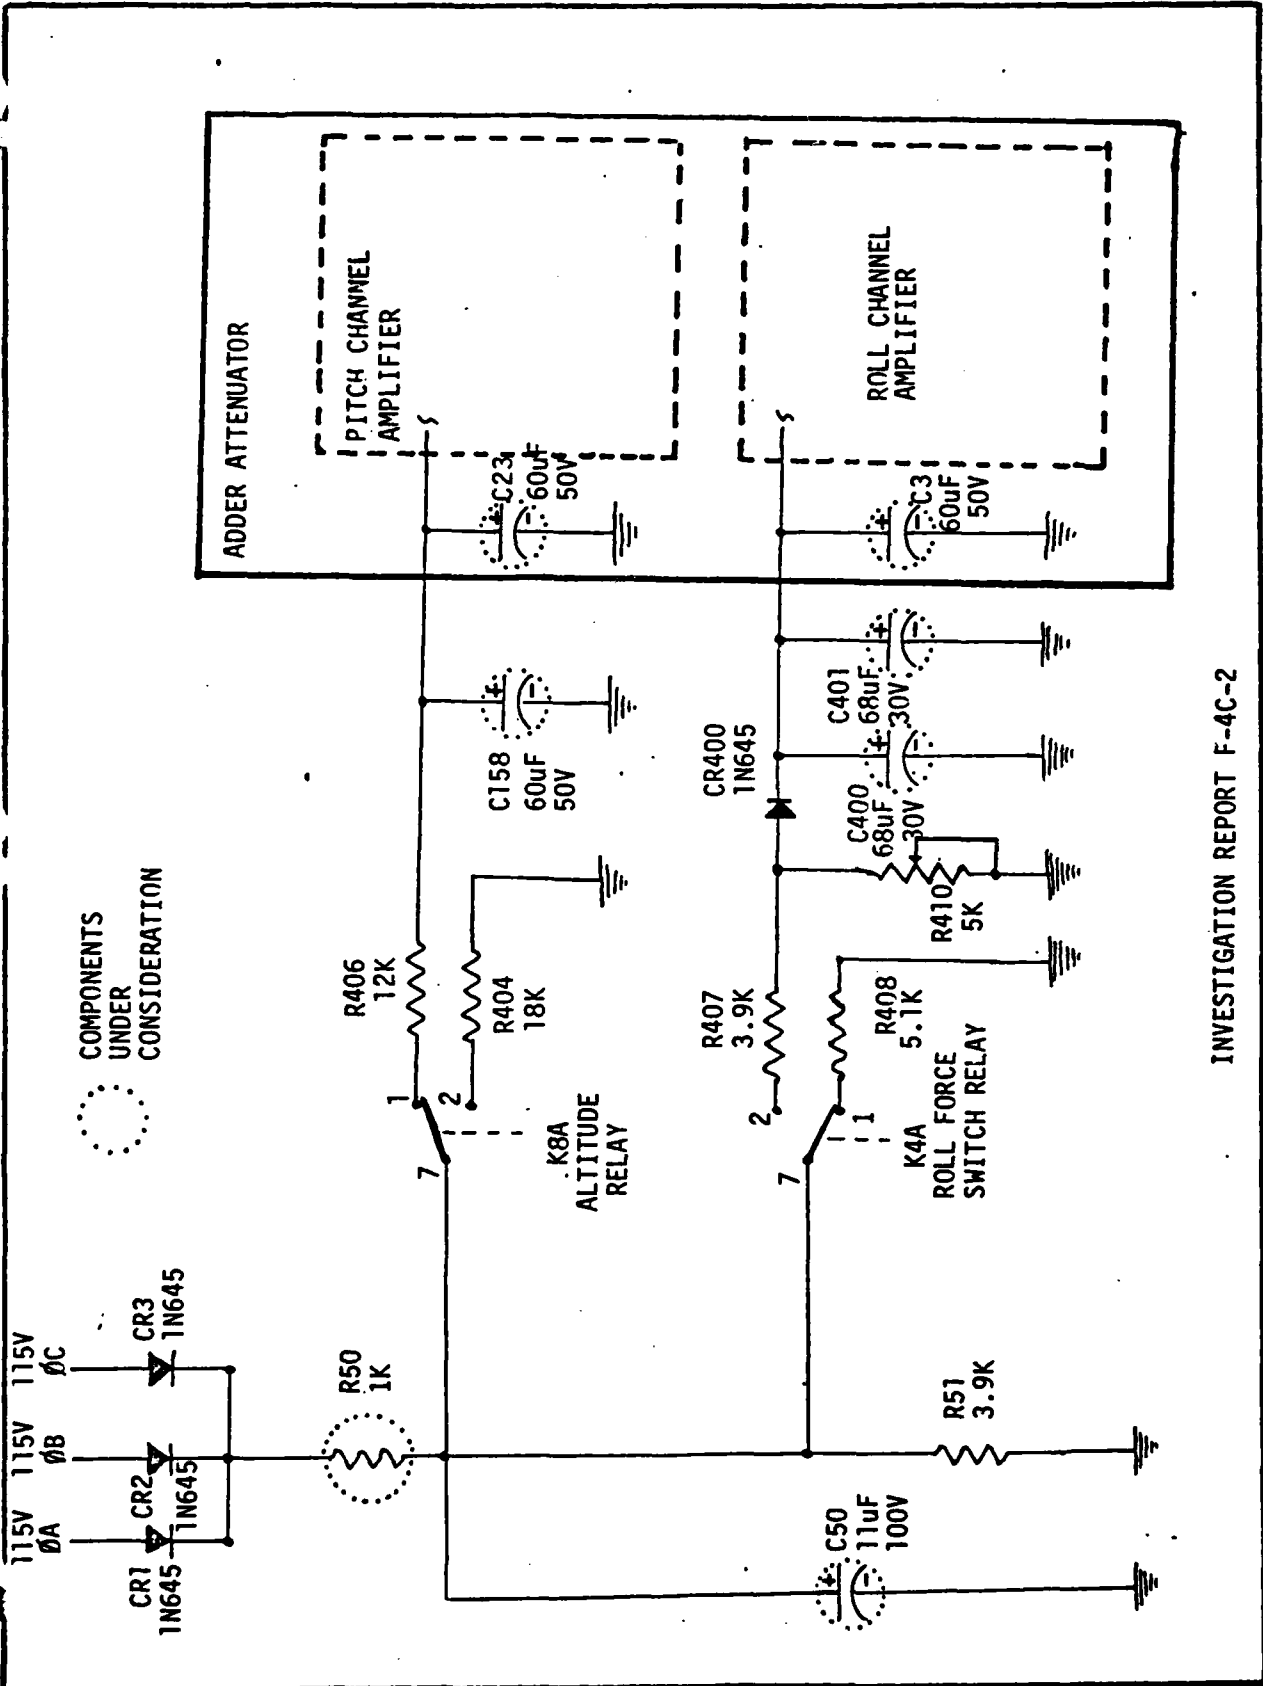
INVESTIGATION REPORT F-4C-2

The pitch amplifier provides normal amplification of signals from the CADC when in the altitude hold mode. When making transitions to and from the altitude hold mode this amplifier fades the altitude hold signal to assure a smooth transition. If capacitor C23 in the Adder Attenuator or capacitor C158 (C158 was not identified as a high failure item but is included here since it has the same effect as C23) in the chassis wiring fail in the shorted mode, the fade effect of this channel will be inhibited. Also, the error signal from the CADC will always be passed by the Adder Attenuator thus opposing pilot controlled pitch maneuvers.

If capacitor C50 in the chassis wiring fails in the shorted mode or if resistor R50 in the chassis wiring fails in the open mode the fade effect of both channels of the Adder Attenuator will be lost and the autopilot will oppose pilot controlled pitch and roll maneuvers.

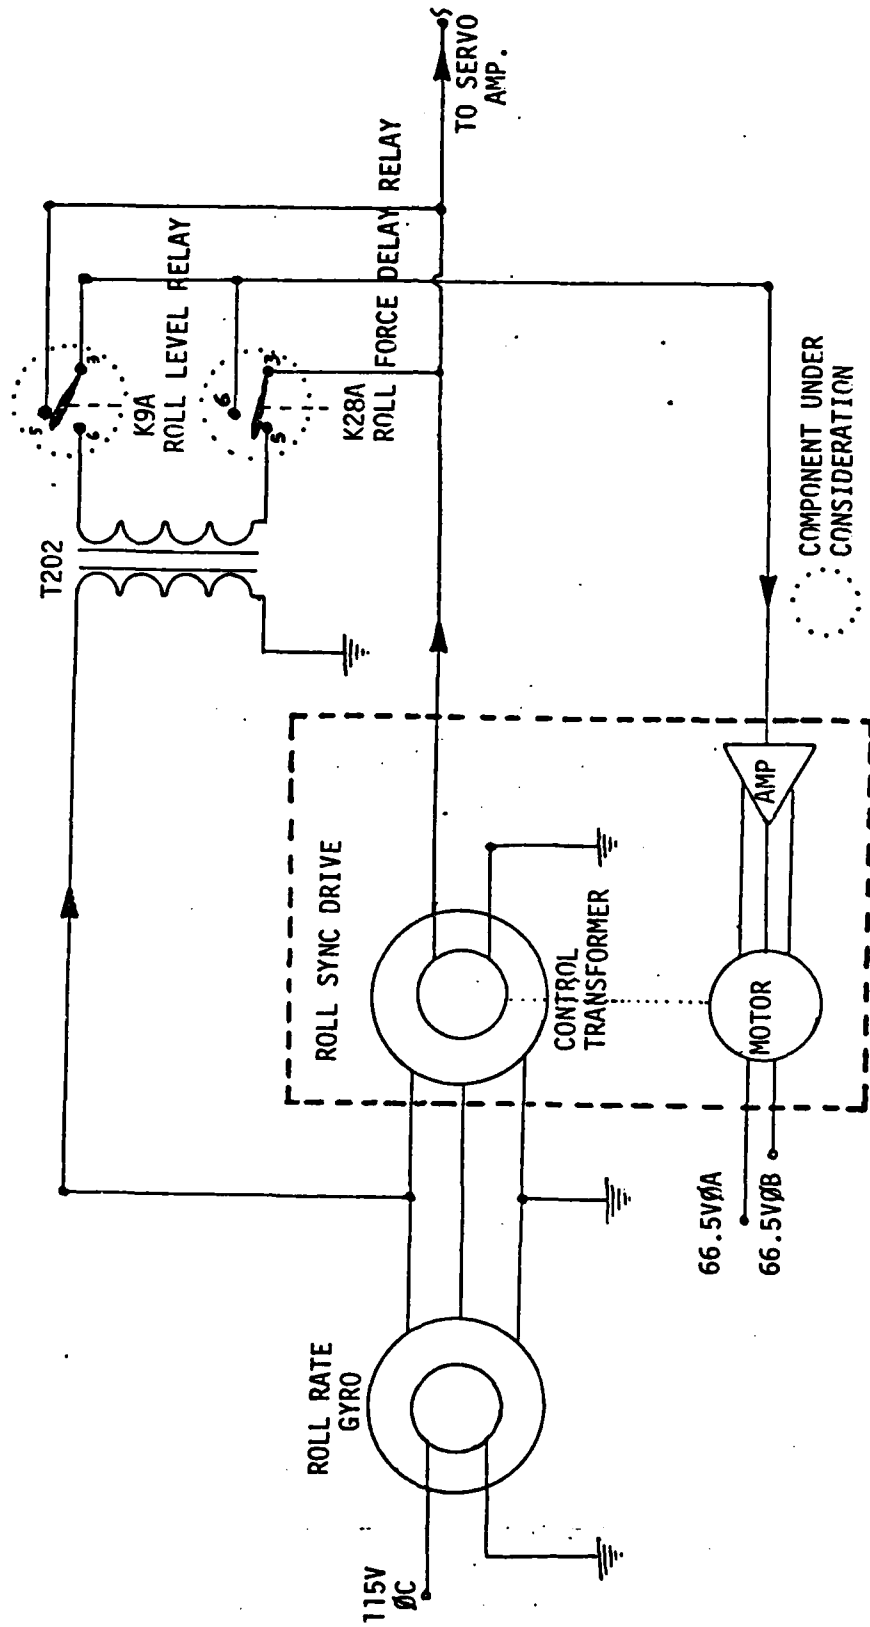
INVESTIGATION REPORT F-4C-3

If the 3-5 contact of K9A hangs open (the 3-6 contact then being closed), the Roll Sync Drive control transformer is by-passed at all times, even when the Course Sync Drive is not operating (see figure 2). With it disabled, a bank angle cannot be maintained by the autopilot, however, it can still hold the aircraft on a course heading.

If the 3-6 contact of K9A hangs open (the 3-5 contact then being closed), the Roll Sync Drive control transformer cannot be by-passed (see figure 2). This would mean that with heading hold established, the Roll Sync Drive will still try to maintain its reference attitude. If the Course Sync Drive needs to adjust the ailerons to maintain the course heading, the Roll Sync Drive will oppose it, trying to maintain its reference attitude.

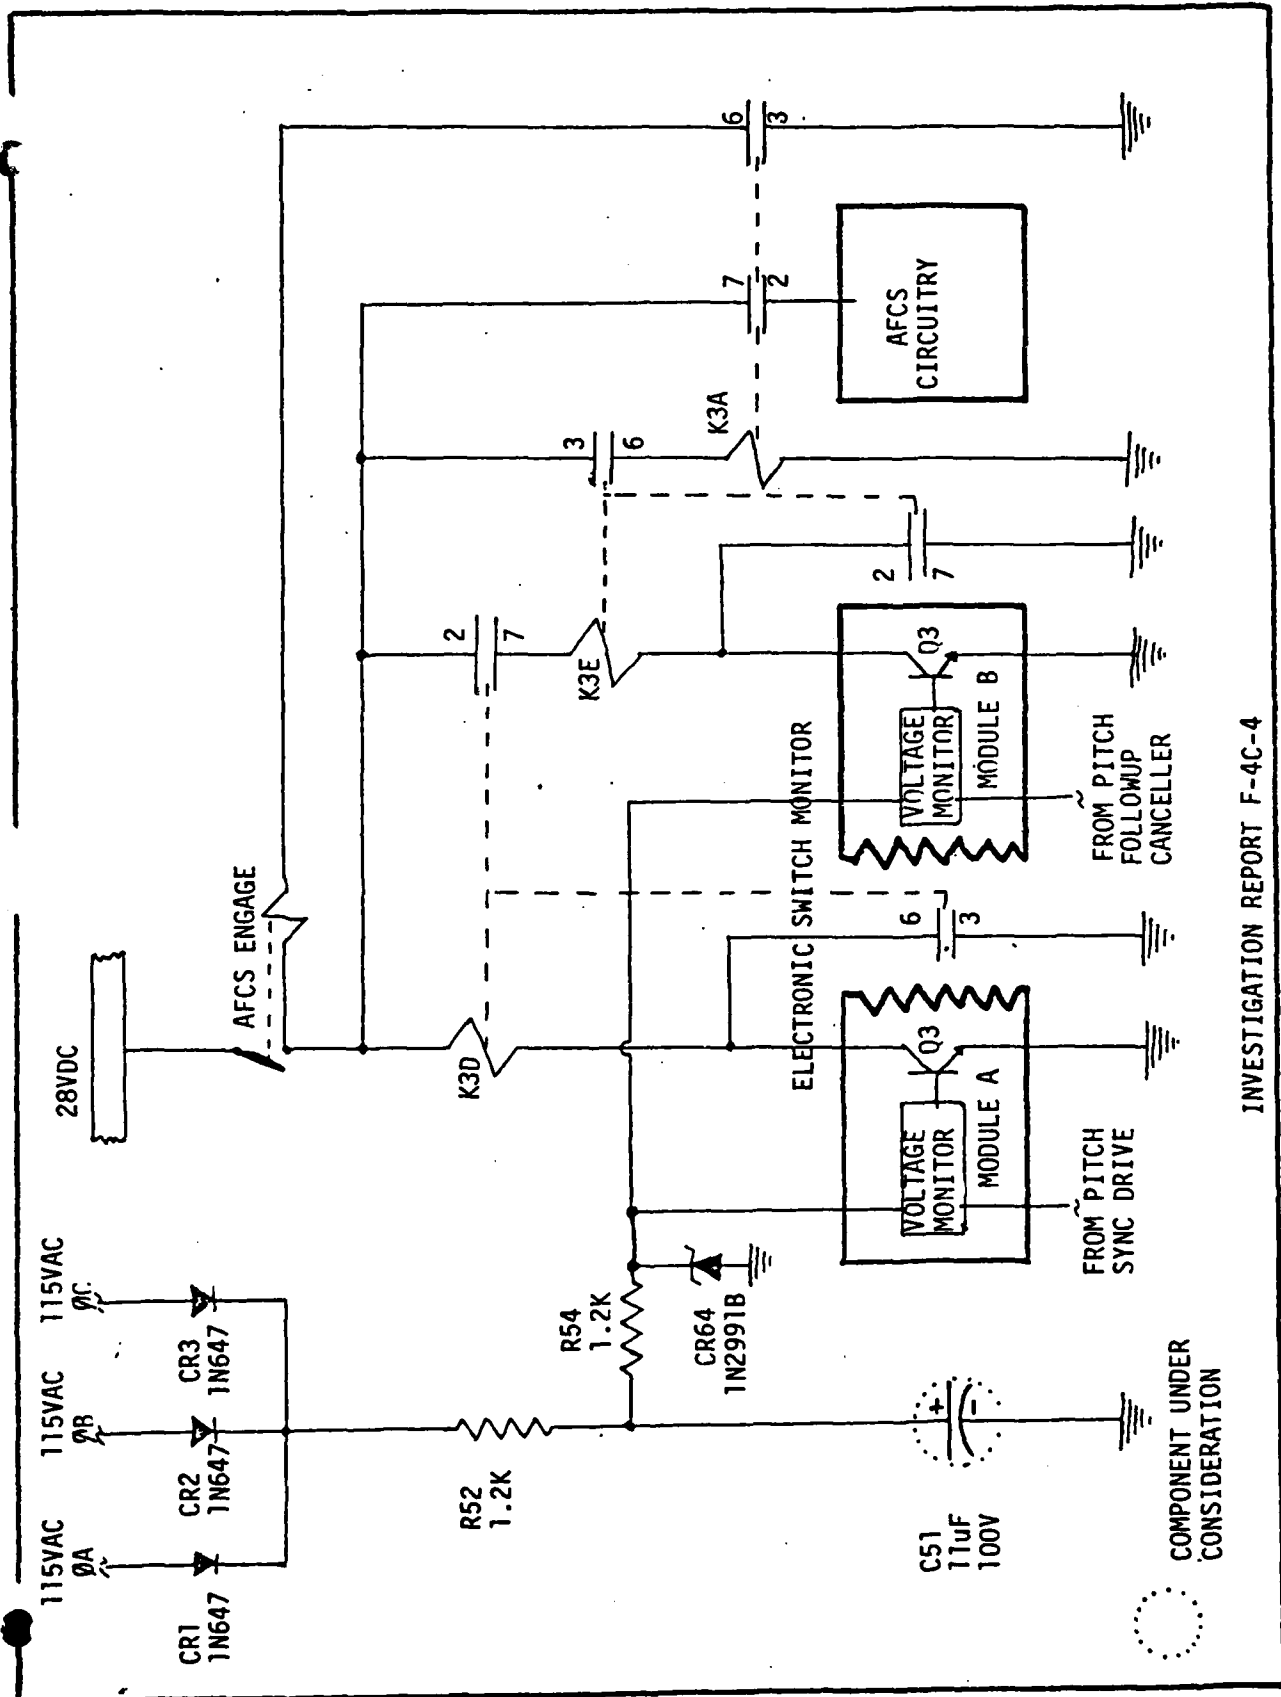
INVESTIGATION REPORT F-4C-4

Capacitor C51 is located in the B+ power supply circuitry of the Control Amplifier. If it fails shorted, the power supply for the Electronic Switch Monitor is shorted. The Electronic Switch Monitor is used to prevent AFCS engagement when a malfunction exists in the Pitch Sync Drive or Pitch Followup Canceller. With power to the Electronic Switch Monitor cut off, relays K3D and K3E lose their paths to ground, preventing AFCS engagement even when no malfunction exists in the pitch channel.

If C51 shorts while the AFCS is engaged, voltage to K20A is lost and it deenergizes, causing the Pitch Sync Brake to disengage and causing the Altitude Engage Clutch to engage. This has the effect of engaging altitude hold. The altitude of the aircraft at that time becomes the reference altitude for the altitude hold circuitry. This cannot be changed without disengaging the AFCS. Once disengaged, the AFCS cannot be reengaged.

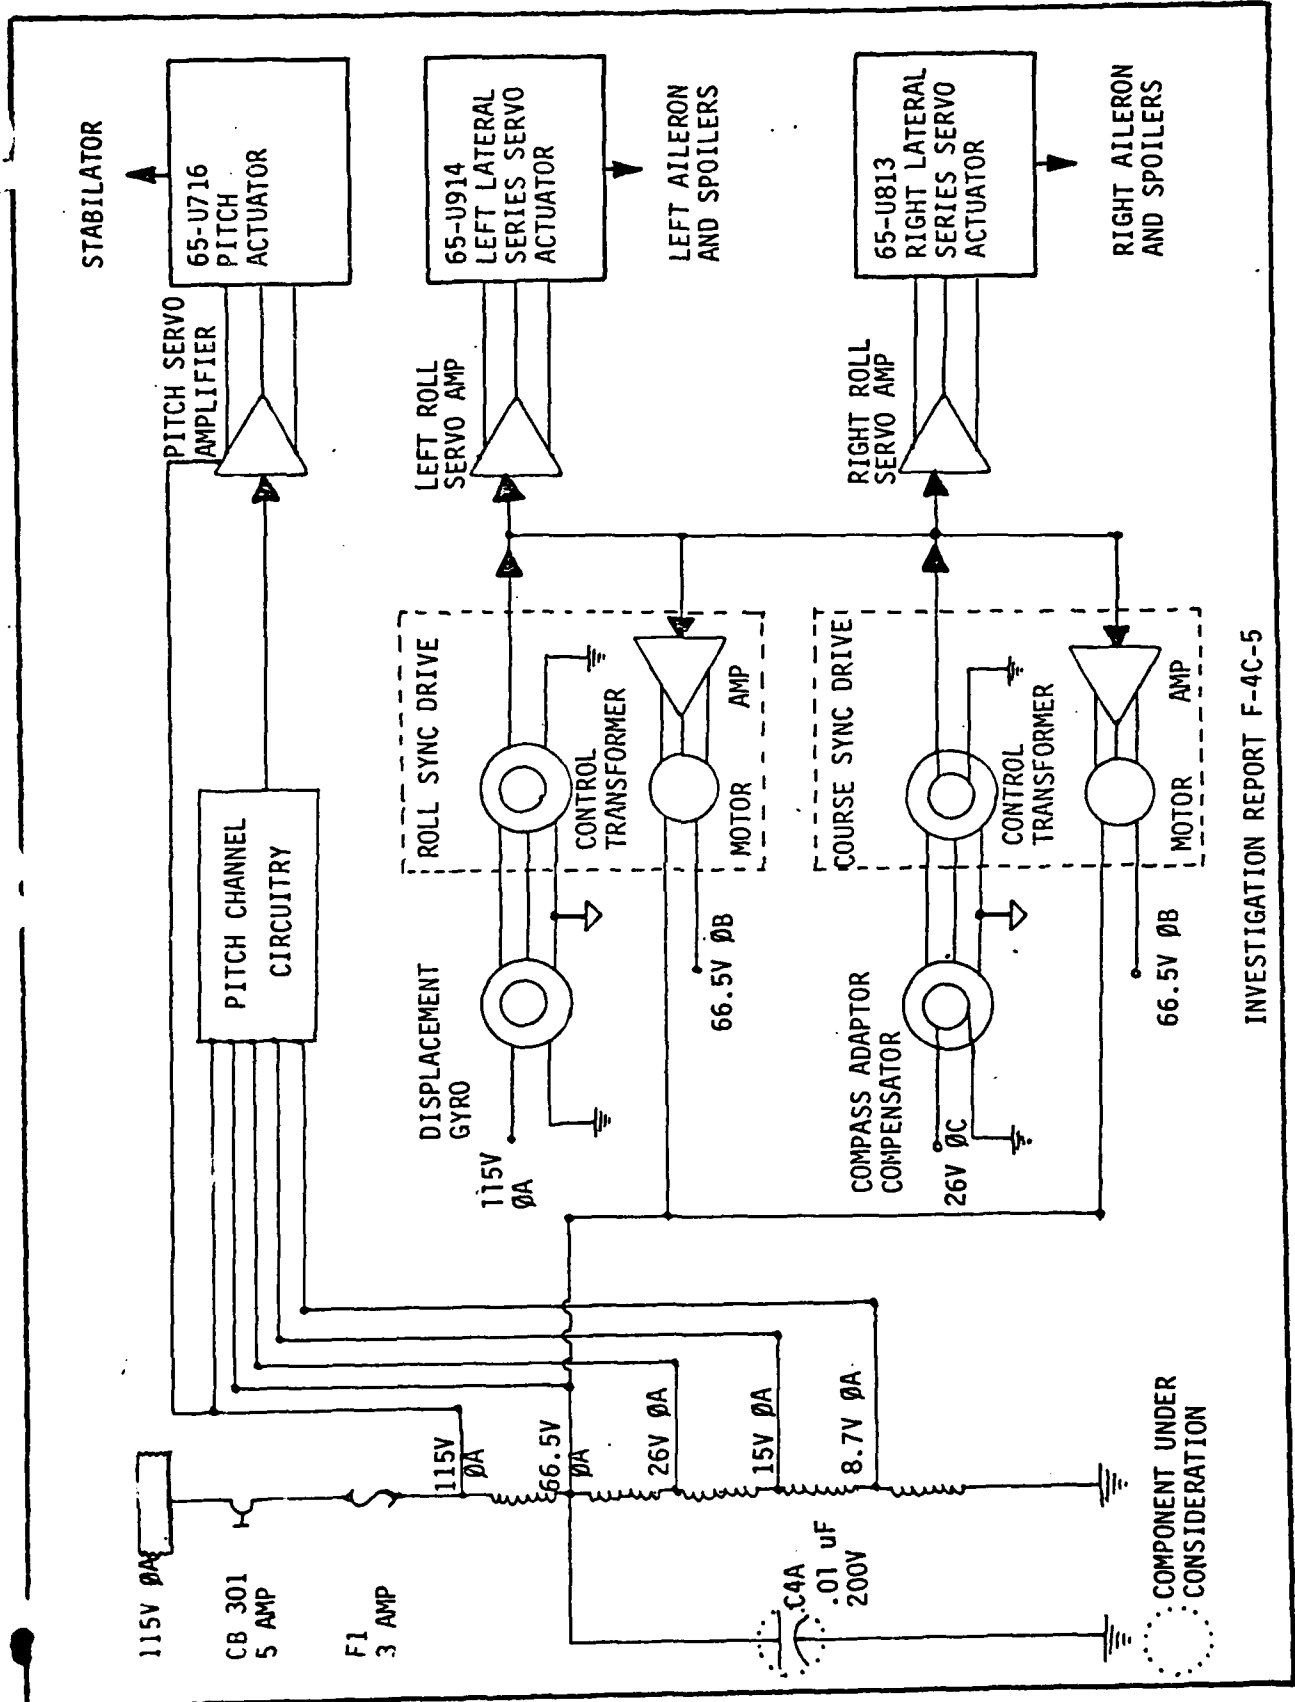
INVESTIGATION REPORT F-4C-5

Phase A also provides power for the fixed phase windings of the Roll Sync Drive Motor. The roll and course attitudes at the time of failure become the only attitudes that the AFCS can maintain. If a course or attitude change is required, AFCS must be disengaged.

Therefore, when C4A shorts, the pitch and roll channels of the AFCS are lost and the stabilator, ailerons, and spoilers must be manually controlled.

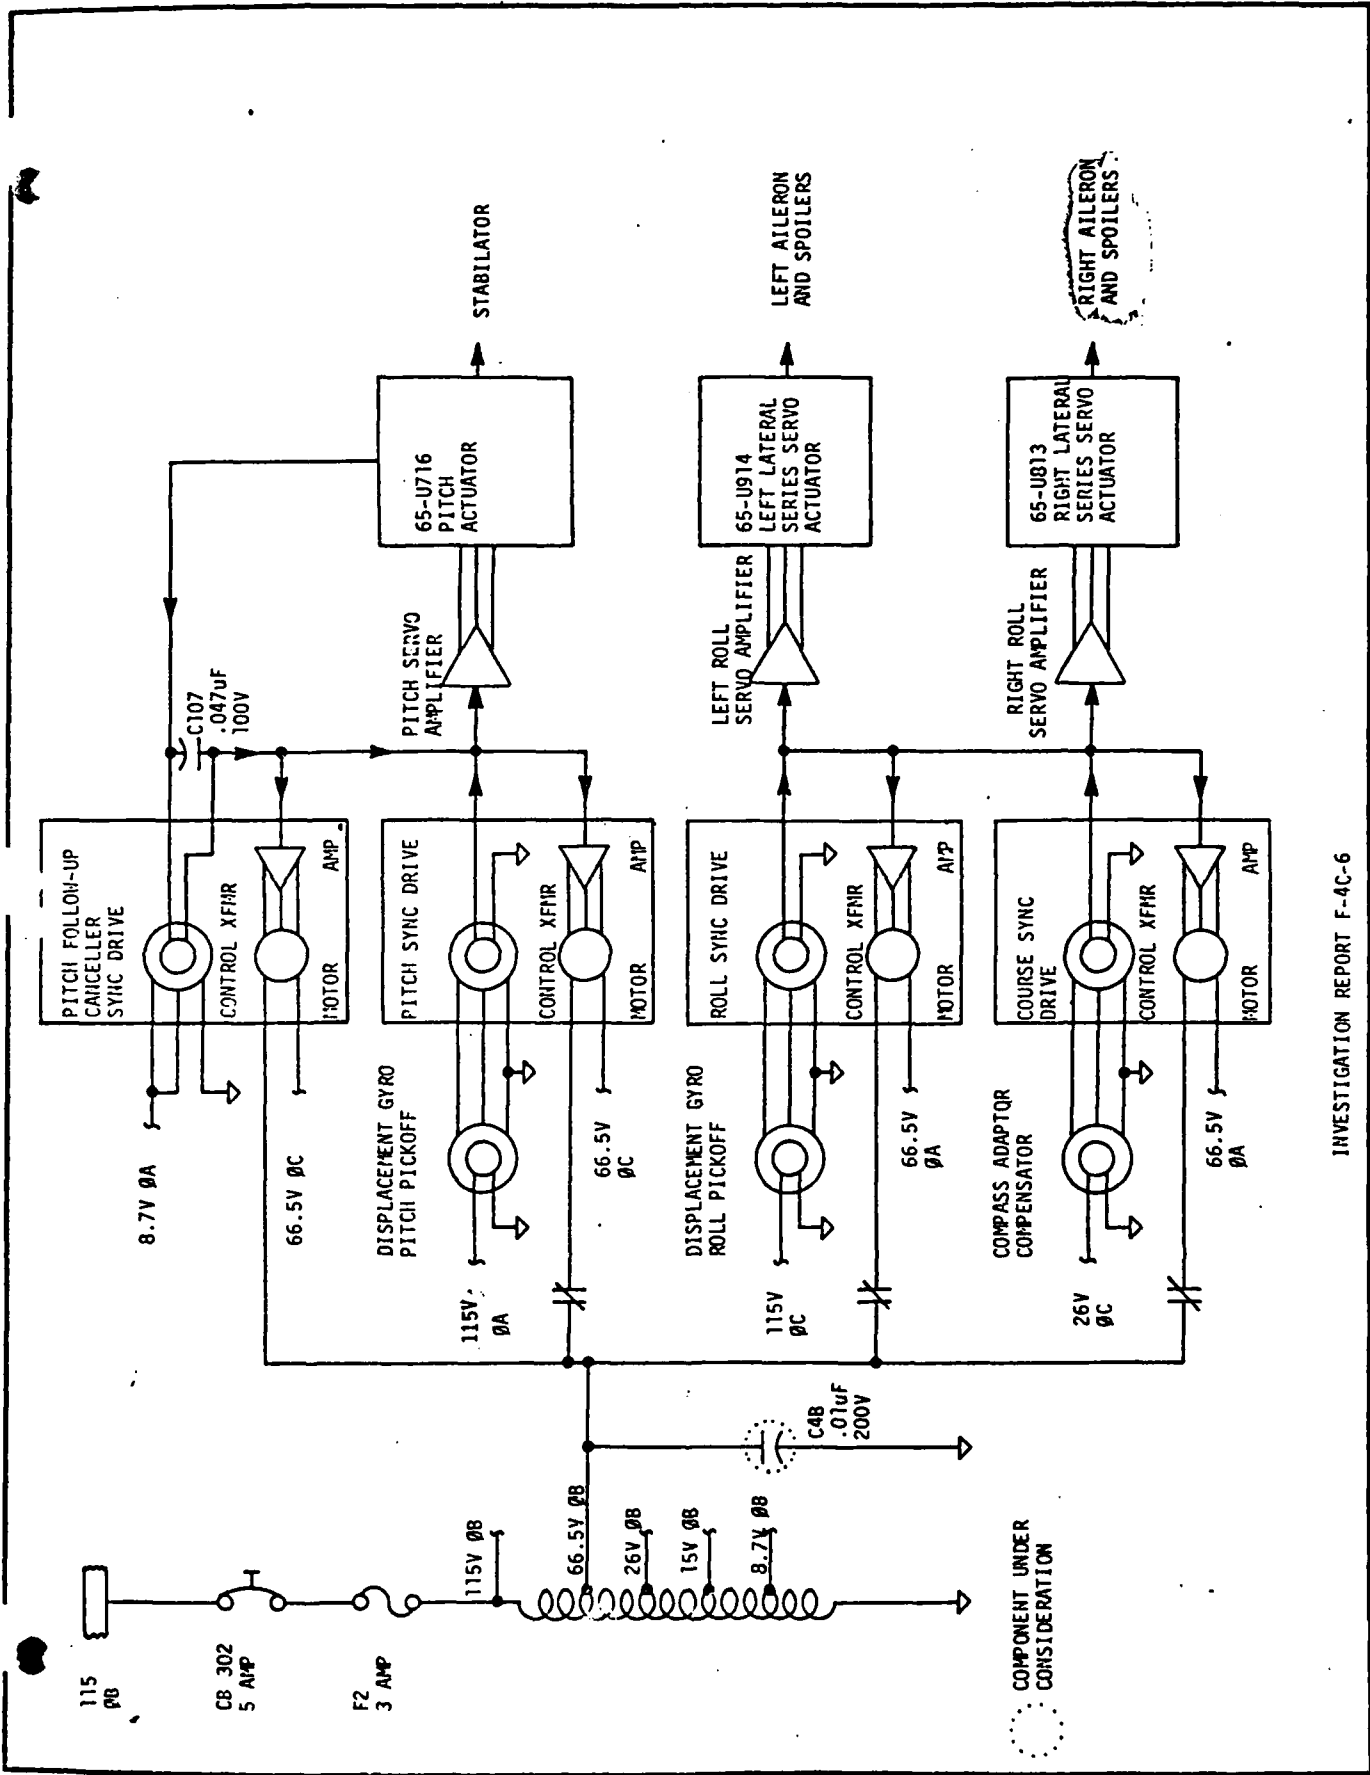
INVESTIGATION REPORT F-4C-6

Phase B provides power to the fixed phase windings of the Pitch Sync Drive Motor, Pitch Follow-up Canceller Sync Drive Motor, Roll Sync Drive Motor, and the Course Sync Drive Motor. The last pitch, roll, and course attitudes established for the aircraft before the failure cannot be changed unless the AFCS is disengaged.

Therefore, when C4B shorts, the pitch and roll channels of the AFCS are lost and the stabilator, ailerons, and spoilers must be manually controlled.

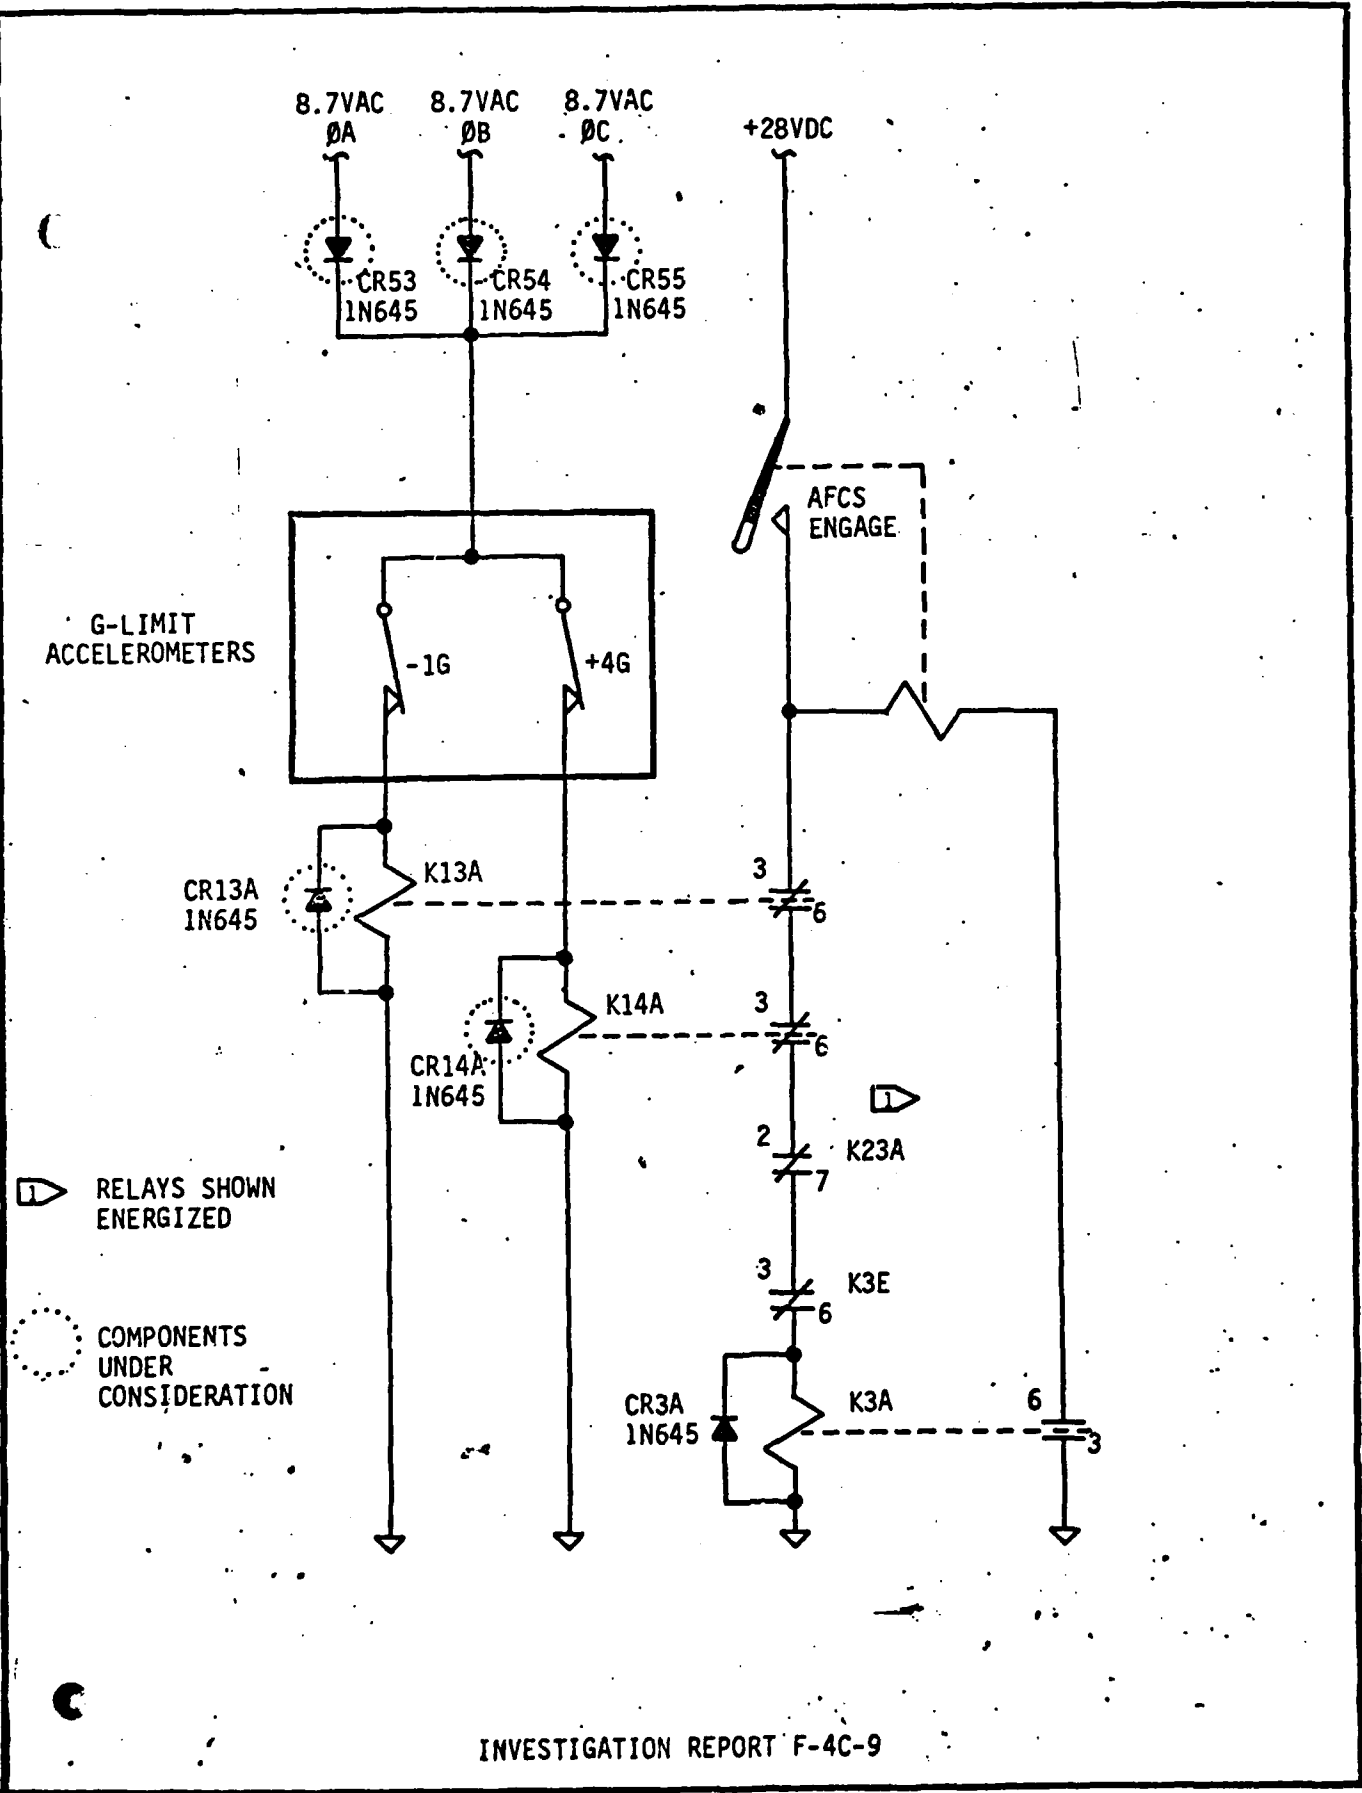
INVESTIGATION REPORT F-4C-9

If any of the diodes CR53, CR54, or CR55 in the chassis wiring fail in the shorted mode (then open) damage to diodes CR13A and CR14A will occur. Loss of CR53, CR54, or CR55 results in insufficient voltage being applied to relays K13A and K14A thus causing them to deenergize. When this occurs AFCS will be disengaged.

This failure mode applies to Control Amplifier, P/N 230E420G3, and earlier. This failure is discussed in greater detail in Design Concern Report F-4C-13.

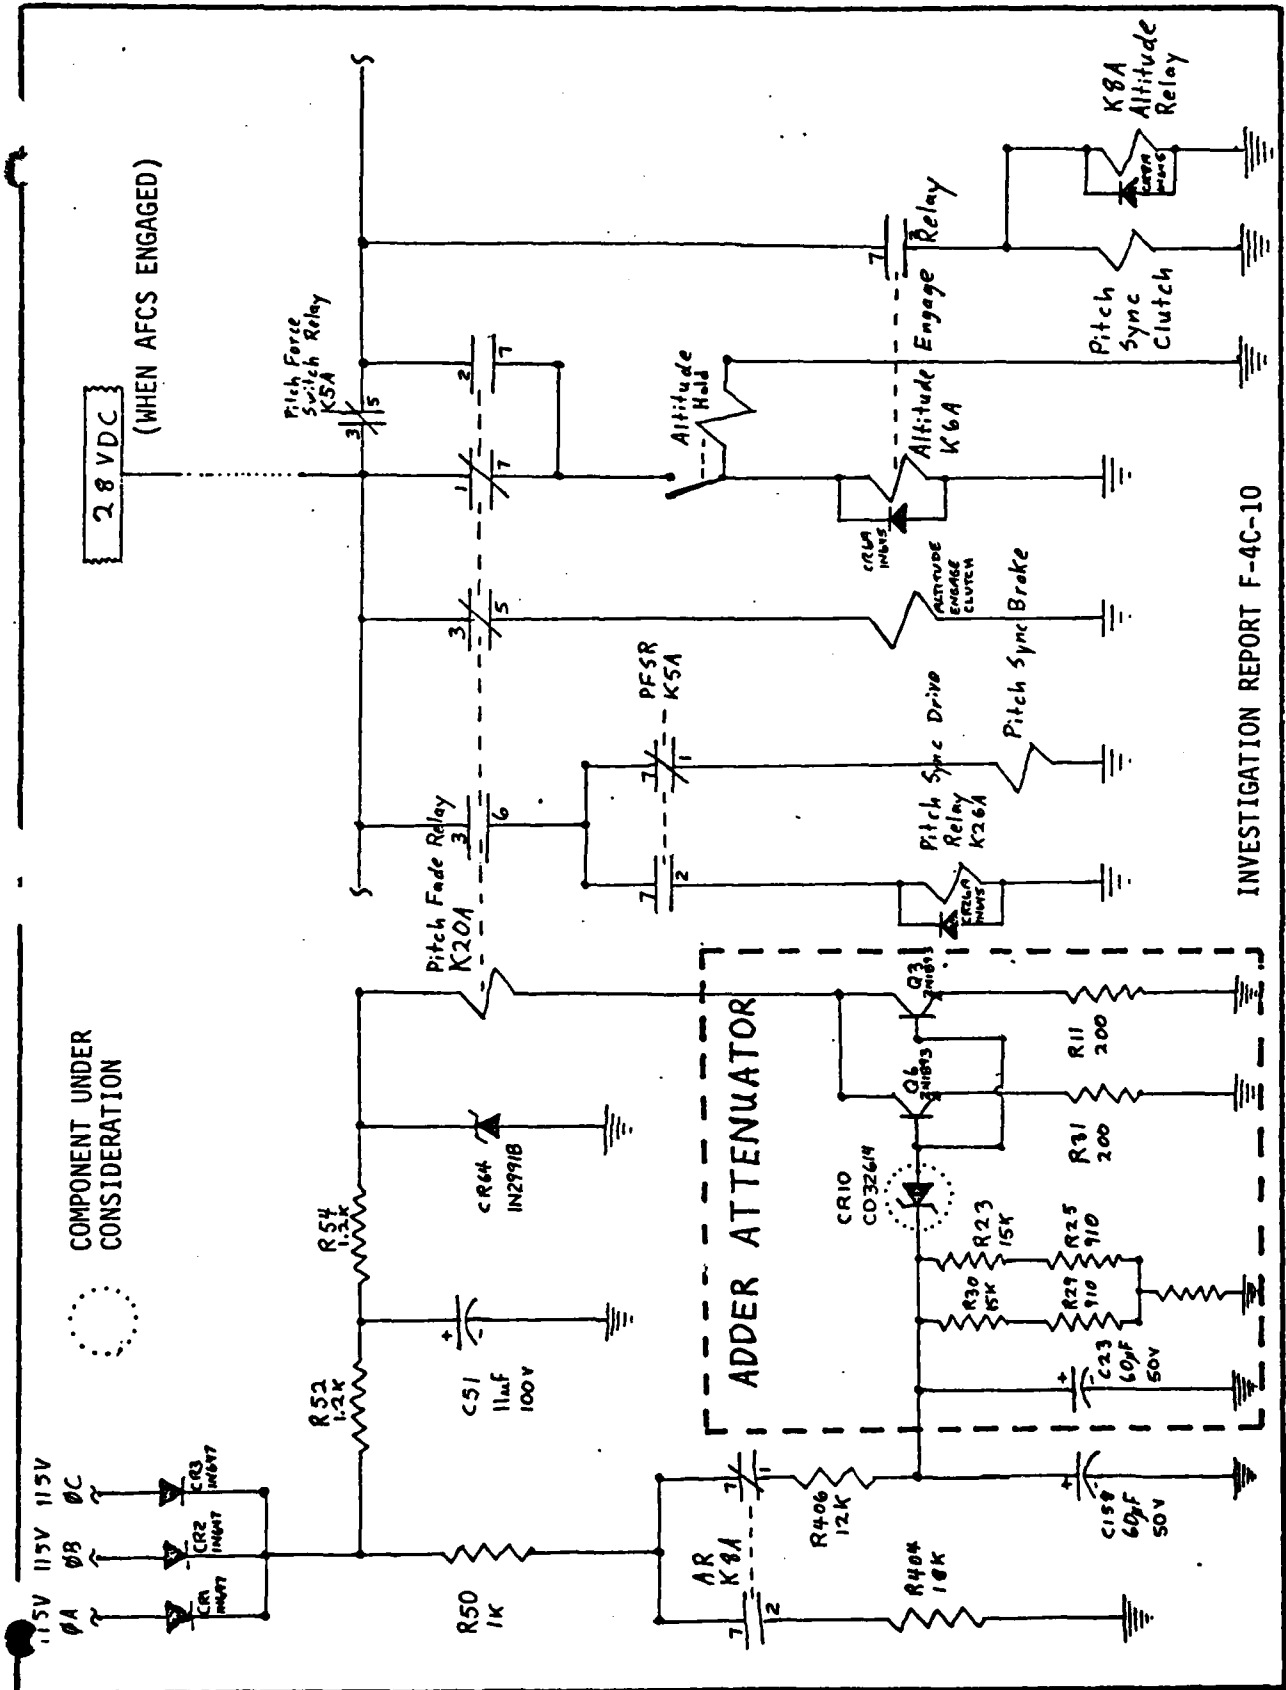
INVESTIGATION REPORT F-4C-10

If CR10 fails shorted, the error signal from the Altitude Hold Synchro will be switched into the pitch channel of the AFCS rather than faded in. This occurs because transistors Q3 and Q6 will not be turned off, thus deenergizing K20A and energizing the Altitude Engage Clutch, until the capacitors have discharged to approximately 1 volt. By this time the gain of the Adder Attenuator will be at maximum. When the Altitude Engage Clutch is energized the error signal from the altitude hold synchro in the CADC will be fully amplified, rather than faded in, by the Adder Attenuator and Pitch Servo Amplifier. Aircraft motion resulting from this failure may be sudden pitch deviations depending on the error signal from the Altitude Hold Synchro.

If CR10 fails open, relay K20A cannot be energized. As a result a pitch attitude in the AFCS mode cannot be established since the Pitch Sync Drive is always nulled to the Vertical Gyro error signal. If the AFCS is engaged, altitude hold can be engaged and the altitude at which it was engaged will be held.

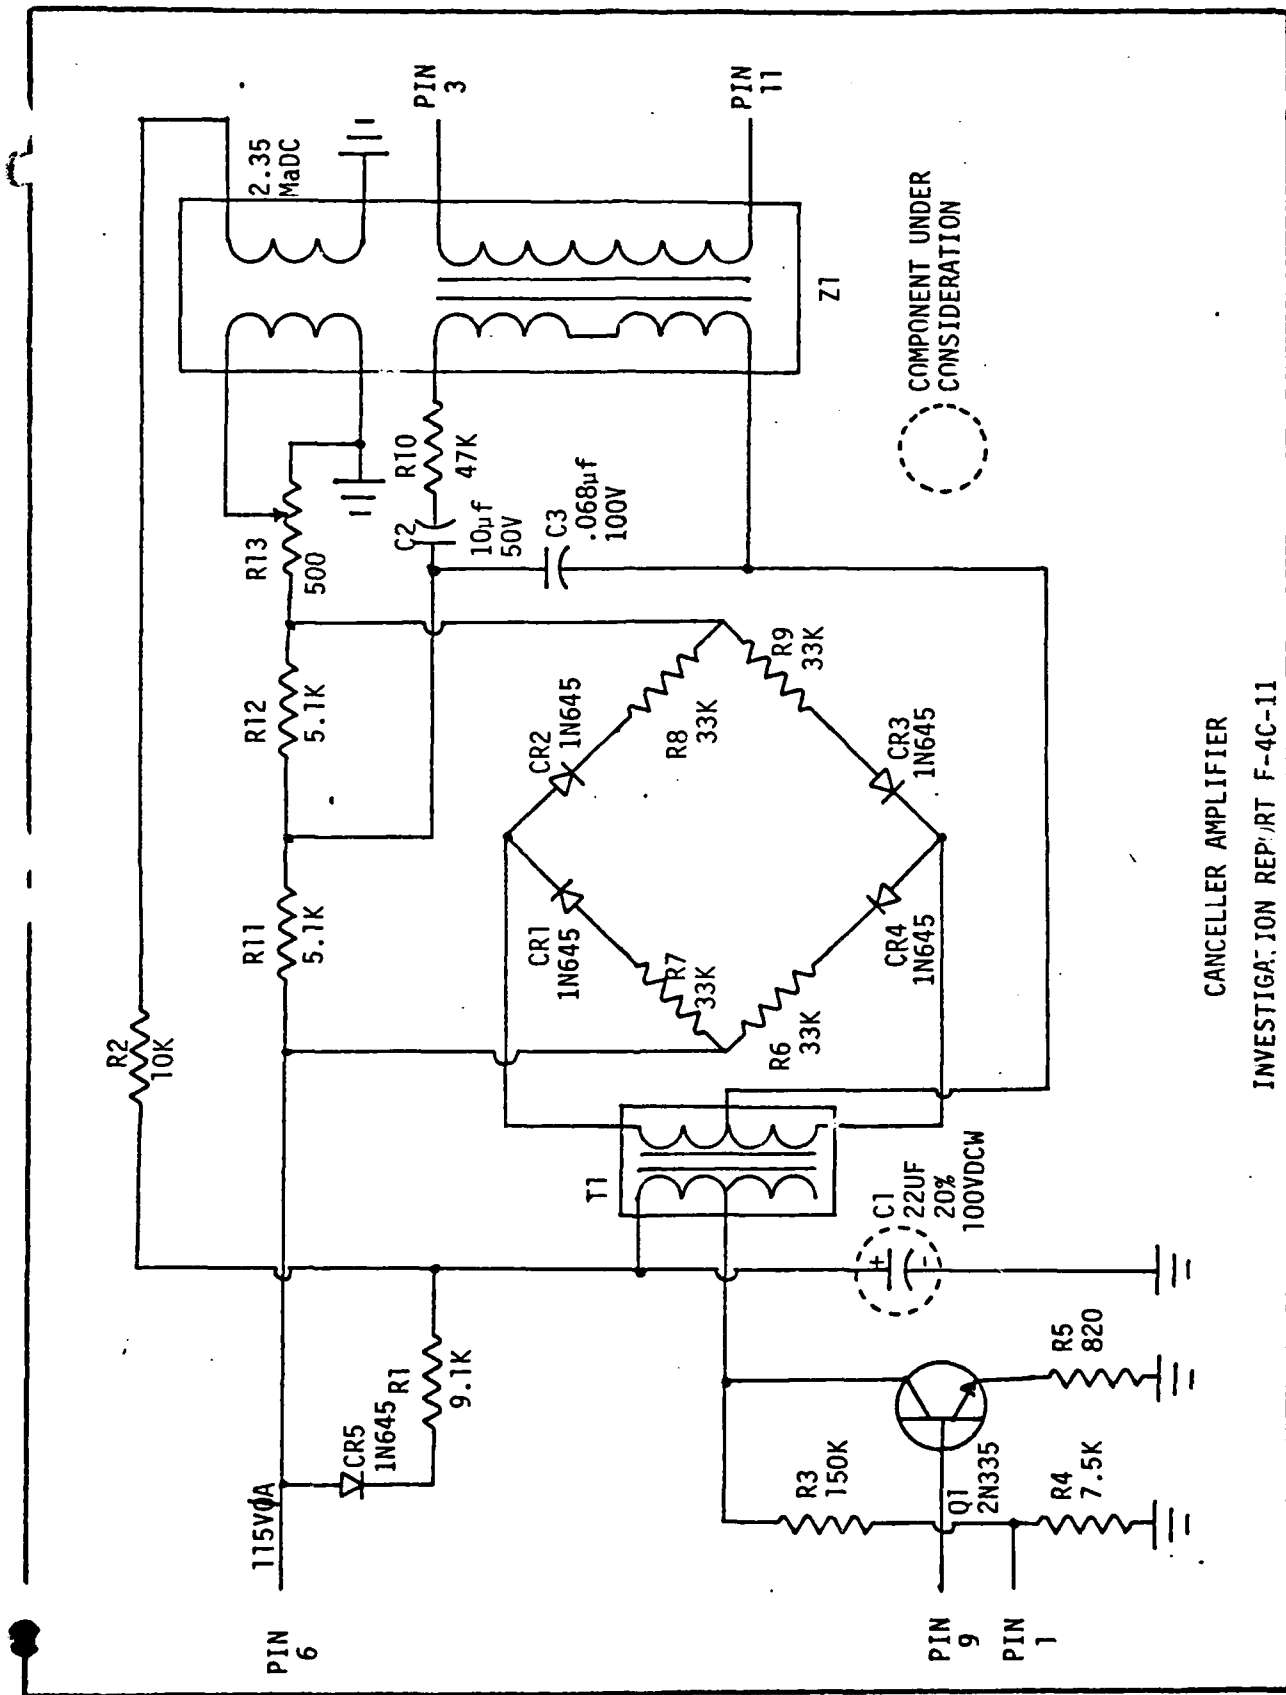
INVESTIGATION REPORT F-4C-11

The canceller amplifier is a high pass filter. Pilot maneuvering produces steady state rate gyro outputs that are cancelled by the canceller amplifier rather than passed on to the servo amplifier. Therefore, the rate gyro will not oppose pilot control of attitude. Aircraft vibration oscillations produce high frequency signals that are amplified and passed on by the canceller amplifier.

If capacitor C1 fails shorted, the bias voltage for transistor Q1 is lost. This will inhibit all rate gyro signals from passing through the canceller amplifier. The effect this failure has on the aircraft is discussed in Investigation Report F-4C-12.

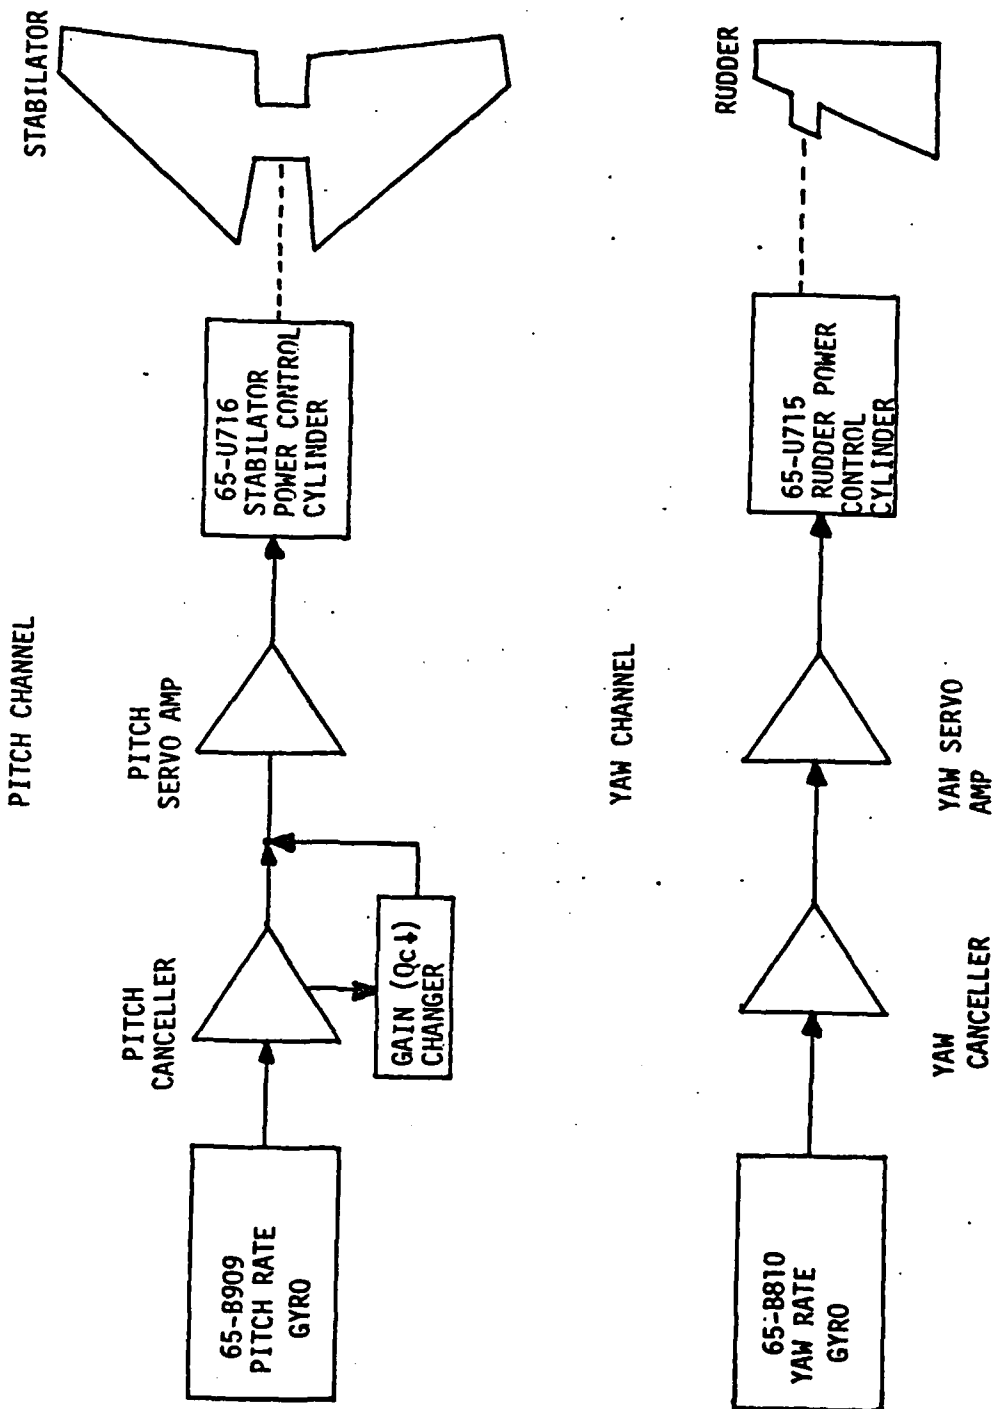
INVESTIGATION REPORT F-4C-12

The error signal from the Yaw Rate Gyro goes to the Yaw Cancellor. The signal from the Yaw Cancellor goes to the Yaw Servo Amplifier. The Yaw Servo Amplifier controls rudder movements.

With the Yaw Cancellor disabled as described in Investigation Report F-4C-11, the Yaw Rate Gyro Pickoff will have no affect on rudder movement, thereby not being able to compensate for aircraft yaw oscillations.

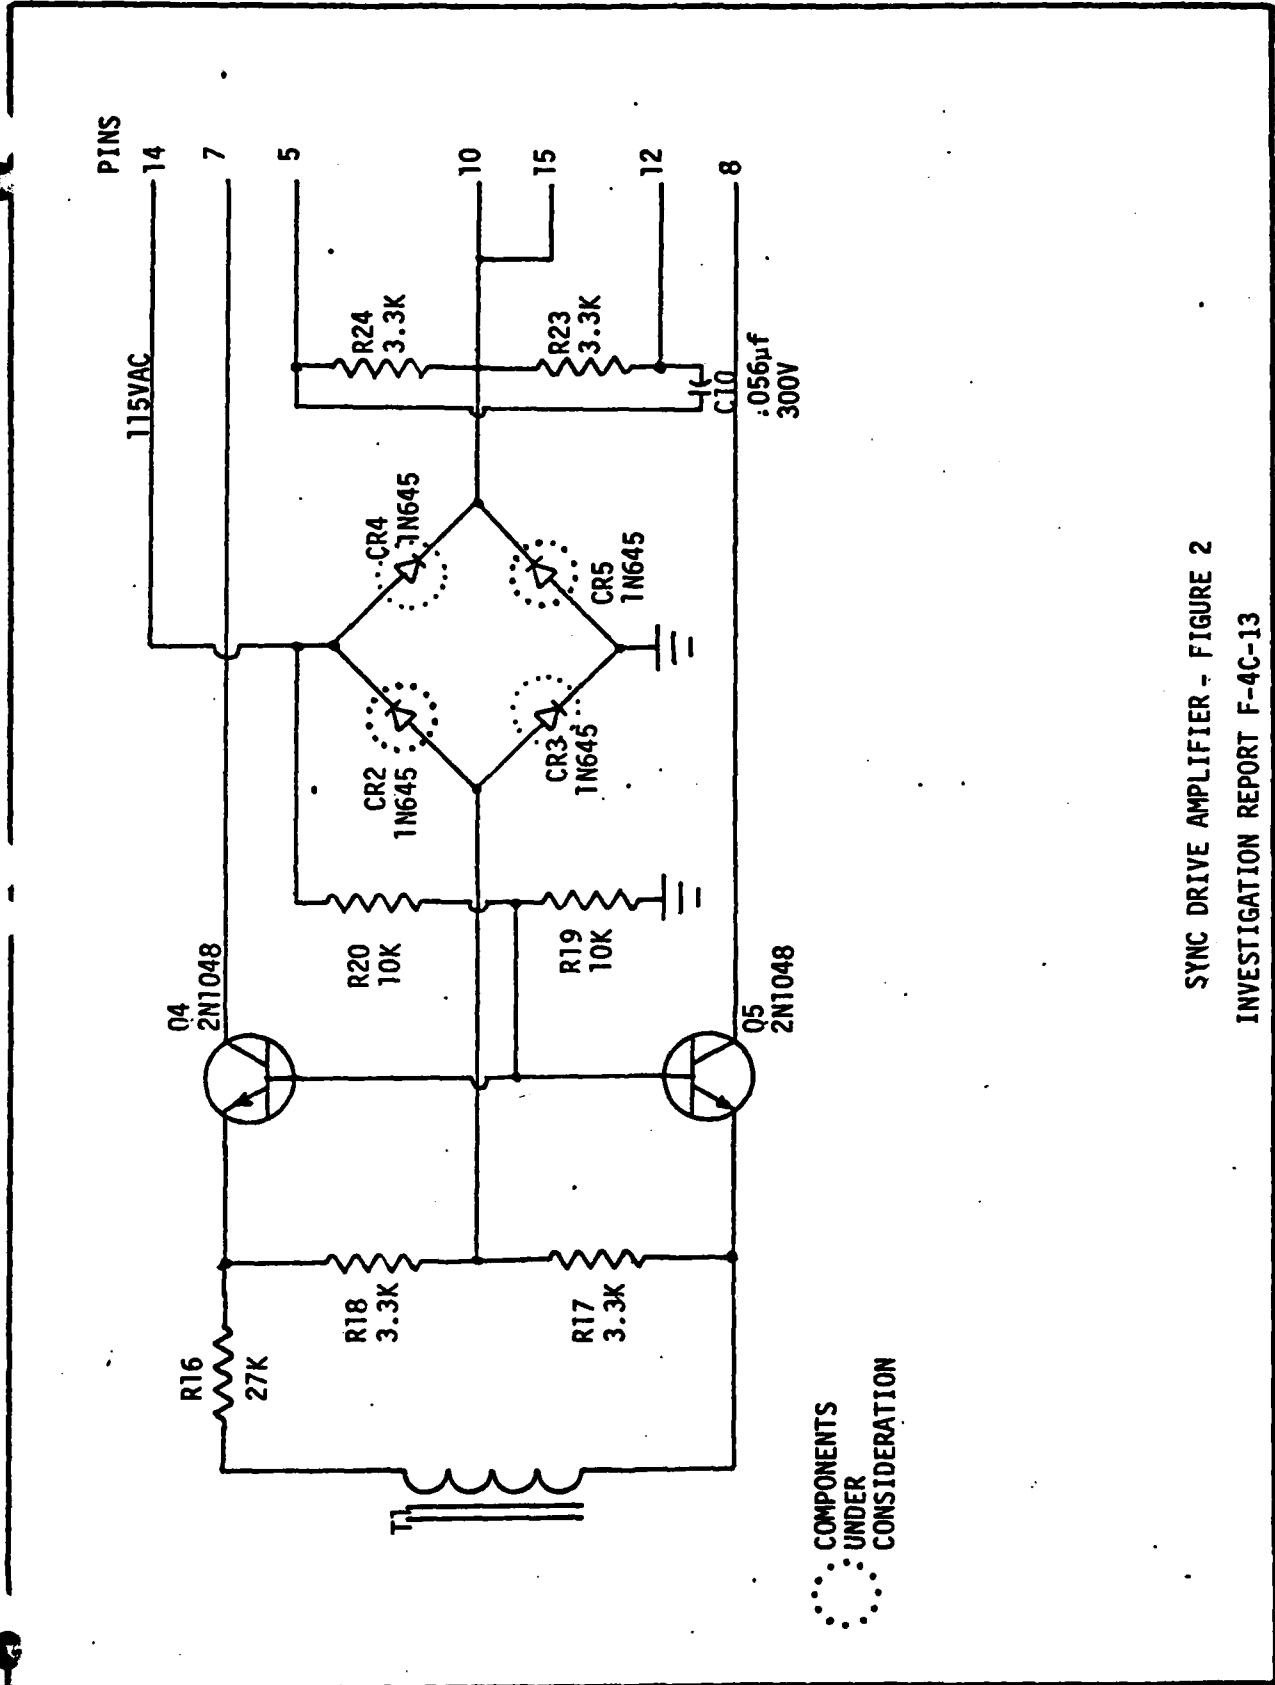
SYNC DRIVE AMPLIFIER - FIGURE 2  
INVESTIGATION REPORT F-4C-13

If the pair of diodes CR2-CR4, CR3-CR5, CR2-CR3, or CR4-CR5 or if more than two diodes fail there will be no output signal from the sync drive amplifier.
