# Sneak Circuit Analysis of F-4C Flight Control System

DOCUMENT NO. D2-118545-1

MODEL NO. F-4C CONTRACT NO. F33657-74-C-0686

SEPTEMBER 17, 1974

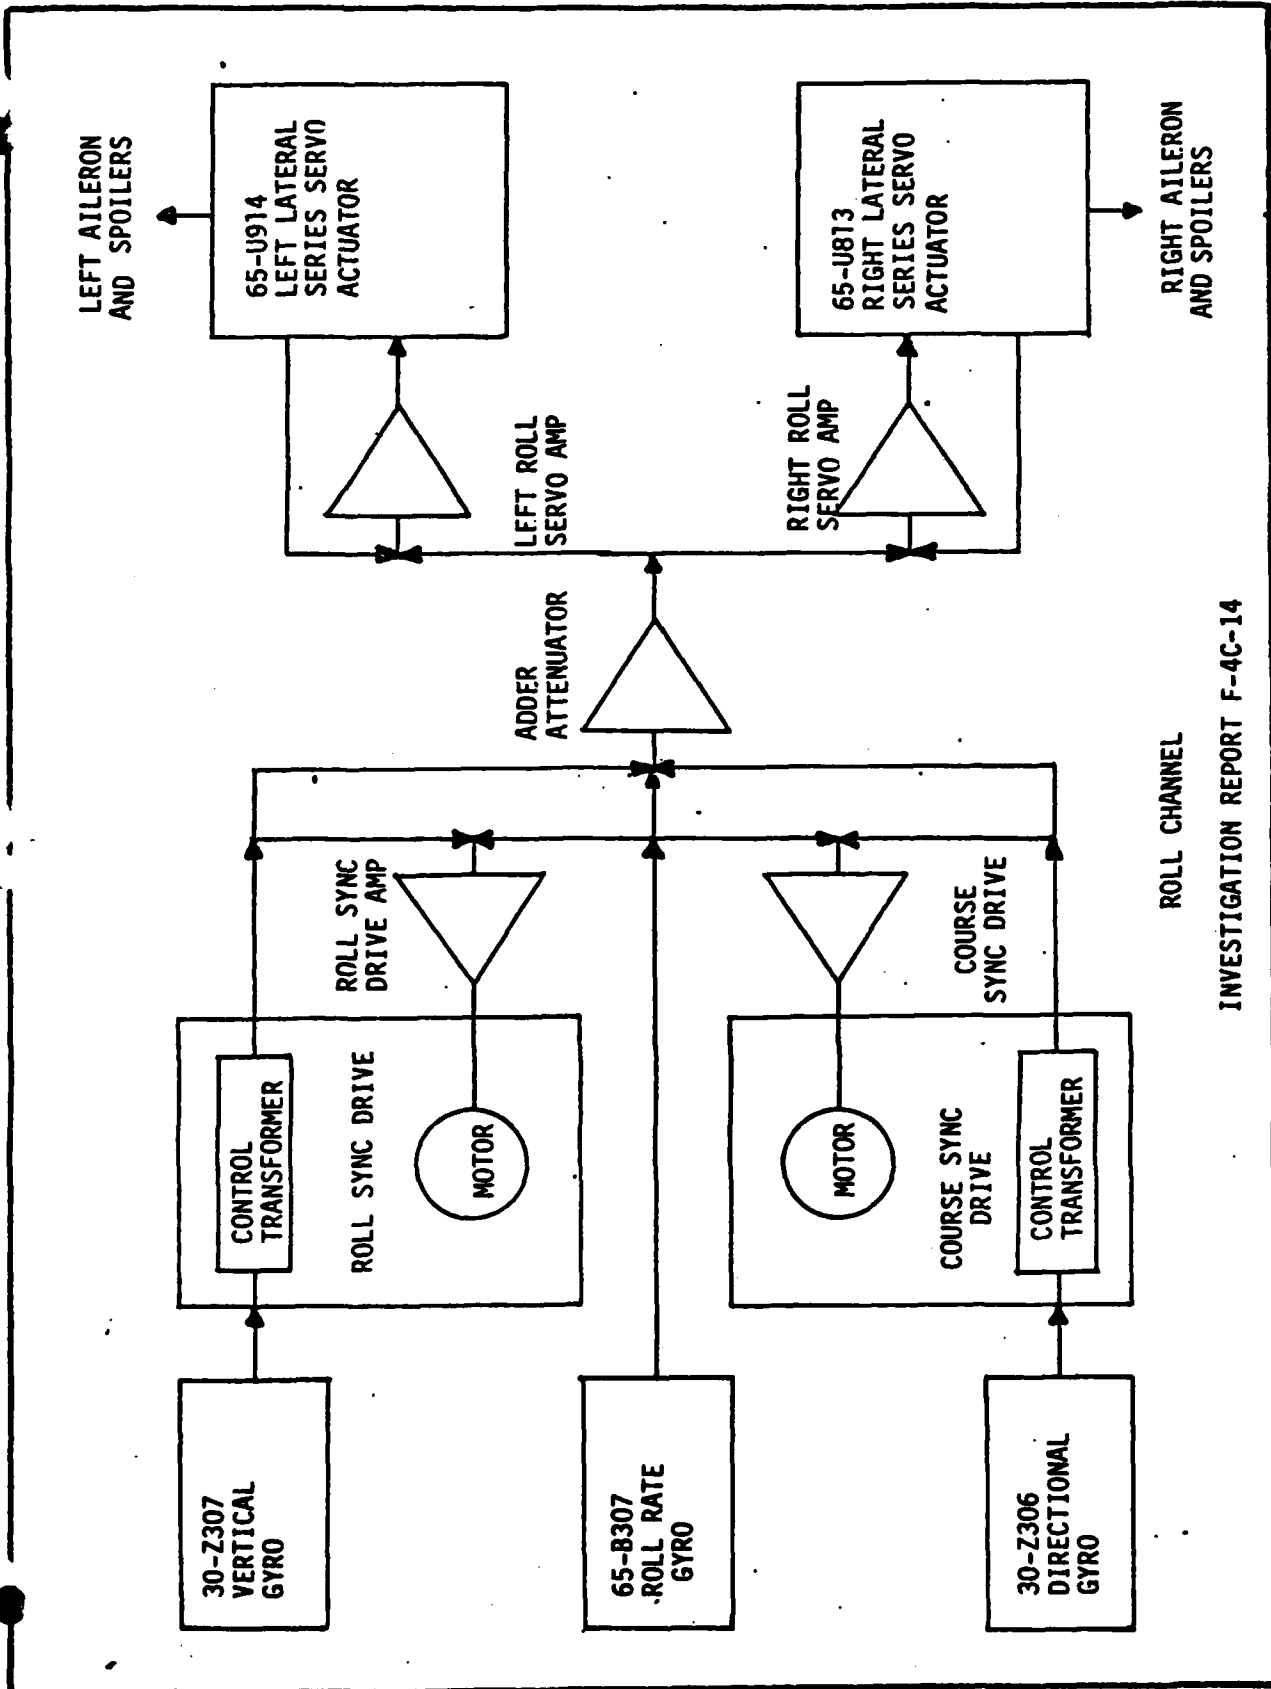
ROLL CHANNEL  
INVESTIGATION REPORT F-4C-14

The signal from the control transformer goes to the Adder Attenuator. The output of the Adder Attenuator goes to the Left Roll Servo Amplifier and to the Right Roll Servo Amplifier. The output of the servo amplifiers go to their respective servos, the Left Lateral Series Servo (Ref. Des. 65-U914) and the Right Lateral Series Servo (Ref. Des. 65-U813). The servos control their respective ailerons and spoilers.

The attitude for which the Roll Sync Drive is set when the Roll Sync Drive amplifier is disabled, will be the only attitude the channel will hold. The attitude cannot be changed. If the AFCS is engaged with the Roll Sync Drive Amplifier disabled, the aircraft will attempt to assume the last roll attitude held by the roll channel before amplifier failure.

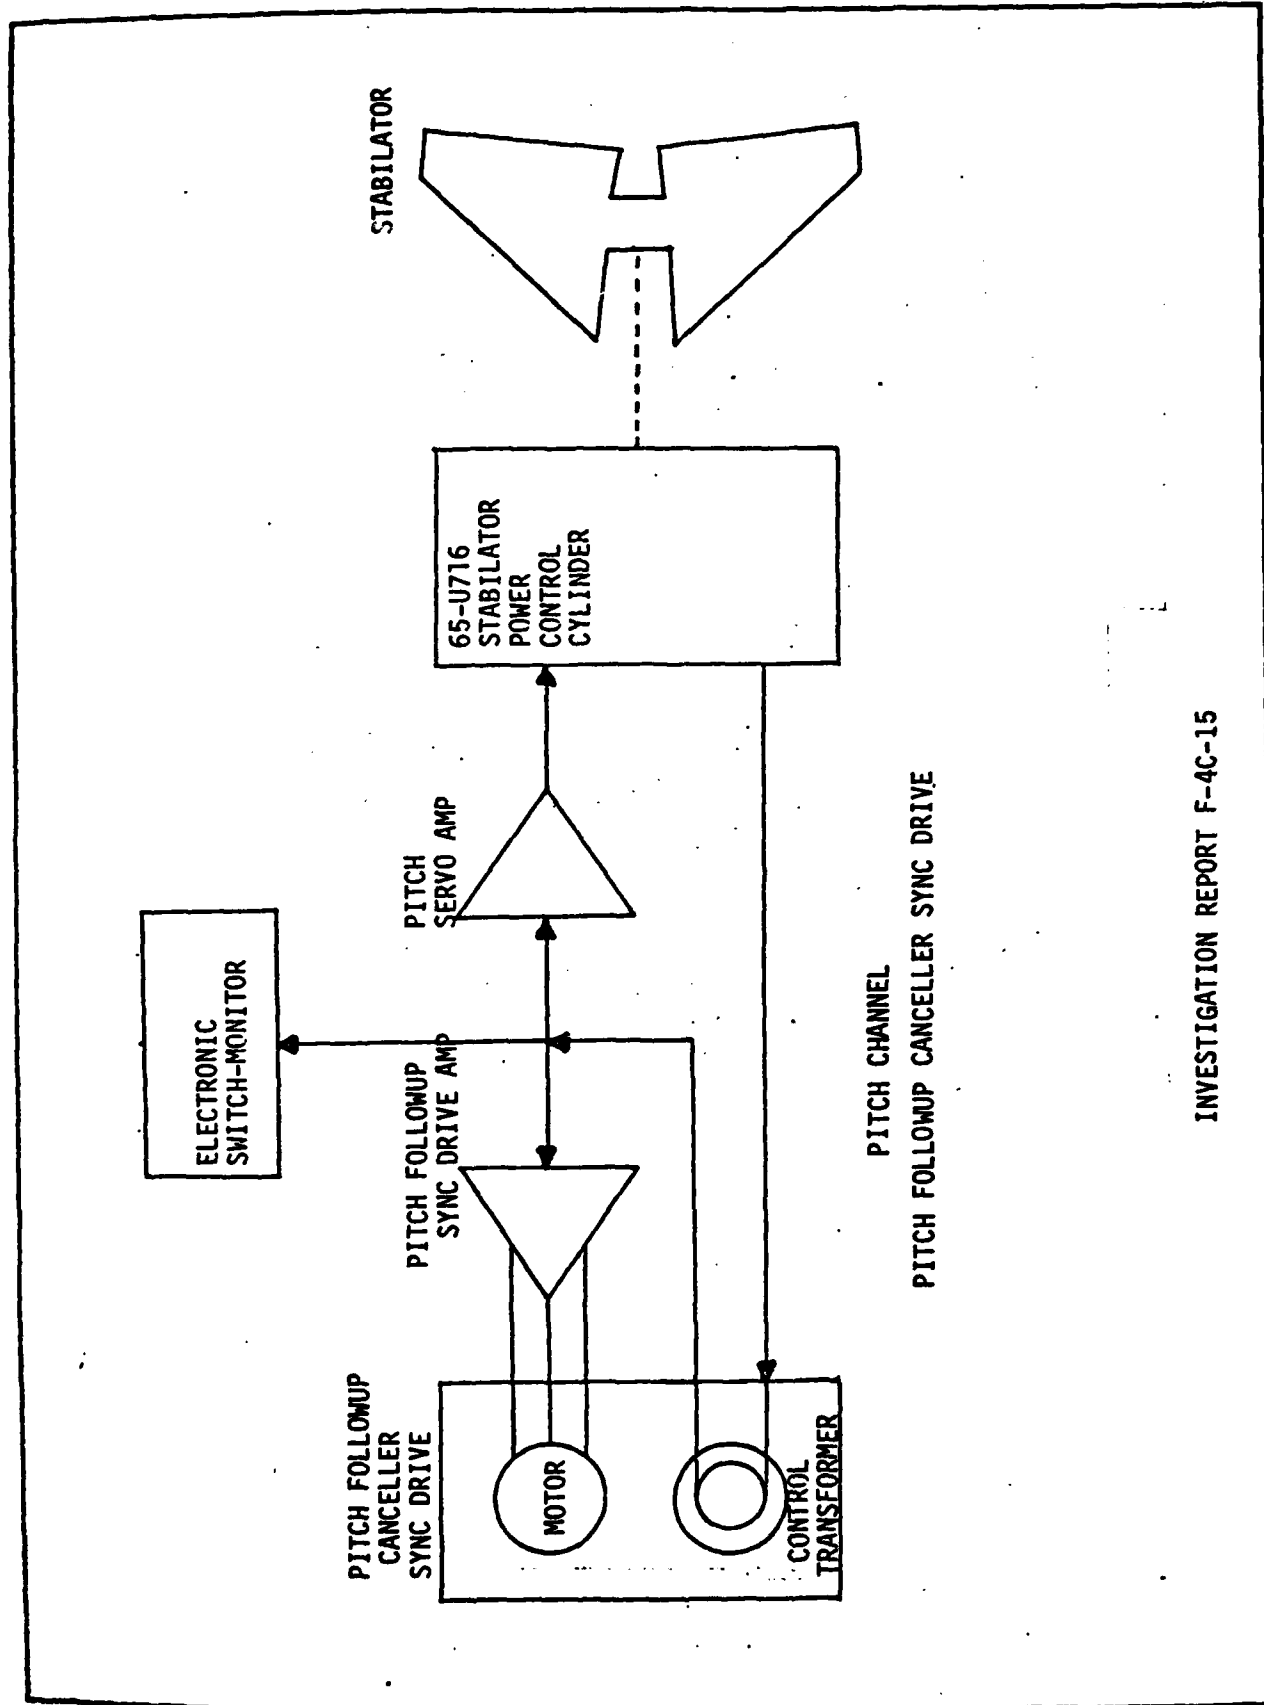
INVESTIGATION REPORT F-4C-15

If the Sync Drive Amplifier is disabled before AFCS engagement, the uncorrectable error voltage from the Pitch Follow-up Cancellor control transformer or main ram follow-up will be detected by the Electronic Switch-Monitor thus preventing AFCS engagement. For the special case where the stabilator is positioned such that it cancels the error voltage from the control transformer, the AFCS can be engaged but the pitch attitude will not be maintained.

In either case of the Sync Drive Amplifier being disabled, before or after AFCS engagement, the pilot will have to manually adjust pitch to compensate for changes in the aircraft configuration.

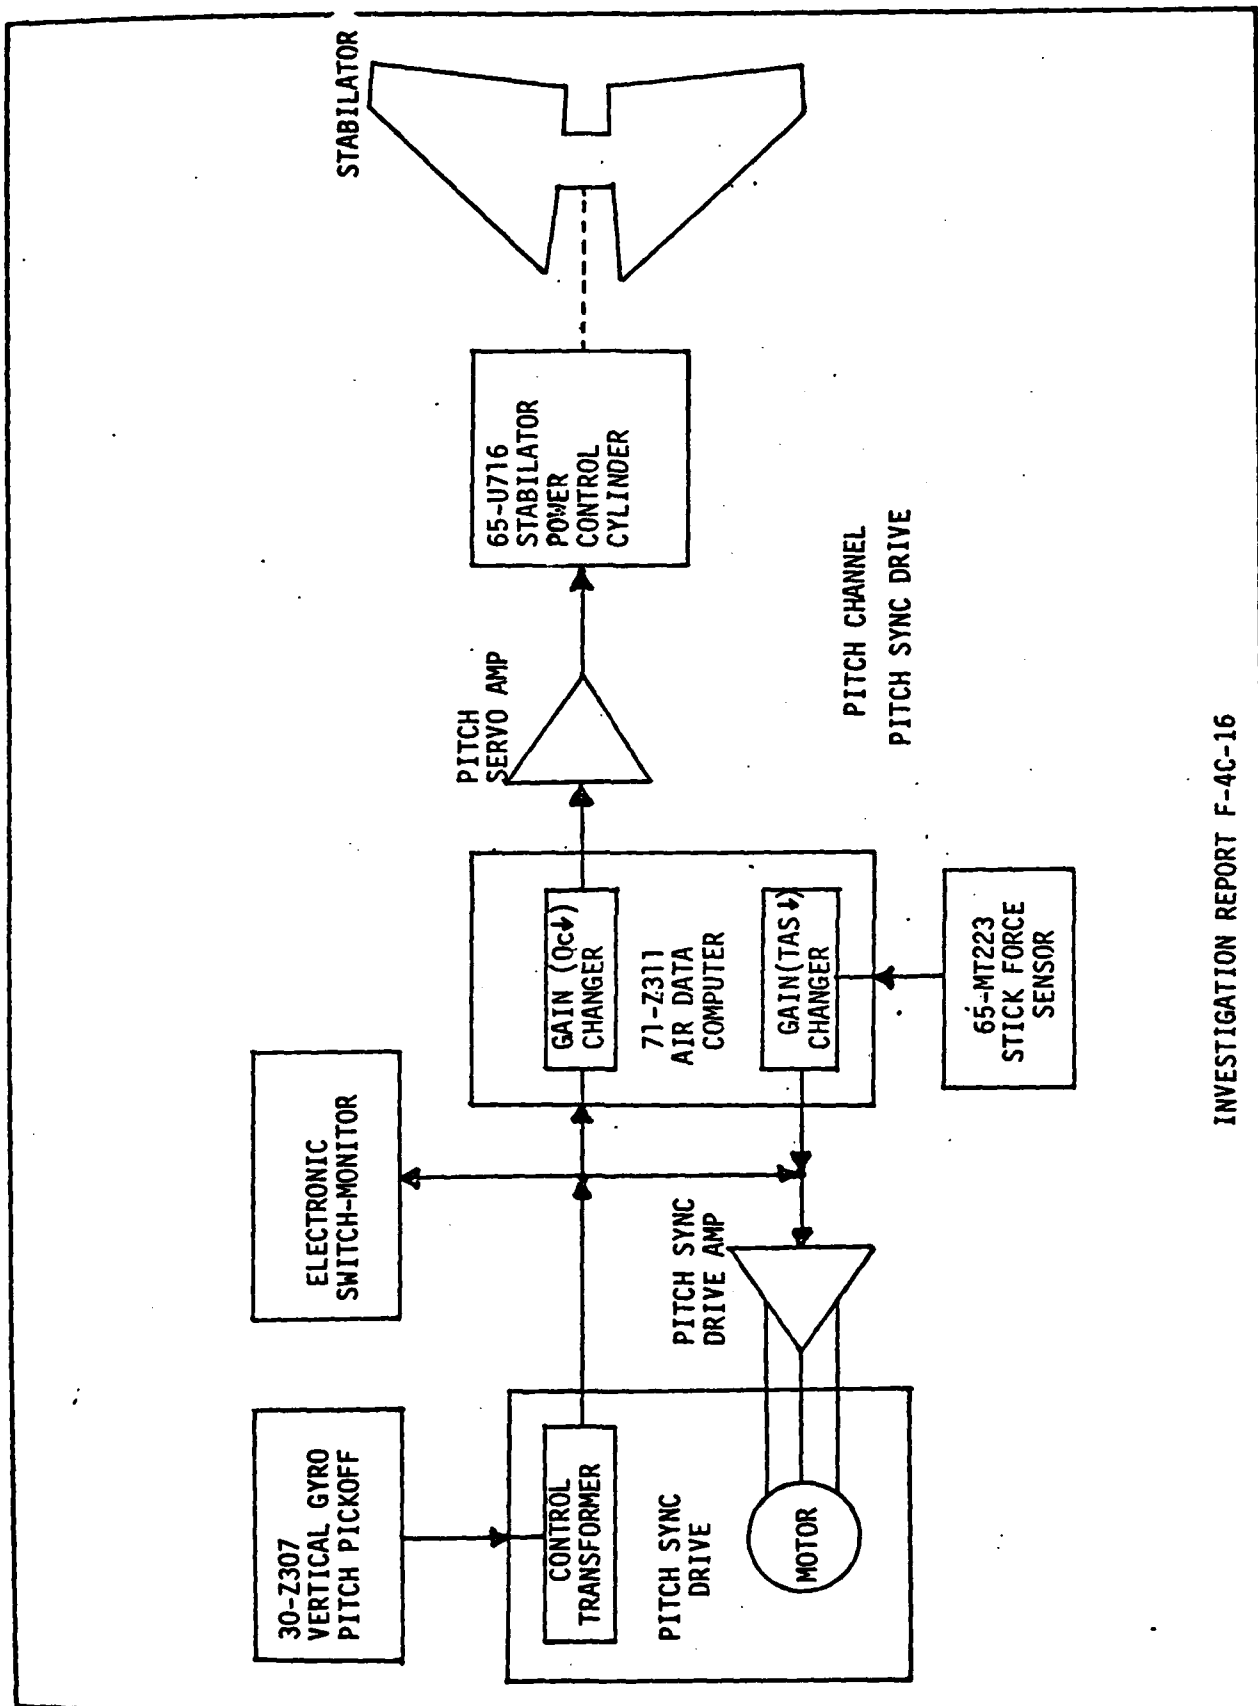
INVESTIGATION REPORT F-4C-16

The signal from the control transformer goes to the CADC for gain changing of pitch attitude. The output of the CADC goes to the Pitch Servo Amplifier. The Pitch Servo Amplifier controls stabilator movement.

The attitude at which the Pitch Sync Drive is set when the Pitch Sync Drive Amplifier is disabled, will be the only attitude the Pitch Sync Drive will hold and this attitude setting cannot be changed.

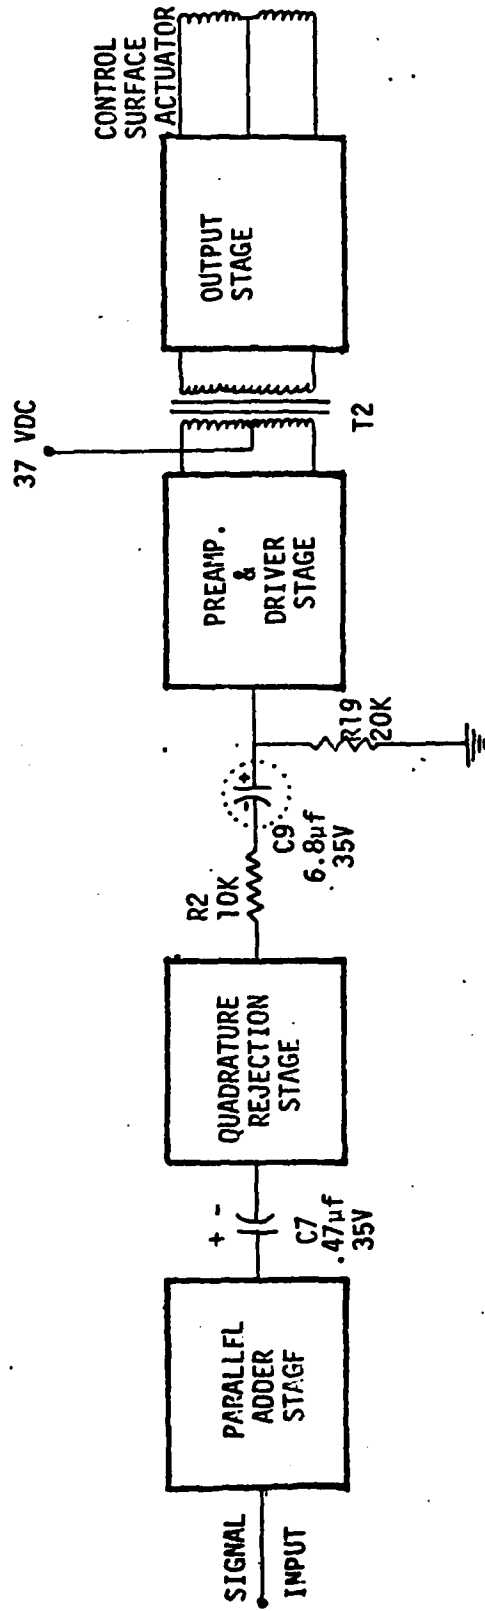
INVESTIGATION REPORT F-4C-18

If capacitor C9 in the Yaw Series Servo Amplifier fails shorted, it could cause the rudder to respond improperly to autopilot maneuvers.
