4. TITLE (and Subtitle) National Program of Inspection of Non-Federal Dams, Tennessee. Coon Creek Dam (Inventory Number TN 04508) near Lenox, Tennessee, Dyer County, TN., Obion River Basin.		5. TYPE OF REPORT & PERIOD COVERED Phase I Investigation Report

This report is based on the findings of the Phase I investigation of OFDBA Site #60-6 on February 4, 1981. This study was done in accordance with "Recommended Guidelines for Safety Inspection of Dams", Office of the Chief of Engineers.

The earth dam is 54 feet high and 726 feet long with a crest width of 25 feet. At normal pool the dam impounds a 125 acre lake (2137 acre-feet) used for flood control. It is in the intermediate size and high hazard potential category. The downstream slope is 2.6H:1V and the upstream slope is 3H:1V.

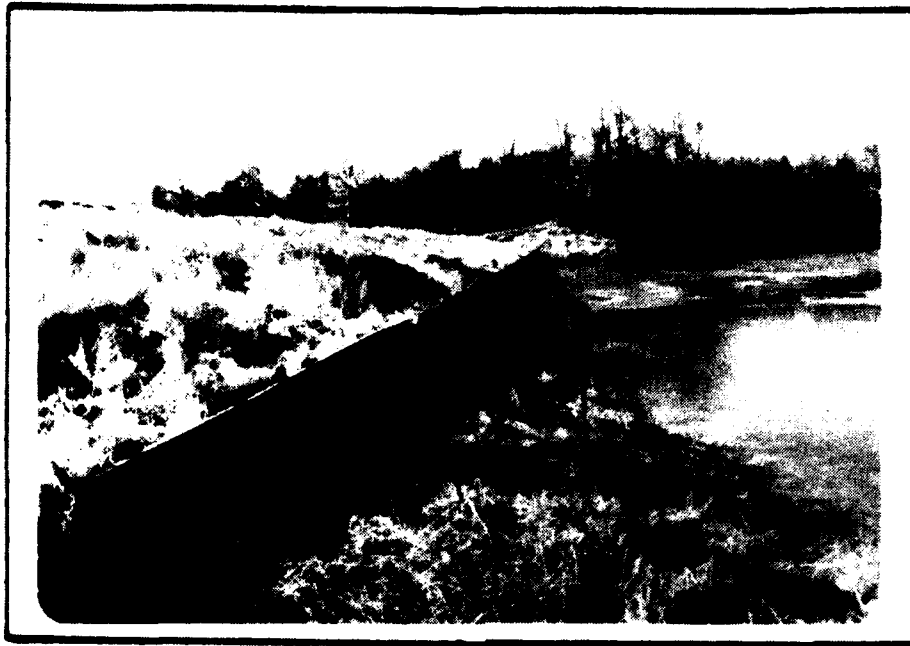
PHOTO NO. 1

Above the water level, the upstream slope is 3H:1V. According to design drawings, there is a 10 foot wide berm on the upstream slope at elevation 360. The berm was reportedly added to increase the safety factor against circular arc failure. At normal pool level, a wooden breakwater fence constructed of 2" x 12" treated boards is provided to decrease erosion from wave action (photo no. 1).

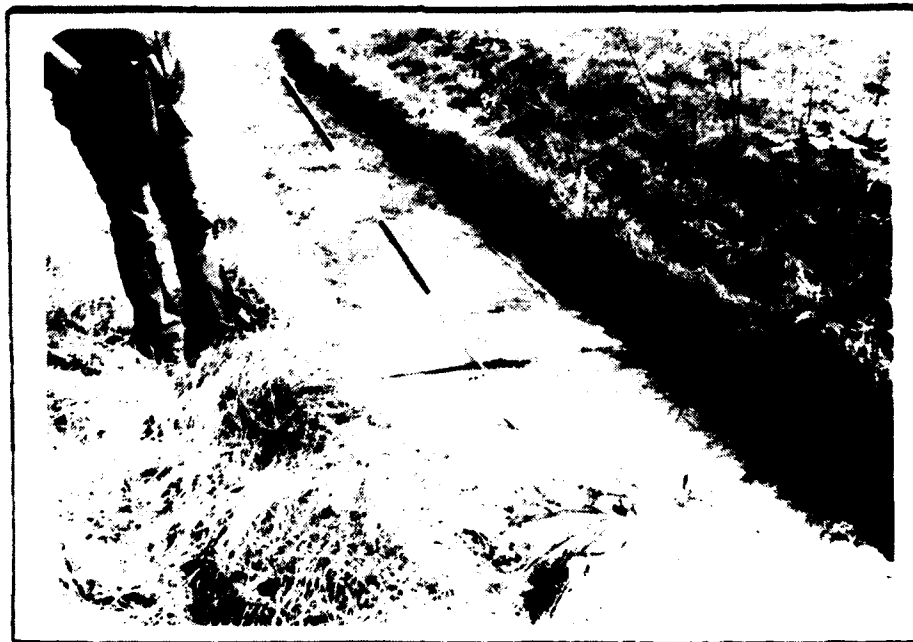
PHOTO NO. 8

Deep holes associated with erosion were also found on the downstream of the crest. The holes appeared to exit on the downstream slope above the upper berm. Fill material was deposited in the concrete drainage channel below (photo no. 8). The deepest hole on the crest was measured to be 8 feet deep vertically (photo no. 6) and appeared to exit from a large hole on the downstream slope (photo no. 7). This hole appeared to be located in line with the drain pipe that extends beneath the dam. There was no evidence to indicate that fill material is entering the pipe. Another large hole is located on the downstream side of the crest near the right end (photo no. 9). The hole is about 3 feet in diameter and several feet deep. It appeared that it is associated with several smaller holes on the downstream slope above the upper berm. Fill material was also observed in the concrete drainage channel in this area.

a. Investigate the cause of the erosive holes on the dam and near the downstream toe of the dam and make recommendations for needed repair. An investigation for the presence of dispersive soils should be included and appropriate recommendations made for treatment if needed.
