4. TITLE (and Subtitle) National Program of Inspection of Non-Federal Dams Tennessee. Nolan Lake Dam (Inventory Number TN 15741) near Memphis, TN, Shelby County, TN, Mississippi River Basin		5. TYPE OF REPORT & PERIOD COVERED Phase 1 Investigation Report

Nolan Dam has an 8.44 acre lake and is located in Shelby County, Tennessee, south of Winchester Road and east of Ross Road, and is an earth fill embankment 14.7 feet high and 640 feet long. The crest varies from 9 feet to 12 feet in width. Facilities for discharge from the reservoir are located in the east abutment and include an inlet section with a bottom width of eight feet and vertical broken concrete masonry walls two feet high. The emergency spillway is crossed by a farm road approximately 50 feet from the entrance and the fill contains four 18 inch corrugated metal pipes protected by a concrete headwall on both sides of the road. A four inch cast iron draw down pipe with a gate valve at the discharge end is located at approximately the center of the dam.

PHASE I INSPECTION
NOLAN DAM
SHELBY COUNTY, TENNESSEE

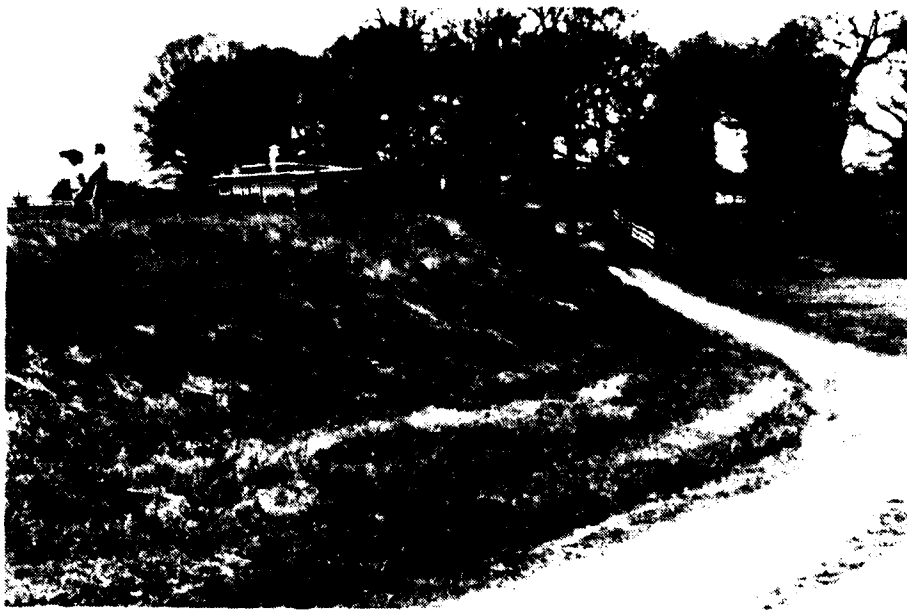
1. Backslope - Nolan Dam. Seep located generally within area bounded by high weeds.

- a. Recommend measures to the owner for the removal and replacement of the upstream slope protection.
 - b. Determine the cause of seepage in the downstream slope and propose remedial measures.

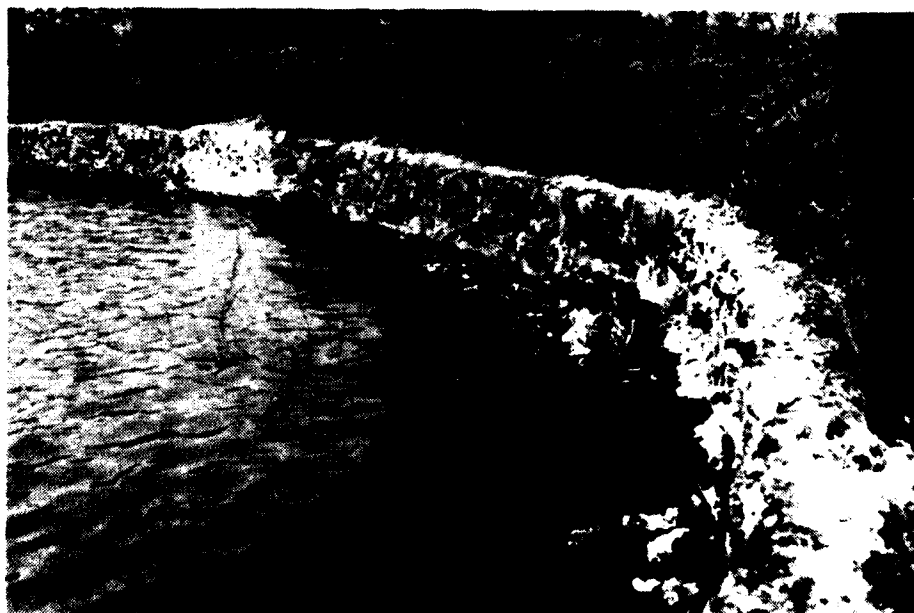
- b. On the basis of engineering judgment and visual observations, the upstream slope appears unstable due to wave action undermining the broken concrete masonry wall and subsequent movement of soil immediately behind the wall.

2. Upstream slope - Nolan Dam. Note masonry wall and patched areas. Also undercutting of foundation.

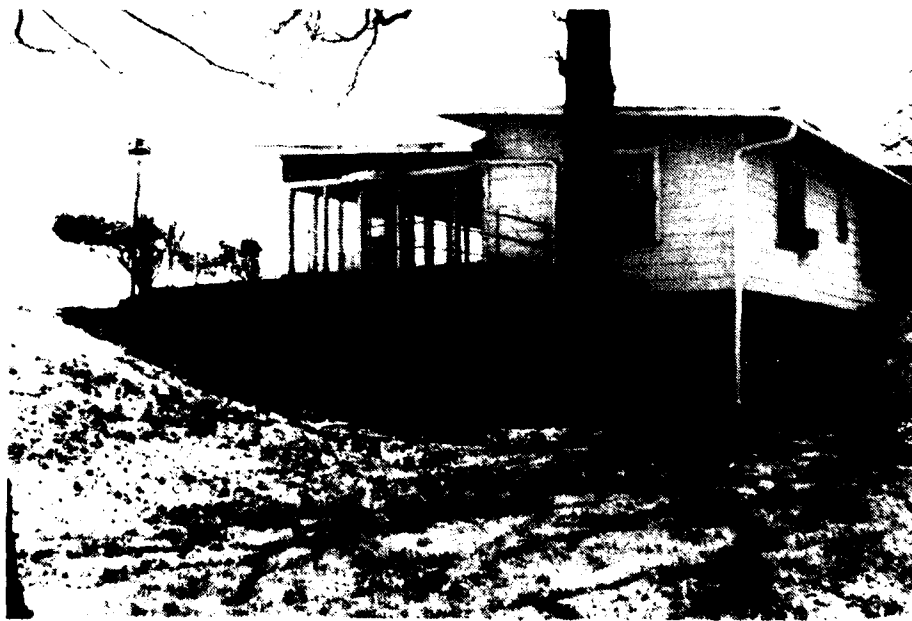
4. House with foundation and lower floor built into downstream slope of Nolan Dam.

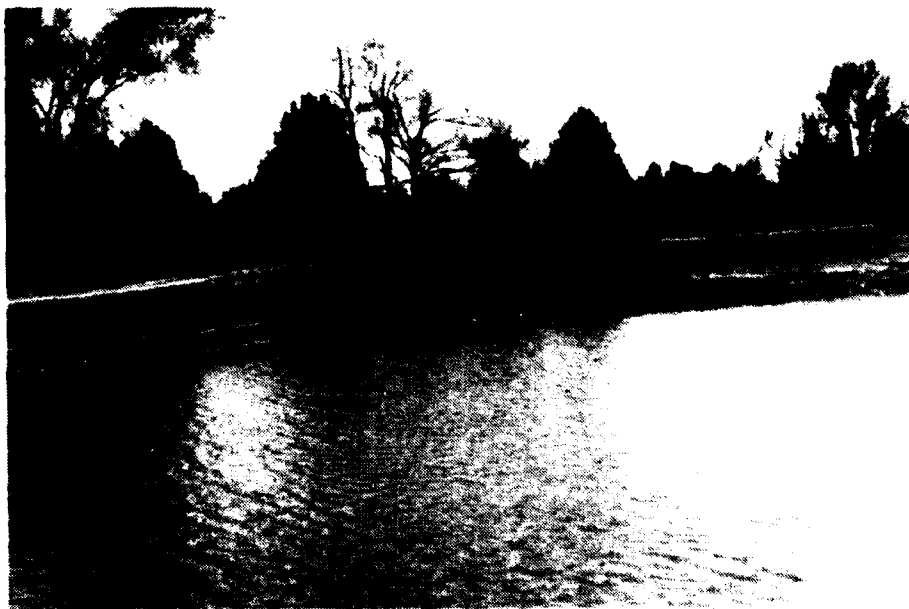
6. Entrance to emergency spillway in right abutment - Nolan Dam.

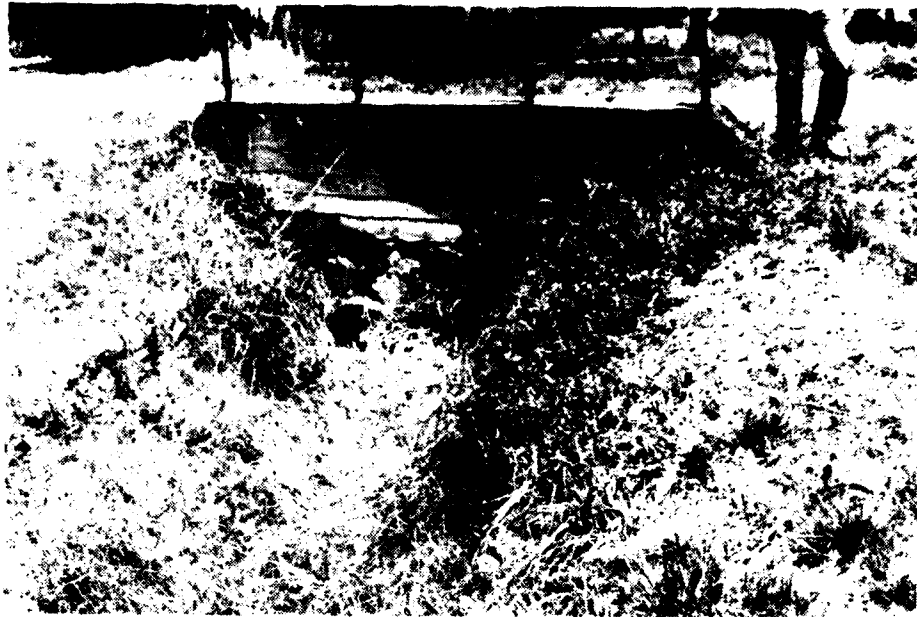
7. Four 18 inch CM pipes under farm road that controls discharge through emergency spillway - Nolan Dam.

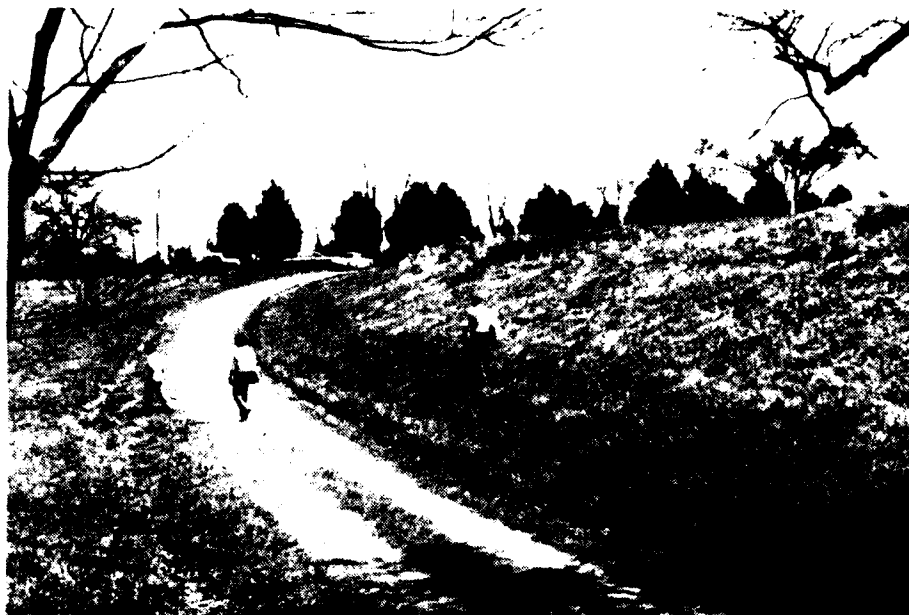
9. Backslope - Nolan Dam. Wet area in high weeds at center photograph. Drawdown pipe outlet of left side of picture where man is standing.
