| REPORT DOCUMENTATION PAGE | | READ INSTRUCTIONS<br>BEFORE COMPLETING FORM |
|---|---|---|
| 4. TITLE (and Subtitle)<br>National Program of Inspection of Non-Federal Dams,<br>Tennessee. Colonial Country Club-16th Hole Dam<br>(Inventory Number TN 15774) near Memphis, Tennessee,<br>Shelby County, TN. Wolf River Basin | | 5. TYPE OF REPORT & PERIOD COVERED<br>Phase I Investigation Report |

PHASE I INSPECTION  
COLONIAL COUNTRY CLUB 16th HOLE DAM  
SHELBY COUNTY, TENNESSEE

PHASE I INSPECTION REPORT  
NATIONAL DAM SAFETY PROGRAM  
TENNESSEE

Name of Dam Colonial Country Club - 16th Hole  
County Shelby  
Stream Tributary Fletcher Creek  
Date of Inspection April 2, 1981

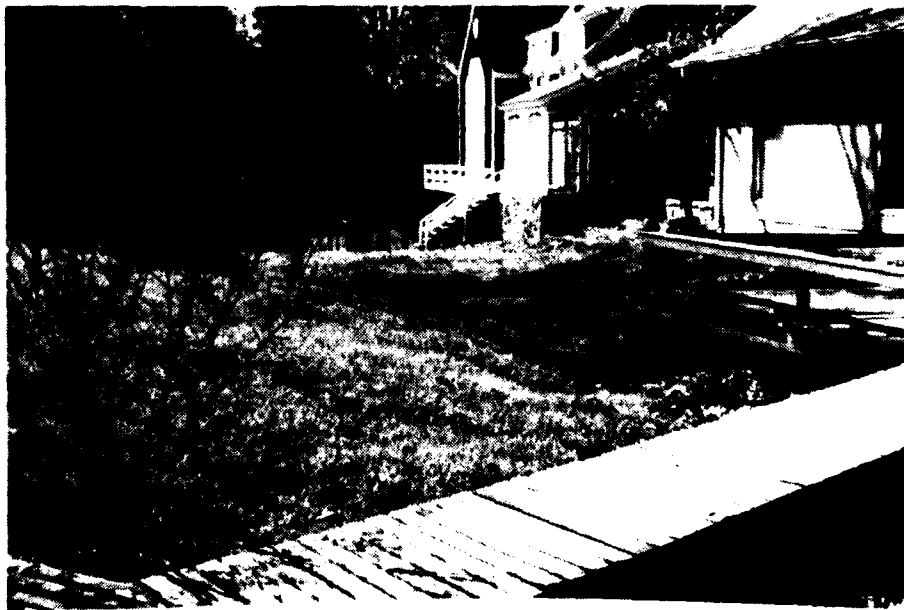
6. Outfall swale for emergency spillway approximately 50 feet from control section.

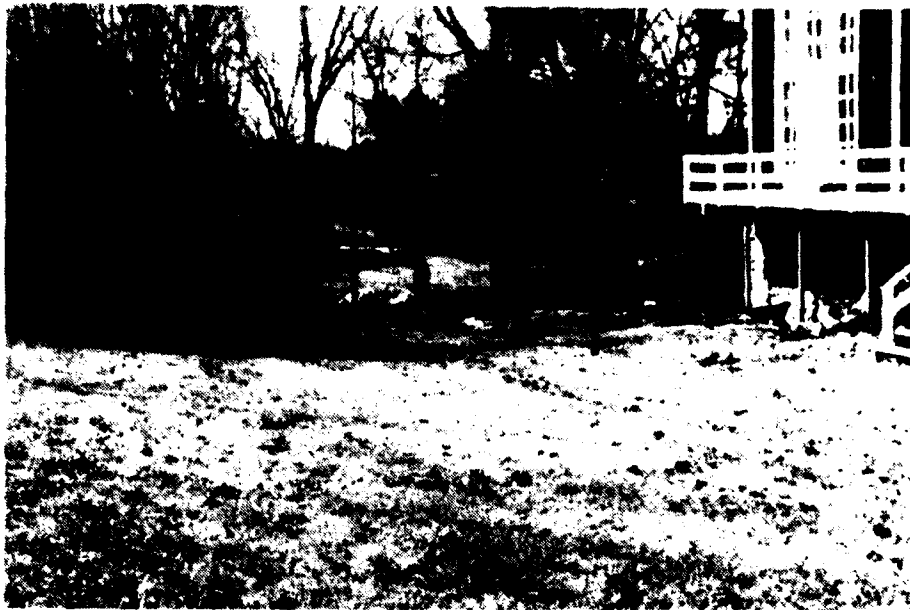
7. Outfall swale for emergency spillway immediately downstream from Photo No. 6.
