| REPORT DOCUMENTATION PAGE | | READ INSTRUCTIONS<br>BEFORE COMPLETING FORM |
|---|---|---|
| 4. TITLE (and Subtitle)<br>National Program of Inspection of Non-Federal Dams<br>Tennessee. Red Boiling Springs Dam No. 1 (Inventory<br>Number TN11104) near Red Boiling Springs, Tennessee<br>Macon County, TN., Barren River Basin | | 5. TYPE OF REPORT & PERIOD COVERED<br>Phase 1 Investigation Report |

Red Boiling Springs Dam No. 1

Macon County

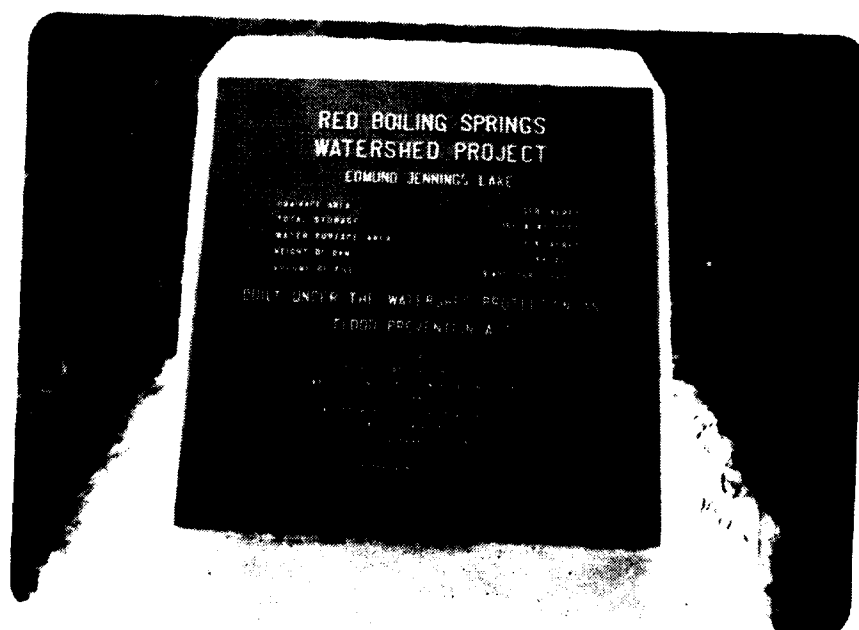
PHOTO NO. 18

- Photo No. 18 - Monument plaque.
- Photo Nos. 19 & 20 - Aerial shots.
