4. TITLE (and Subtitle) National Program of Inspection of Non-Federal Dams Tennessee. Houser Creek Dam No. 2 (Inventory Number TN 13114) near Union City, Tennessee, Obion County, TN., North Fork Obion River Basin.		5. TYPE OF REPORT & PERIOD COVERED Phase 1 Investigation Report

PHASE I INSPECTION  
HOUSER CREEK DAM NO. 2  
OBION COUNTY, TENNESSEE

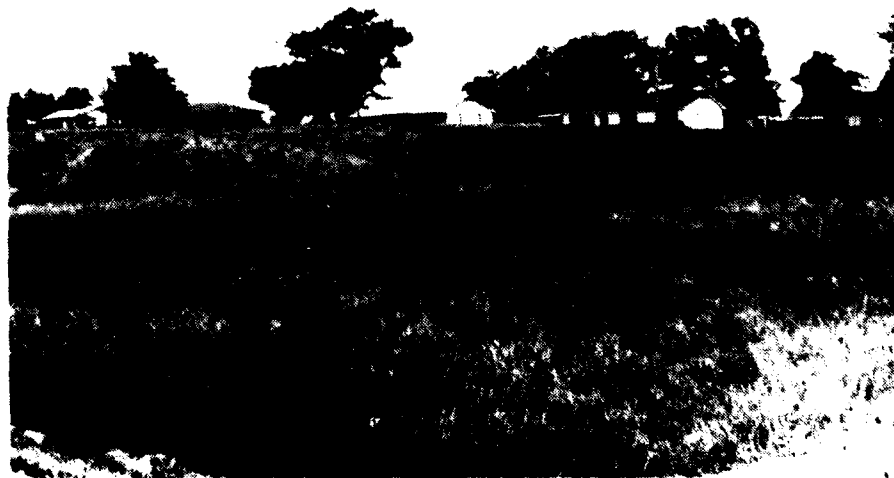
The emergency spillway is located in the left abutment. The general condition of the emergency spillway is fair. The entrance channel is grown up with trees and other small brush and in the control section, trees are beginning to grow. The exit channel presently is clear with the lower section under cultivation.

10. Control section of emergency spillway in east abutment.
